## SERVICE BULLETIN

AT18-009

### MIL ON WITH DTC P0776, P1715 AND MAY HAVE HESITATION AND/OR LACK OF POWER

**APPLIED TRANSMISSION:** CVT (RE0F10D)

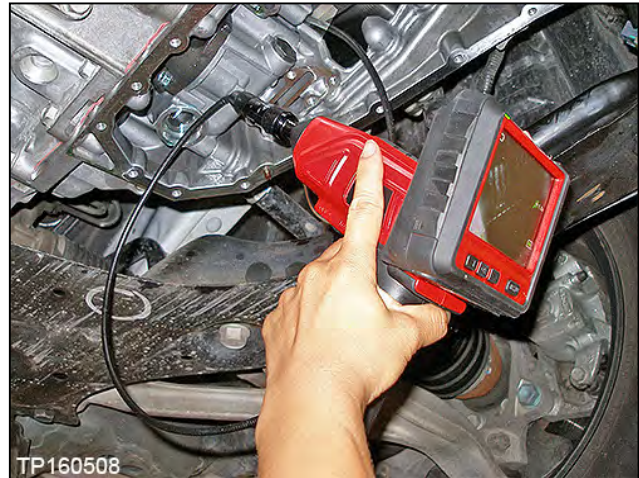
Figure 5

- Holding the borescope with one hand allows for turning the tire with the other hand (see Figure 5).

**CAUTION:** If the tire is rotated in the rearward rotation, the camera lens may get caught between the belt and pulley.

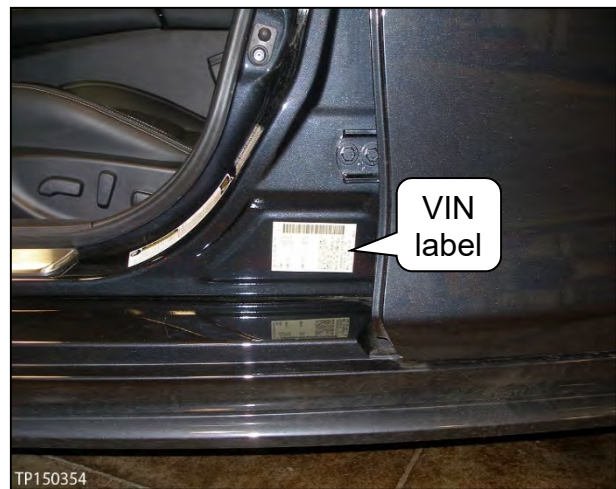
Figure 7

- f. If CVT replacement is required based on the inspection results from 6b and 6d, use borescope J-51951 to record a continuous video, 15 seconds or less, of the most severe evidence of belt slip and the VIN on the F.M.V.S.S. certification label (VIN label). See Figure 7.

**NOTE:** This required video must be attached to the Powertrain Call Center CVT Preauthorization Form (in ASIST) prior to calling for authorization. Failure to submit a continuous video will cause immediate denial of request for replacement.

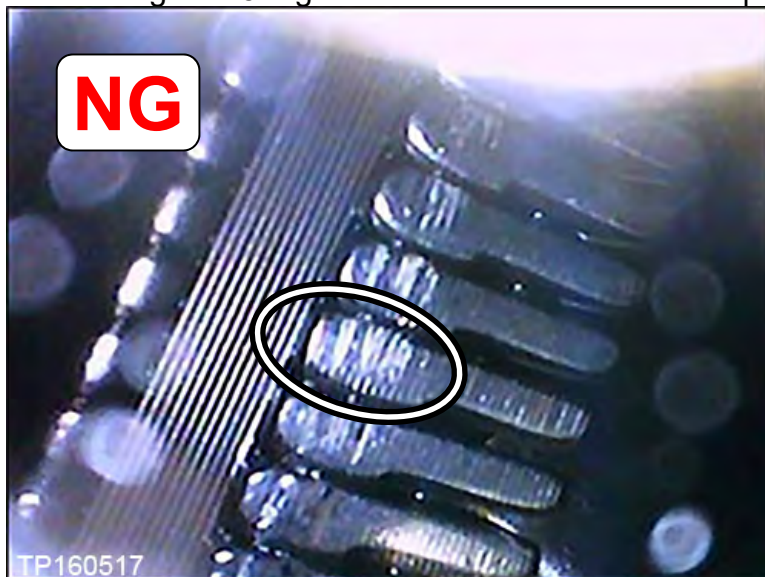
Pictures in Figure 15-Figure 17 were taken with borescope J-51951.

Figure 15: Example of NG belt

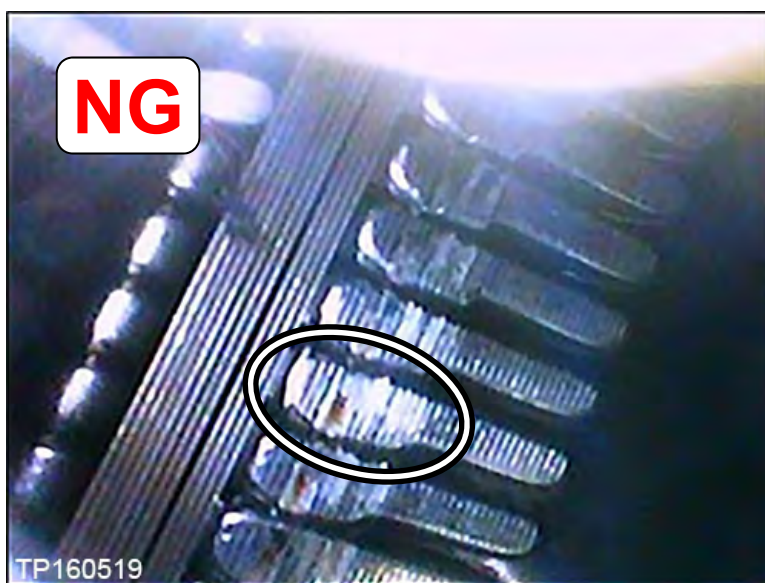
Figure 17: Example of NG belt

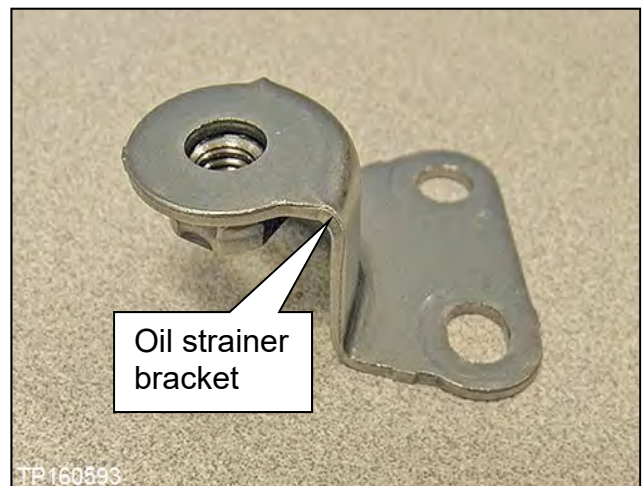
Figure 18

**NOTE:** If an oil strainer bracket was removed, discard it. An oil strainer bracket (Figure 18) will not be used with the new oil strainer.
