# Technical Service Bulletin

## 19 Water pump/thermostat housing revised repair procedure

19 18 96 2052657/2 November 21, 2018. Supersedes Technical Service Bulletin Group 19 number 18-95 dated October 24, 2018 for reasons listed below.

Model(s)	Year	VIN Range	Vehicle-Specific Equipment
All	2013 - 2019	All	EA888 Evo2 Engine

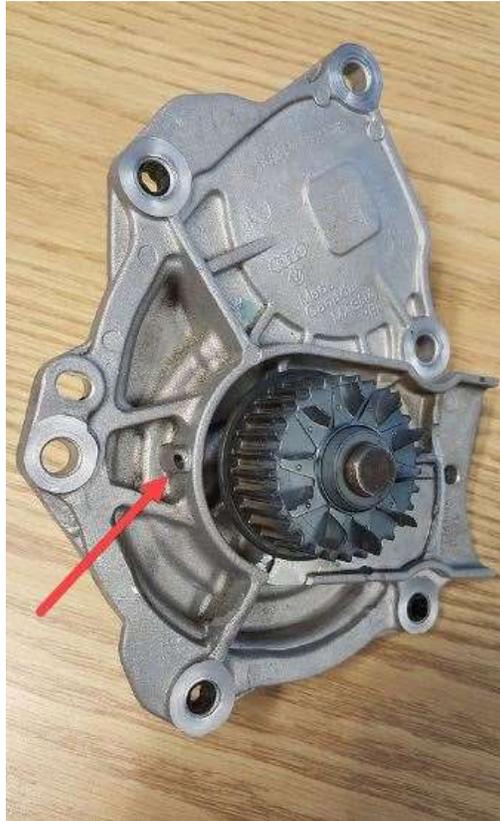
*Figure 1. Control/weep hole leak.*

The water pump should only be replaced if there is a leak from the control/weep hole (Figure 1). All other replacements are unauthorized i.e. combination replacement with the thermostat housing.

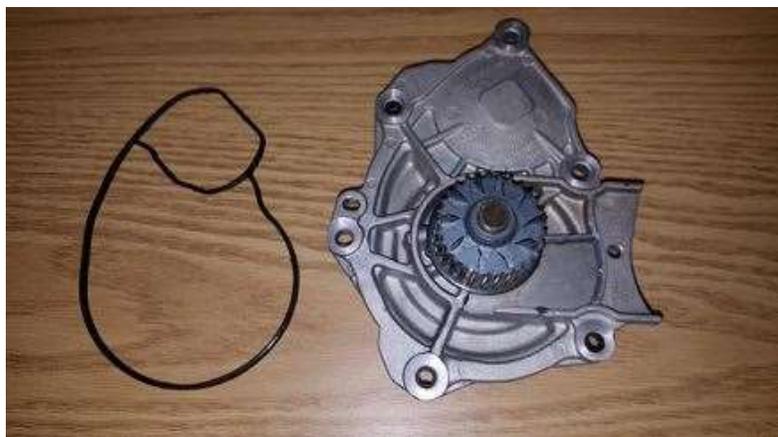
*Figure 2. Water pump replacement required parts.*

**Do not** replace the thermostat housing and the water pump at the same time. Regardless of which part is replaced, the seal must be replaced as well (Figure 2 and 3).

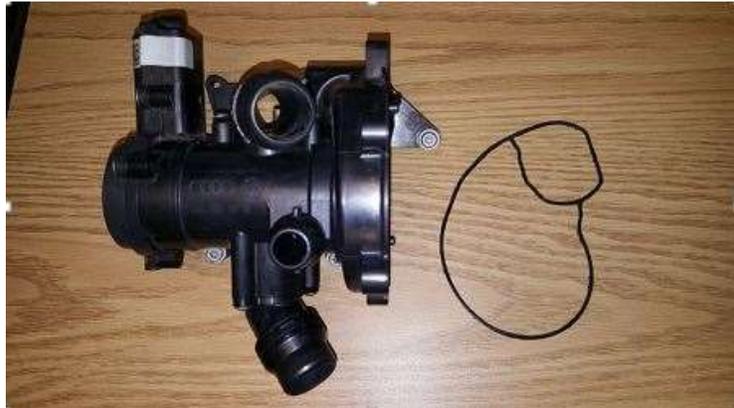
*Figure 3. Thermostat housing replacement required parts.*
