**Complaint - Tail Light Has Visual Defects (161/18)**

Vehicle Type: **Cayenne (9YA)**

Model Year: **As of 2018 up to 2019**

Subject: **Tail light**

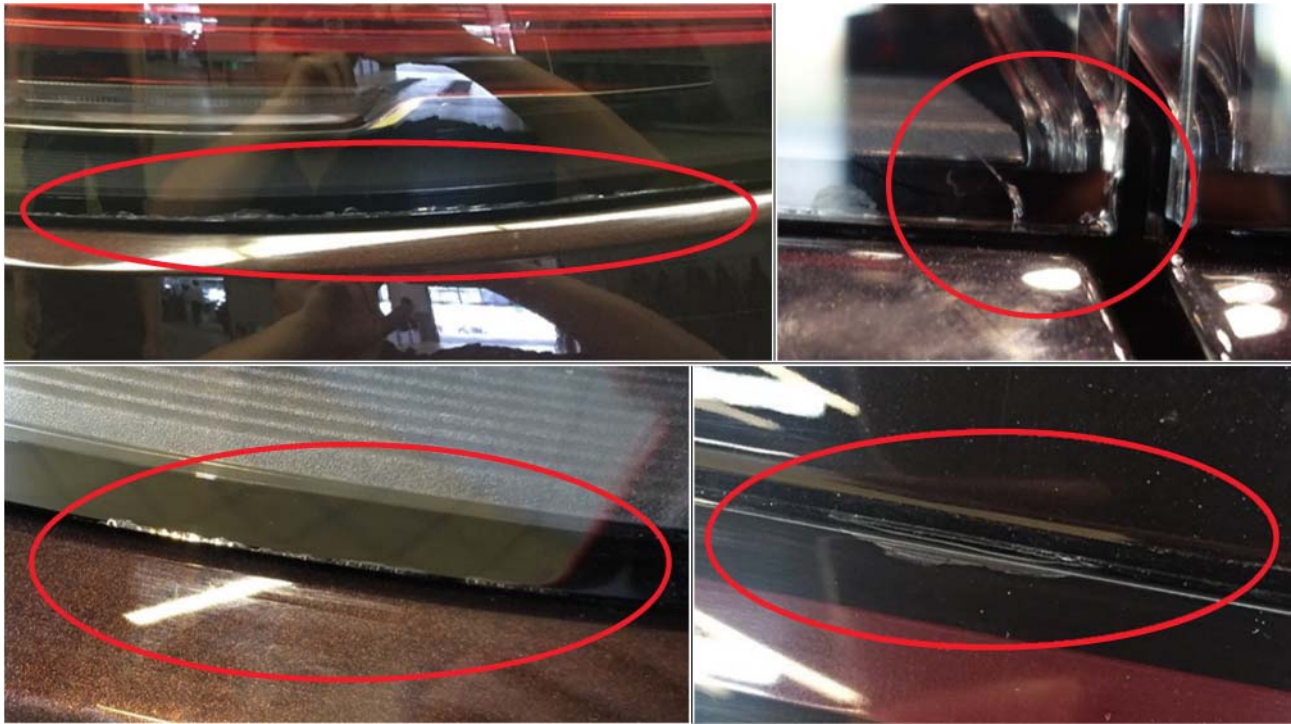
Differentiation: **Case 1: Slight defect**

⇒ *Example 1: Slight defect*

⇒ Replacement **must** be delayed until the new tail light is available in sufficient quality and quantity.

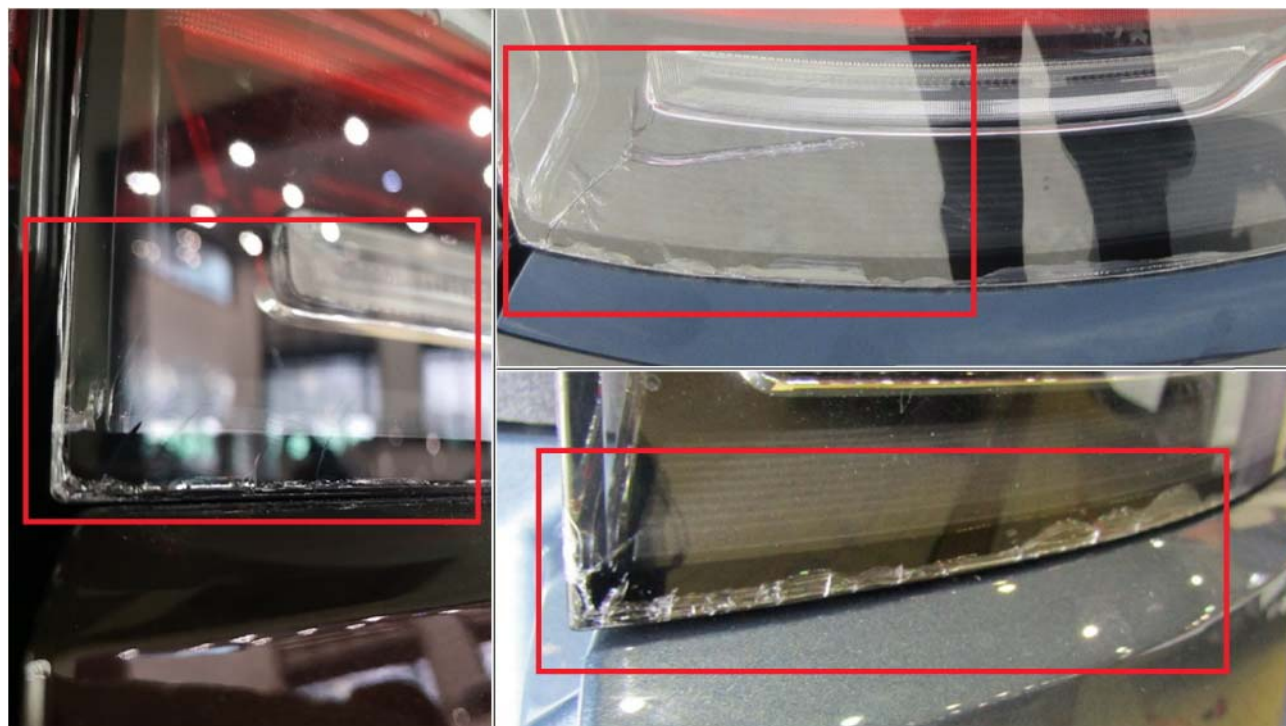
Example 2: Significant defect

**Case 2: Significant defect**

⇒ *Example 2: Significant defect*

⇒ The tail light may be ordered and replaced.
