Countries: CANADA, UNITED STATES **Document ID:** IK0900132
Availability: ISIS, Bus ISIS, IsSIR **Revision:** 0
Major System: COOLING **Created:** 12/17/2018
Current Language: English **Last Modified:** 12/18/2018
Other Languages: NONE **Author:** Brandon Akridge
Viewed: 71

Title: CE Propane/Gas Bus coolant hose kink

Applies To: CE Bus with a Propane/Gas engine

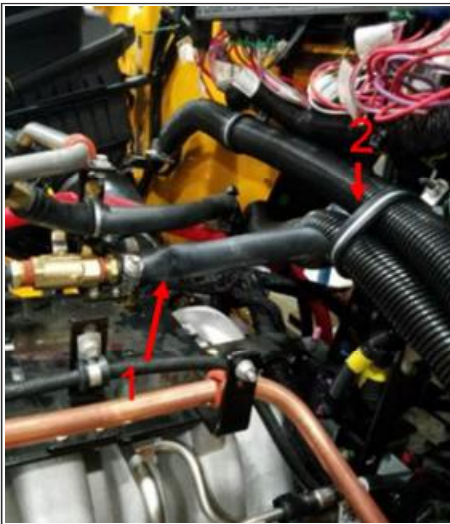
Figure # 1: Engine coolant supply hose

SES light on for Mechanical System Not Responding or Out of Adjustment//Engine Coolant Temperature. Also poor heater performance inside the bus.

Step	Action	Decision
#2	DIAGNOSTIC: Is your coolant hose kinked like in figure #1? You may have to remove the hose loom to reveal the kink.	Yes. Proceed to Repair Section
		No. Search for other iKnow documents.

Item 1: Hose kink

Item 2: Double clamp

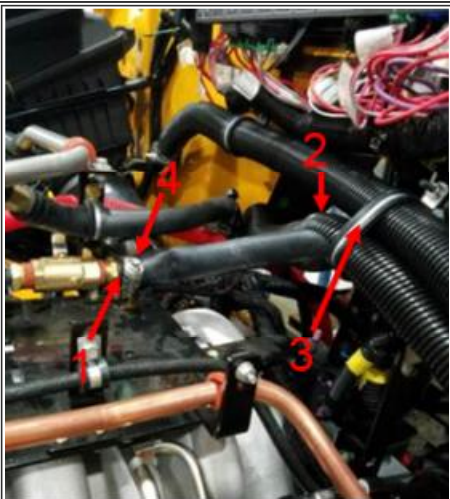
Figure # 2: Hose kink on supply line

Item 1: Straight pipe fitting

Item 2: Loom

Item 3: Double clamp

Item 4: Hose clamp

1. Turn off coolant supply valve connected to straight pipe fitting (item 1) shown in Figure 2
2. Clamp off coolant line approximately 5" to the right of the double clamp (item 3) in Figure 2
3. Remove double clamp from supply and return lines and discard

4. Pull back loom as far as needed
5. Loosen hose clamp, item 4, and slide up hose for later use
6. Remove hose from straight fitting (note: coolant will come out the end of the hose, so a small bucket may be useful)
7. Remove straight fitting and discard

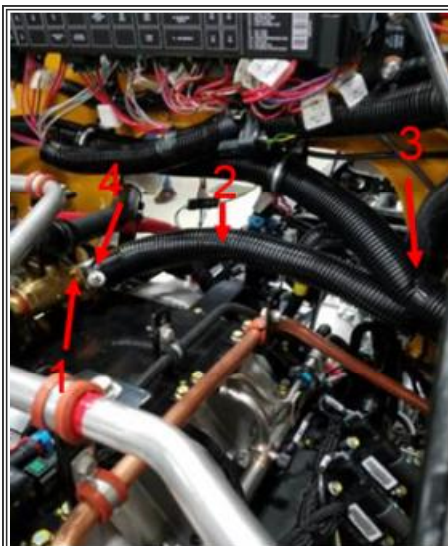
Figure #3: Updated hose routing

Item 1: 45 degree fitting
Item 2: loom
Item 3: single clamp
Item 4: hose clamp

1. install new 45 degree fitting as shown in Figure 3
2. install hose onto new 45 degree fitting, please note that the hose may need to be shortened to optimize the fit
3. slide hose clamp back down into position and tighten
4. reinstall loom cover over the hose, it may need trimming also
5. Install single clamp to return line only in place of the previously removed double clamp
6. Hose routing should look similar to Figure 3. Supply valve can be reopened and line clamp remove.
