Title: Gasoline Engine Bus Fuel System Issues

Applies To: PSI Gasoline Bus

This article identifies known fueling issues on the PSI 8.8 Gasoline Engine for Bus.

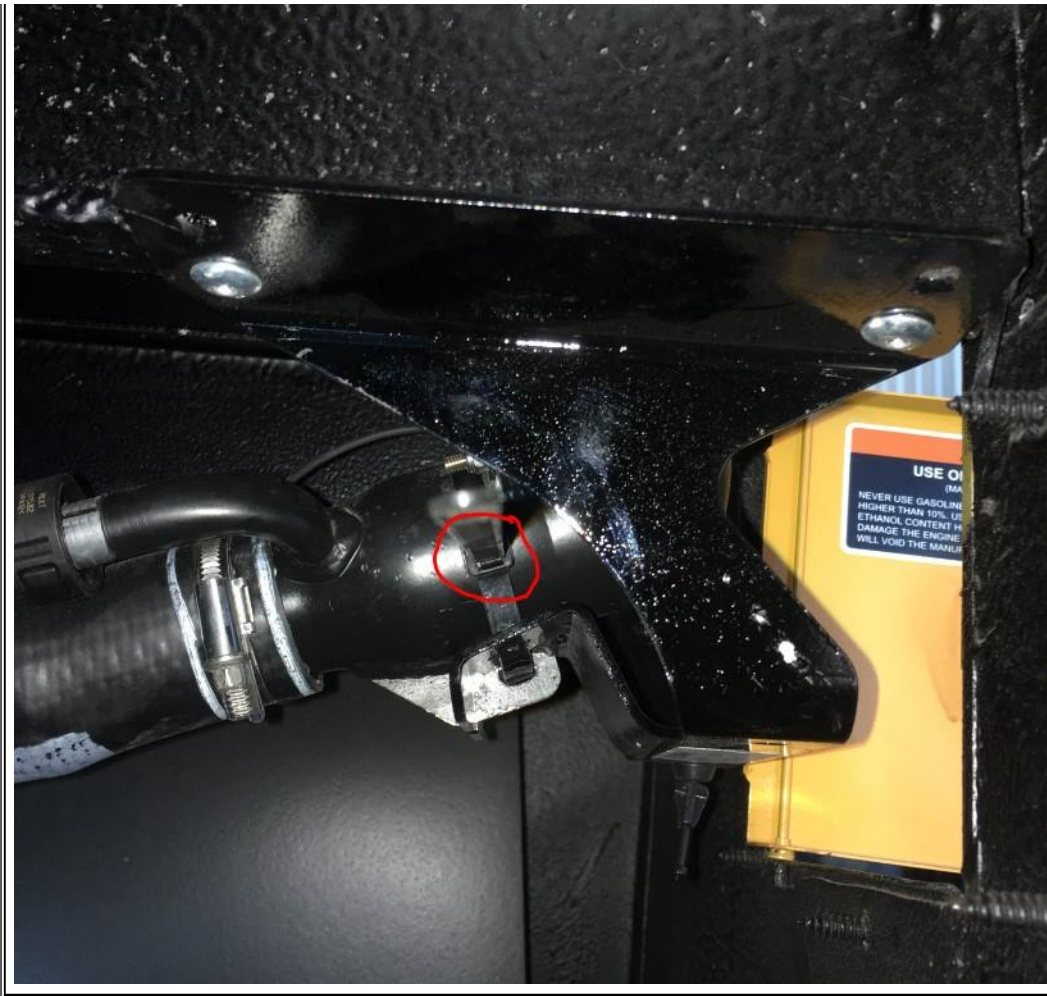
Step	Action	Decision
3	DIAGNOSTIC: Verify fuel fill receiver is properly secured with the tie strap as per Figure 3	Yes: Go to Step 4
	YES/NO QUESTION? Is the fuel fill receiver properly secured and NOT able to be moved by hand just holding on to the fuel cap?	No: Go to Repair steps for Filler Neck Alignment

1. Step 1: Follow the procedure in the link on Step 2
2. Step 2: [Fuel Neck Alignment Repair](#)
3. Step 3: Verify that the fuel receiver tie strap is locked in the correct position as per drawing in the procedure above

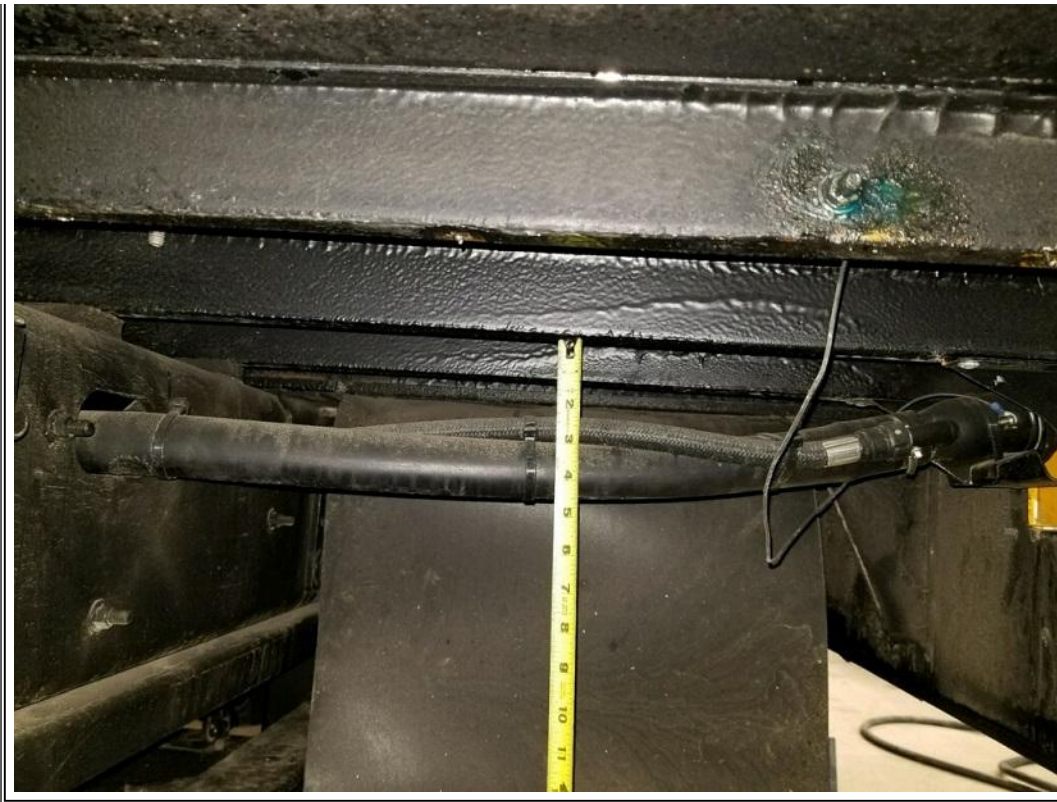
Step	Action	Decision
5	DIAGNOSTIC: Inspect the fuel fill hose for excessive droop. Acceptable droop Figure 4 Unacceptable droop Figure 5 YES/NO QUESTION? Is the fuel fill hose within acceptable droop range?	Yes: Go to Step 6
		No: Go to Repair steps for Fuel Fill Hose Excessive Droop

Figure 4 - Acceptable Fuel Fill Hose Droop

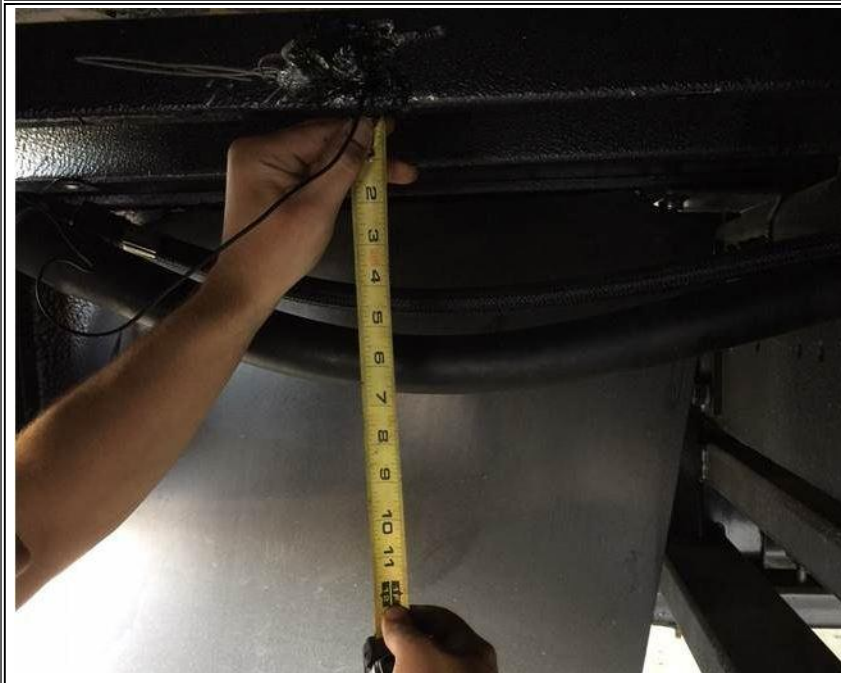
Figure 5 - Unacceptable Fuel Fill Hose Droop

1. Step 1: Disconnect the fuel fill hose from the filler neck
2. Step 2: Trim the fuel fill hose as needed
3. Step 3: Reattach the hose as per "Fuel Neck Alignment" steps above
4. Step 4: Make sure to torque fill neck clamp to 38-42 in-lb

5. Step 5: Verify the fuel fill hose is within an acceptable droop range
6. *****Note***** Do not over stretch the fuel fill line to the point it is effecting the angle of the fuel fill receiver

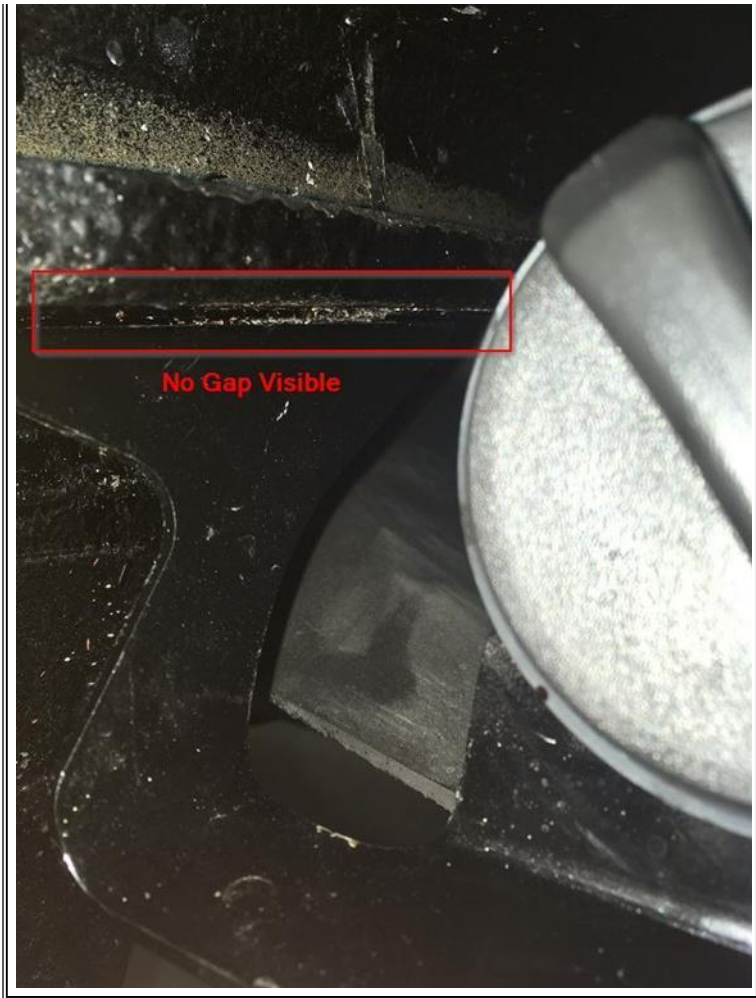
Step	Action	Decision
7	DIAGNOSTIC: Check the gap between the fuel fill receiver bracket and the sill Acceptable - Figure 6 Unacceptable - Figure 7 YES/NO QUESTION? Is there excessive gap noticed?	Yes: Go to Repair Steps for Fill Receiver Bracket Repair
		No: Go to Step 8

Figure 6 - Acceptable Fill Receiver Bracket Gap

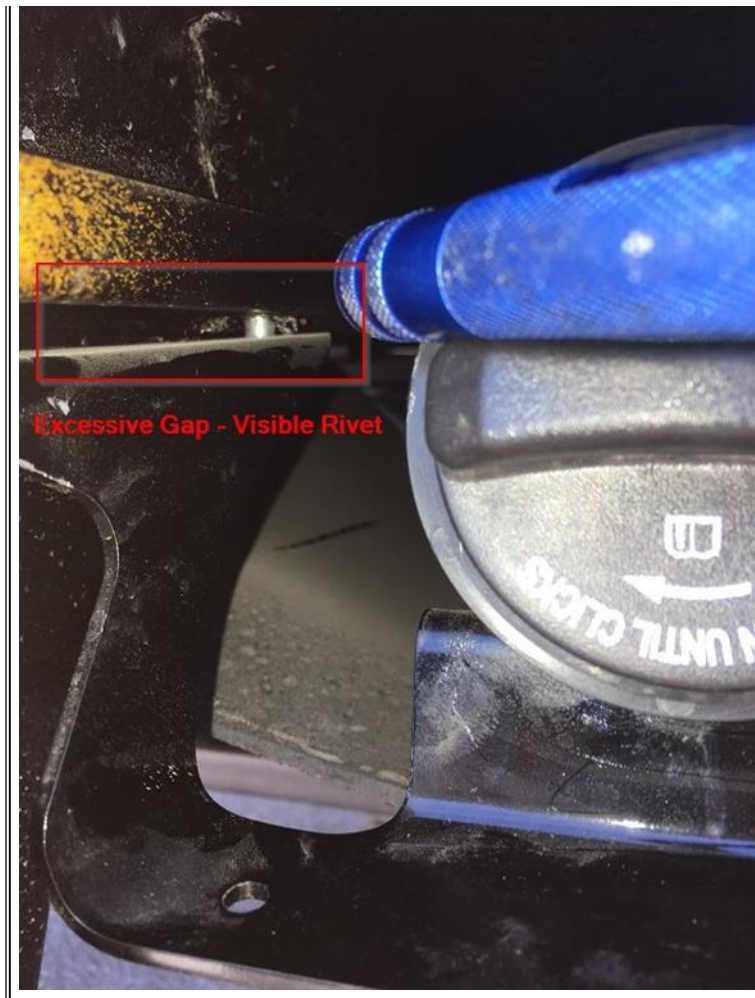
Figure 7 - Unacceptable Fill Receiver Bracket Gap

1. Step 1: Remove the fill hose protecting diaper
2. Step 2: Remove the fill receiver from the support bracket by cutting the zip ties
3. Step 3: Drill out the improperly installed rivets
4. Step 4: Mount the bracket flush to the sill with new rivets
5. Step 5: Reinstall the fuel fill receiver as per "Fuel Neck Alignment Repair" above
6. Step 6: Verify the gap is no longer visible
