SI B16 08 18
Fuel Supply Systems

SERVICE ACTION: CHECK AND, IF NECESSARY, REPLACE THE FUEL DELIVERY UNIT

G12 (7 Series Sedan)	G30 (5 Series Sedan)	G32 (6 Series Gran Turismo)	
----------------------	----------------------	-----------------------------	--

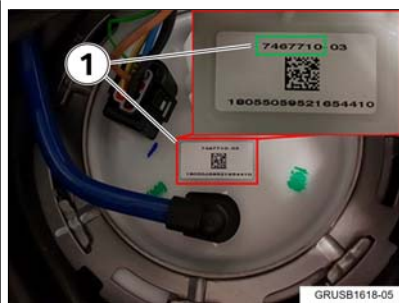
Check the part number of the fuel delivery unit (1). Compare the installed part number with the table below.

- If the part number matches any of the part numbers listed (for model/engine) no further repair is necessary.
- If the installed part number does not match the listed number in the table, the fuel delivery unit will need to be replaced. Continuing following the **Repair Instruction 16 14 090 Removing and installing/replacing the delivery unit (without drawing off and filling fuel)** to replace the fuel delivery unit.
