## Closed-circuit Current Measurement

This Service Information bulletin supersedes SI B61 08 00 **dated November 2015**.

Closed circuit current needs to be measured.

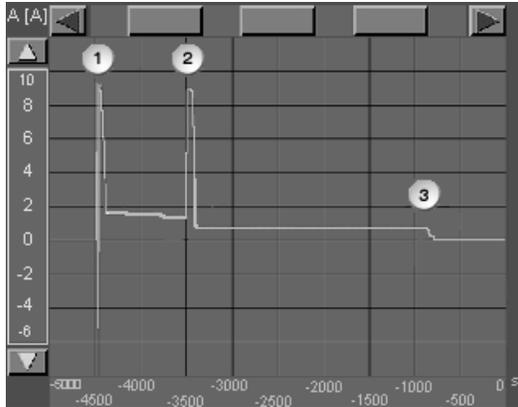
## E65 normal closed circuit current values

Regular sleeping without additional wakings to check the coolant temperature and with transport mode OFF (battery switch ON):

No	Time	Event	Typical current values
1	0 - 3 min	Reaching the idle state	10 to 15 A depending on the equipment.
	3 - 16 min	Vehicle sleeping	0.9 to 1.5 A depending on the consumer units that are switched on (e.g. map-reading light or glove box light).
2	16 - 17 min	PM wakes up the vehicle: First consumer shutdown (roof)	8 to 11 A depending on the equipment.
	17 - 60 min	Vehicle sleeping	approx. 300 mA.
3	60 min	Second consumer shutdown (body)	< 30 mA depending on the equipment.

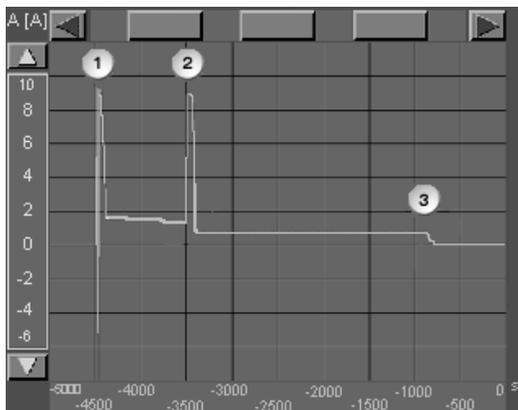
## E70 normal closed circuit current values

Regular sleeping without additional wakings to check the coolant temperature:

No	Time	Event	Typical current values
1	0 - 3 min	Reaching the idle state	6 to 15 A depending on the equipment.
	3 - 8 min	Vehicle sleeping	0.4 to 1.5 A depending on the consumer units that are switched on (e.g. map-reading light or glove box light).
2	8 - 9 min	FRM wakes up the vehicle: Consumer unit shutdown.	6 to 10 A depending on the equipment.
	9 - 30 min or 9 - 60 min	Vehicle sleeping	500 to 650 mA depending on the equipment.
3	30 or 60 min	Shutdown of terminal 30g	< 25 mA depending on the equipment.

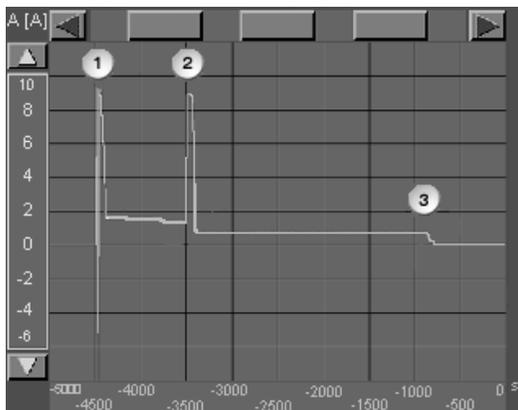
## E6x up to 3/2006 normal closed circuit current values

Regular sleeping without additional wakings to check the coolant temperature:

No	Time	Event	Typical current values
1	0 - 3 min	Reaching the idle state	8 to 14 A depending on the equipment.
	3 - 16 min	Vehicle sleeping	0.8 to 1.5 A depending on the consumer units that are switched on (e.g. map-reading light or glove box light).
2	16 - 17 min	KBM wakes up the vehicle: Consumer unit shutdown.	6 to 10 A depending on the equipment.
	17 - 30 min or 17 - 60 min	Vehicle sleeping	approx. 250 mA.
3	30 or 60 min	Shutdown of terminal 30g	< 30 mA depending on the equipment.

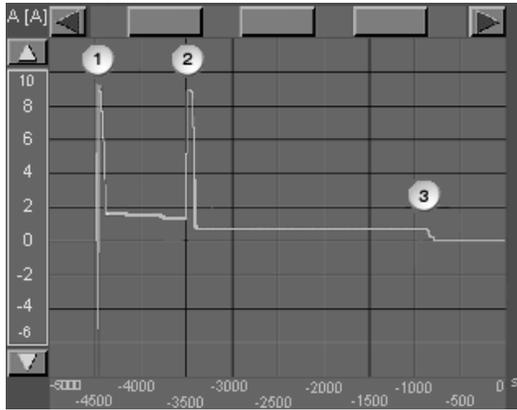
## E6x from 3/2006 normal closed circuit current values

Regular sleeping without additional wakings to check the coolant temperature:

No	Time	Event	Typical current values
1	0 - 3 min	Reaching the idle state	8 to 14 A depending on the equipment.
	3 - 8 min	Vehicle sleeping	0.8 to 1.5 A depending on the consumer units that are switched on (e.g. map-reading light or glove box light).
2	8 - 9 min	KBM or FRM wakes the vehicle: Consumer unit shutdown.	6 to 10 A depending on the equipment.
	9 - 30 min or 9 - 60 min	Vehicle sleeping	- Before model year 03/2007: approx. 250 mA - As of model year 03/2007: approx. 450 mA (relay of the electric fan at terminal 30g).
3	30 or 60 min	Shutdown of terminal 30g	< 30 mA depending on the equipment.

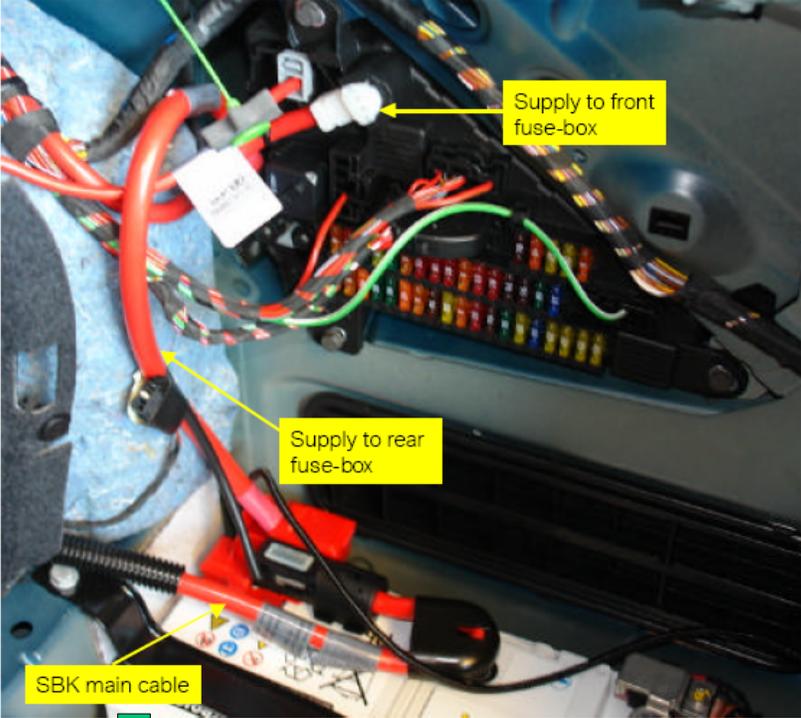
- Using the 50A clamp isolate which circuit the draw is coming from.
- Clip on each cable as noted in the diagram.

**Example 1 – Excessive drain on front fuse box circuits**

By connecting the 50A clamp to the 25mm cable at the rear fuse box that supplies power to the front fuse box the problem can be seen to be on this circuit.

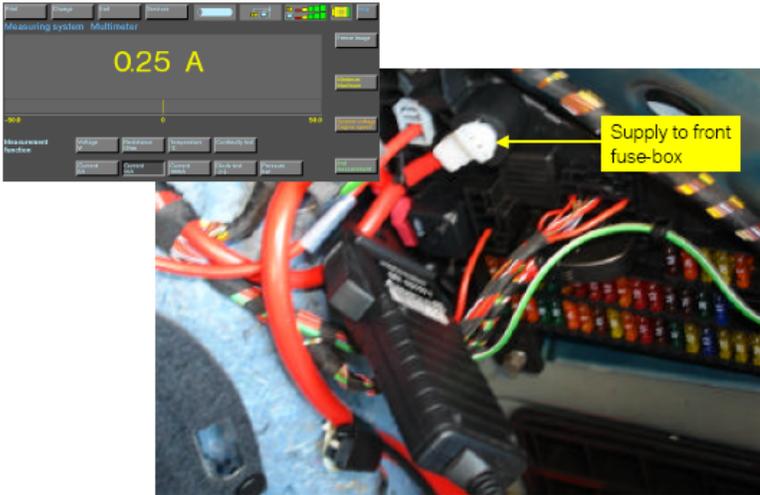
- If the front fuse box is the source of the draw, remove Fuse 18 (Terminal 30g\_f power supply).
- Refer to the wiring diagram for each component that is powered by F18. For example; CCC/MASK, TCU, CDC, CA, etc
- Isolate the cause of the draw by disconnecting fuses from the front fuse box.

This circuit must be split further now by separating Terminal 30g\_f power supply (designated 30\_KGM in the wiring diagram) – remove fuse 18 to do this.

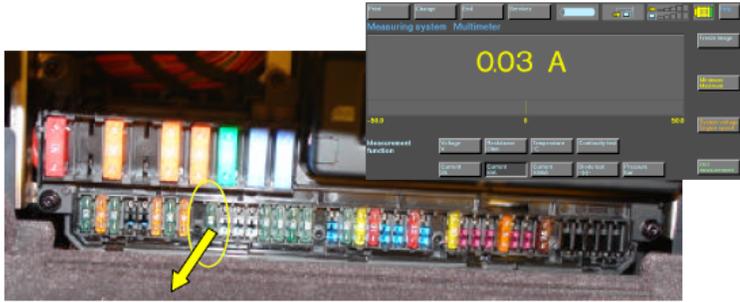
**Closed-circuit current troubleshooting**  
 - Continue troubleshooting by disconnecting each fuse one at a time until the draw is found.

On removal of the fuse the excessive current is no longer present, refit the fuse and allow the car to shut down again. Now disconnect each unit on the Terminal 30g\_f circuit to locate the problem.

If the drain is still present with Terminal 30g\_f isolated the problem is on the main terminal 30 power supply. Continue isolating each circuit by removing fuses one at a time until the excessive closed circuit current is removed.

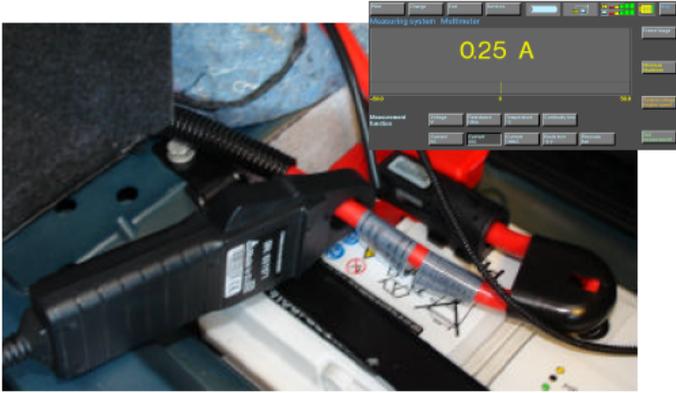
**Example 2 – Excessive drain on SBK main cable**  
 With the 50A clamp connected to the SBK main cable the fault is localised to the components within the engine compartment.

Refer to the schematic diagram before disconnecting components or fuses on this circuit to eliminate the excessive drain.

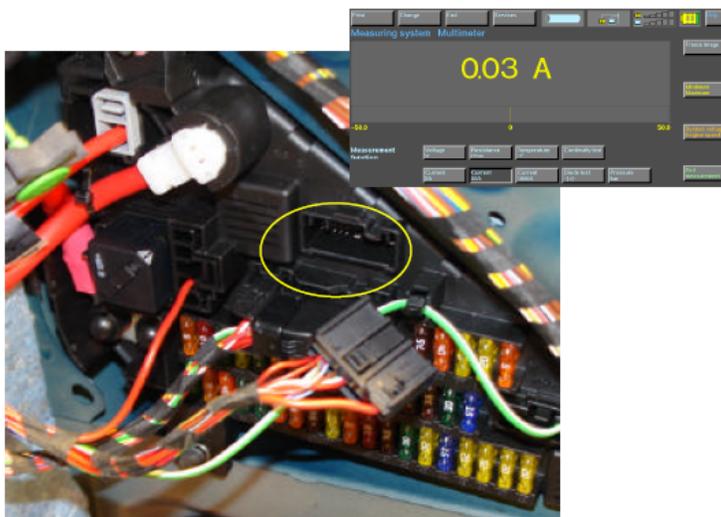
If the excessive closed circuit current cannot be traced to one of the main power supplies, then the problem is on one of the circuits supplied directly from the rear fuse-box.

With the 50A clamp connected back on the battery earth cable, disconnect the individual plug connections at the rear fuse-box to locate where the problem is – this connection is the power supply for the KGM.

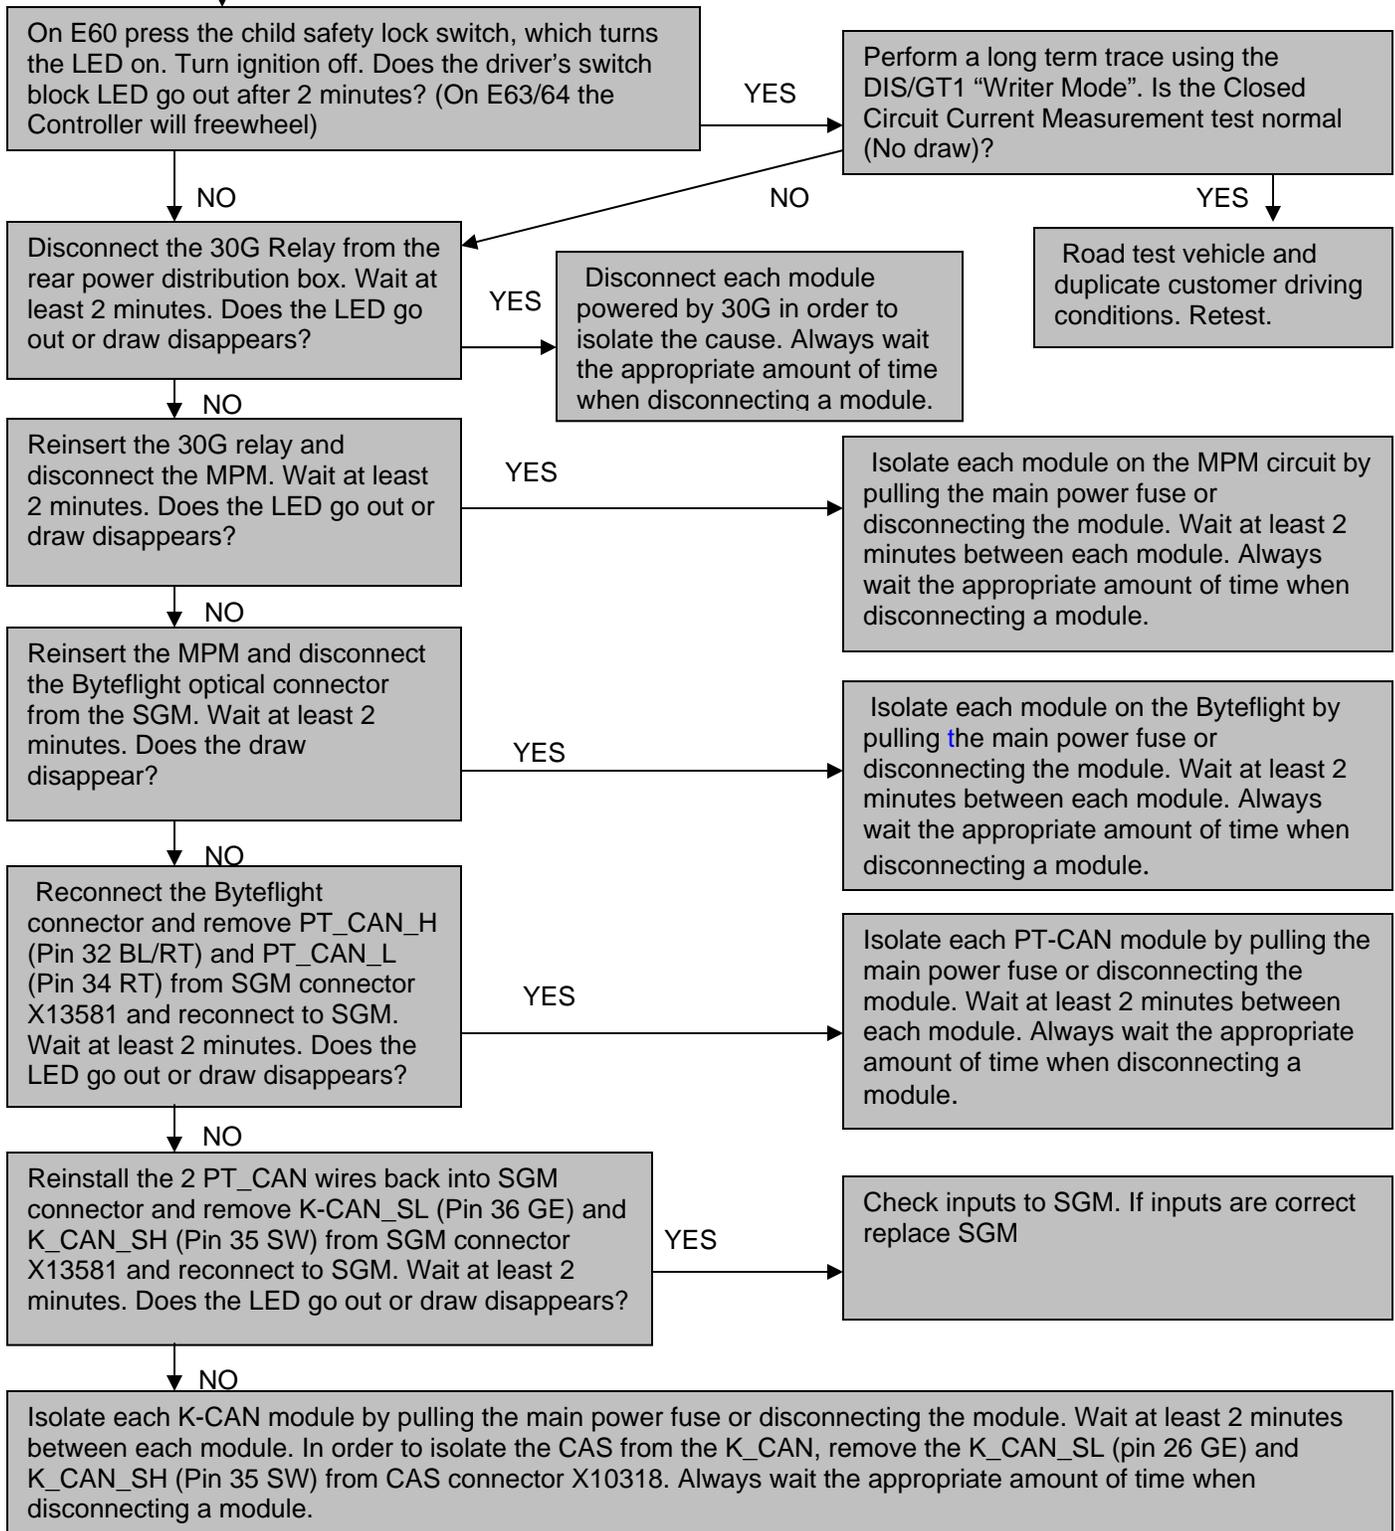
## E6x up to 9/05 production Excessive Closed Circuit Current

**Before proceeding further with this troubleshooting chart always perform the "Energy Diagnosis" test plan using the DIS/GT1.**

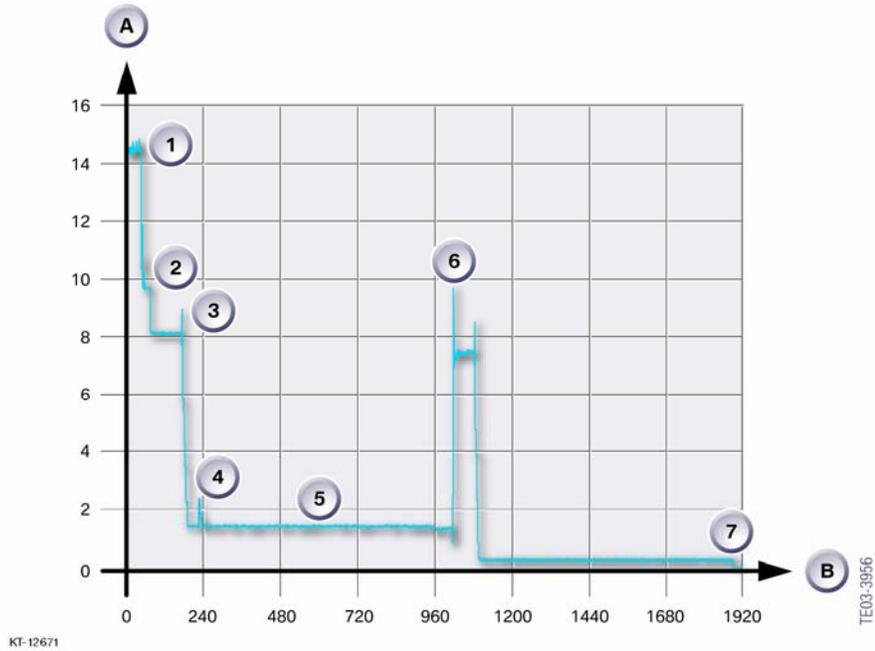
Fig. 3: Current progression after terminal 15 off, E60

Index	Explanation
<b>A</b>	Current (Amps)
<b>B</b>	Time (seconds)
<b>1</b>	Terminal 15 off
<b>2</b>	Terminal R off
<b>3</b>	Bus at rest: Green "child safety lock" lamp in driver's door switch block goes out
<b>4</b>	Current peak, air conditioning flaps closed
<b>5</b>	Dependent on load cutout (map reading light, vanity mirror)
<b>6</b>	16 min.: terminal VA off
<b>7</b>	30 min. or 60 min., telephone cutout terminal 30g, selector lever SMG/EGS LED goes out

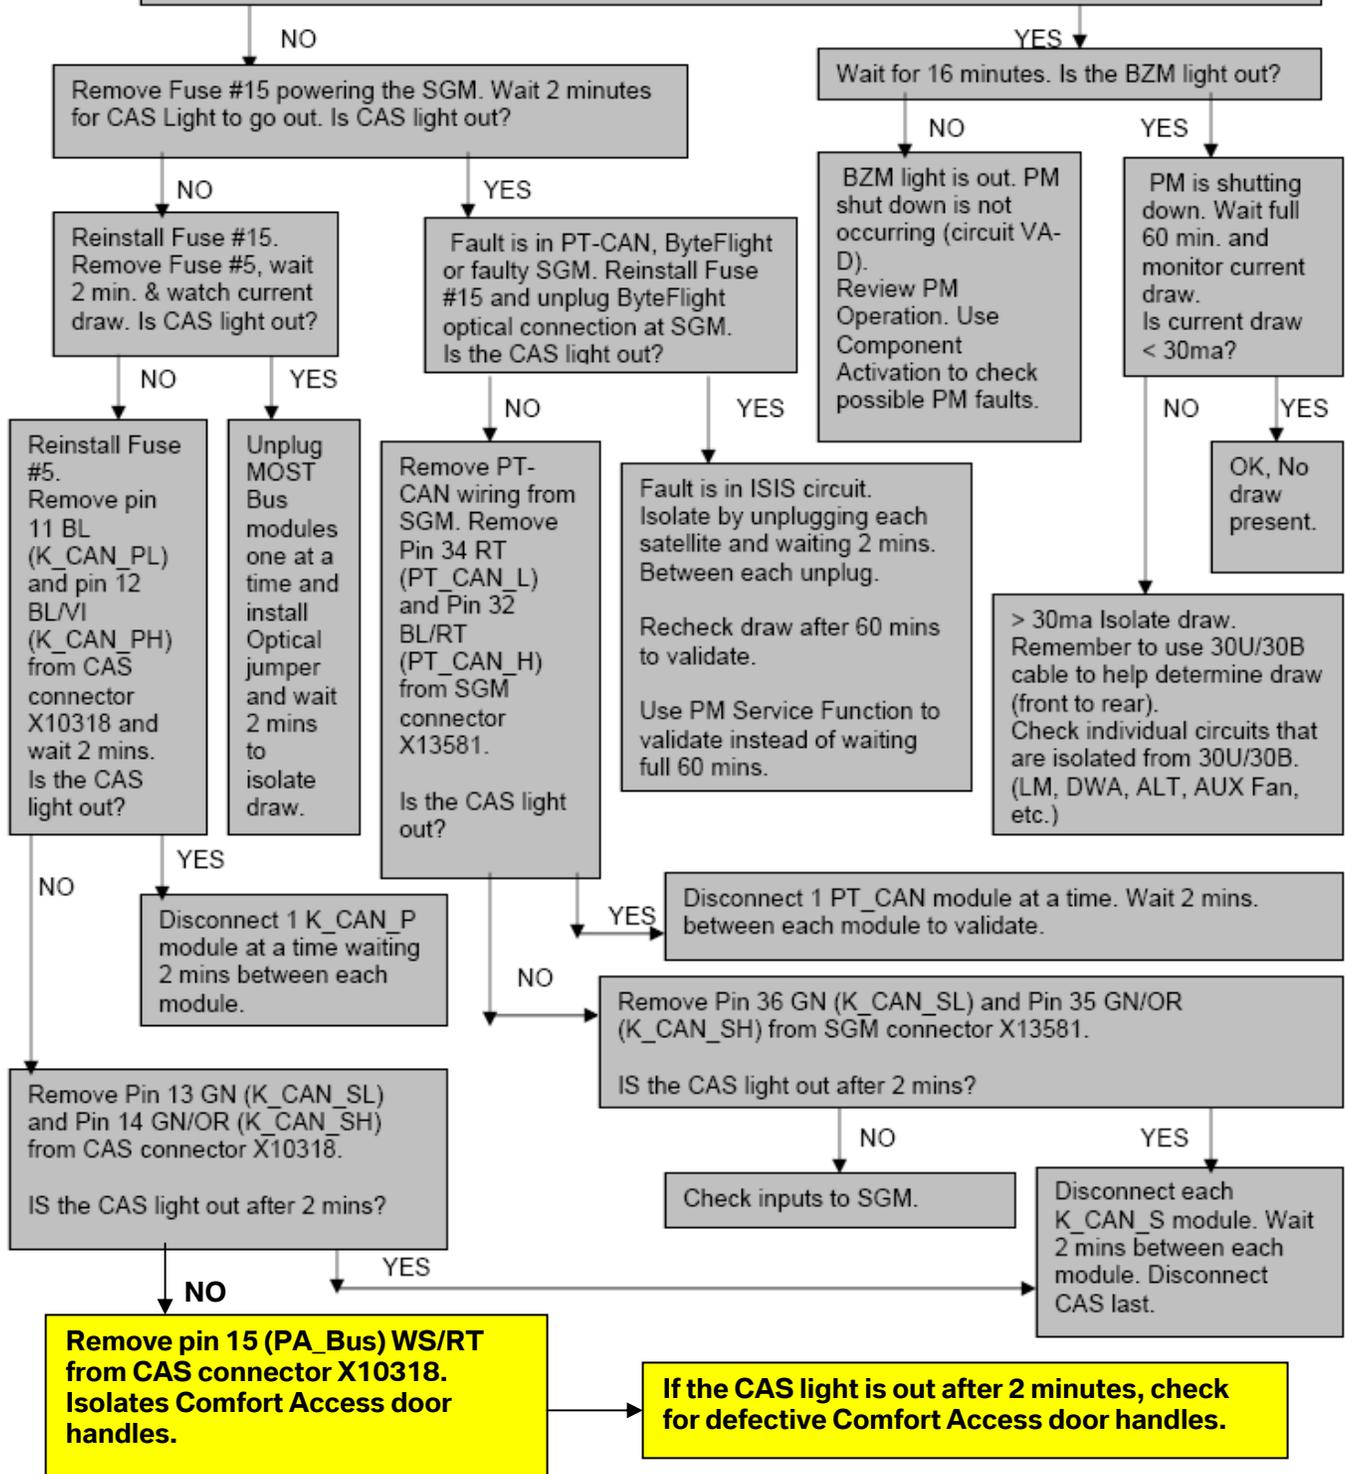
## E65 (From 3\_2004) Excessive Closed Circuit Current

*Before proceeding further with this troubleshooting chart always perform the "Energy Diagnosis" test plan using the DIS/GT1.  
Key Off = KL"0", Wait 2 min. Is the CAS LED Out?*

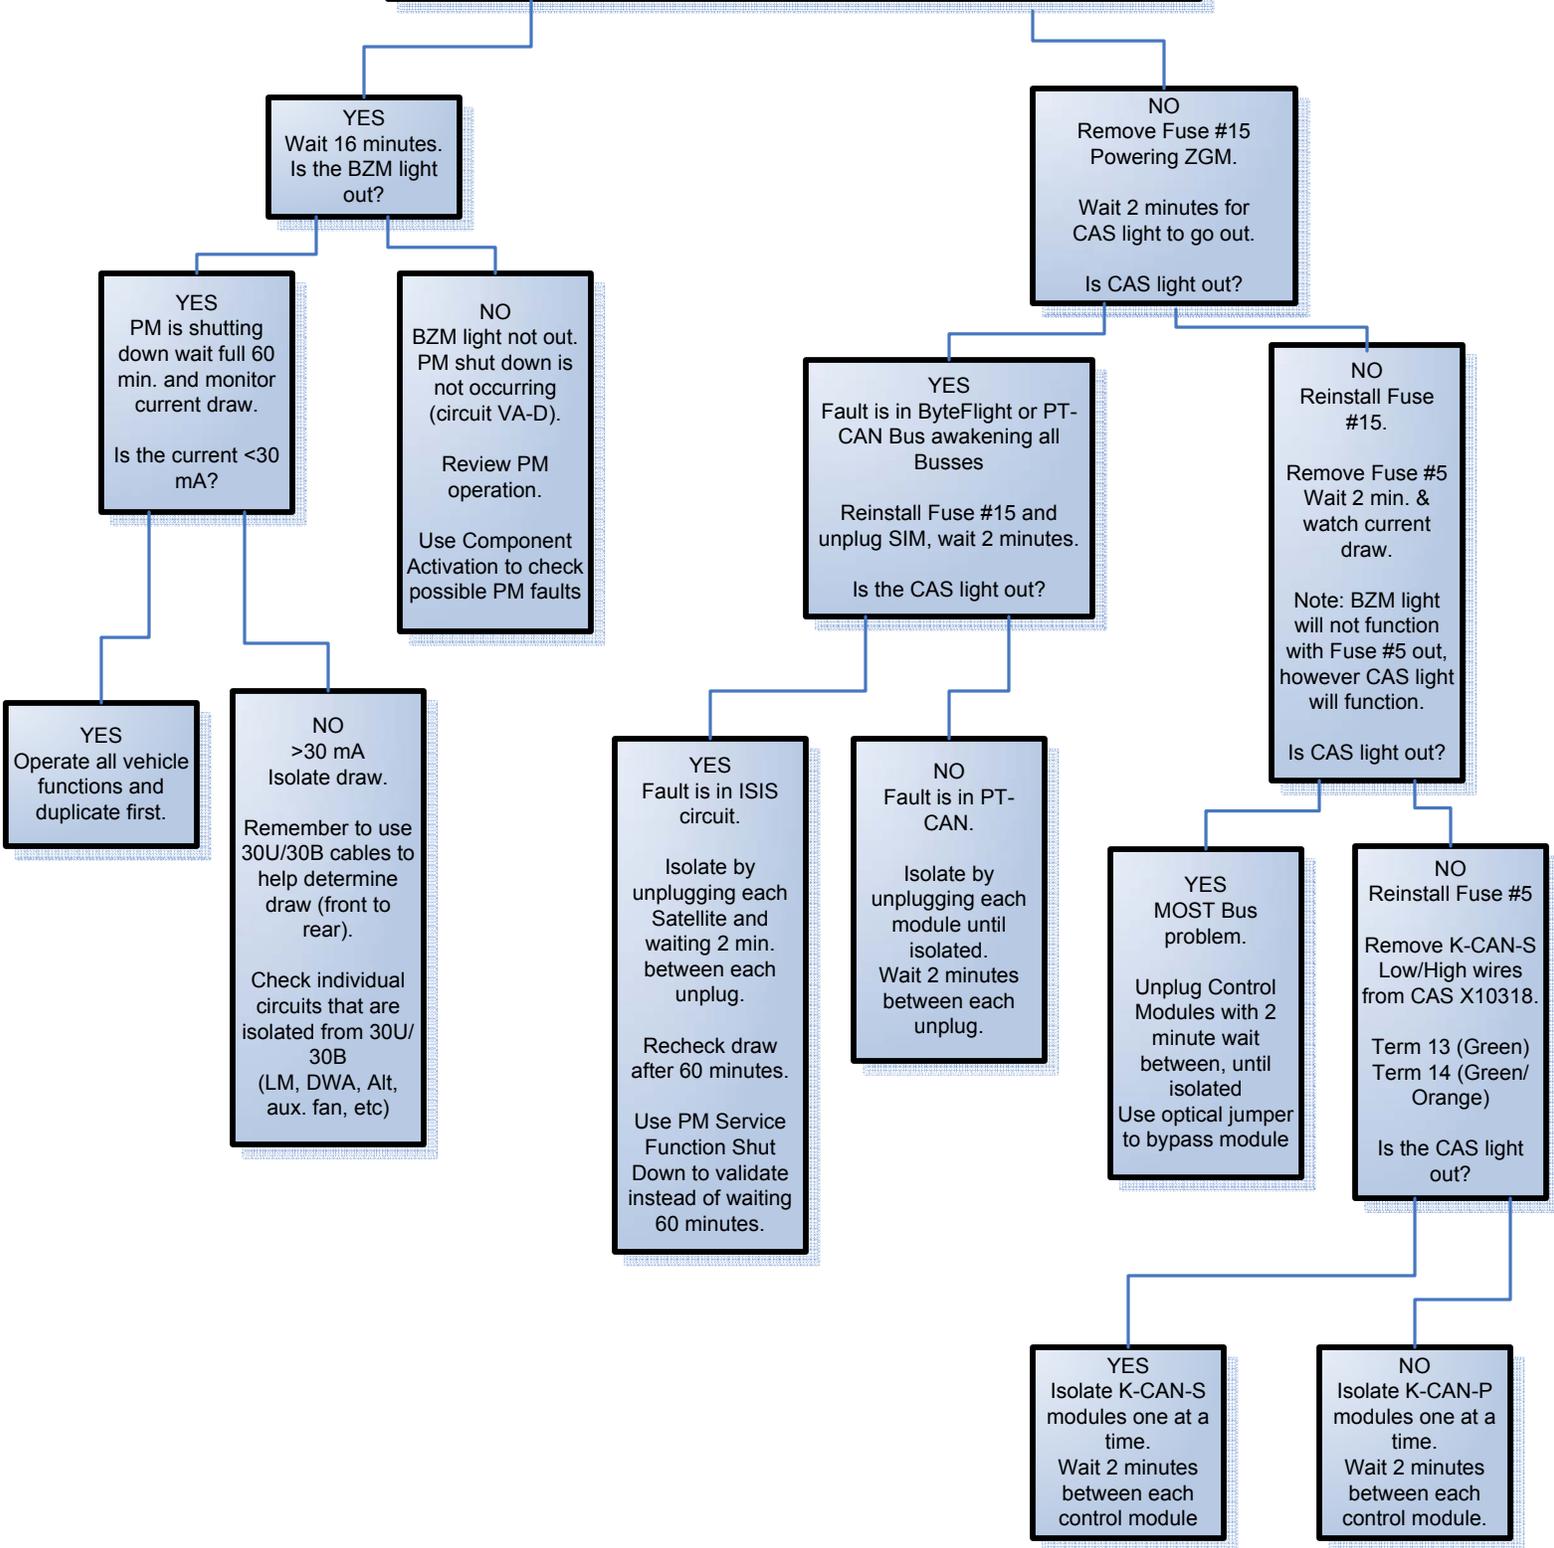
**Closed Circuit Current Monitoring Diagnosis E65 up to 3\_2004**  
**Key Off = KL "0", Wait 2 min. Is the CAS LED Out?**
