Technical Tip

Topic	26-18-06TT - Gen III TDI - G295 - NOx Sensor Bung Mounted Off Center
Market area	United States 444 Volkswagen of America, Inc. (6444)
Brand	Volkswagen
Date	December 14, 2018

Gen III TDI -G295- (NOx) Sensor Bung Mounted Off Center

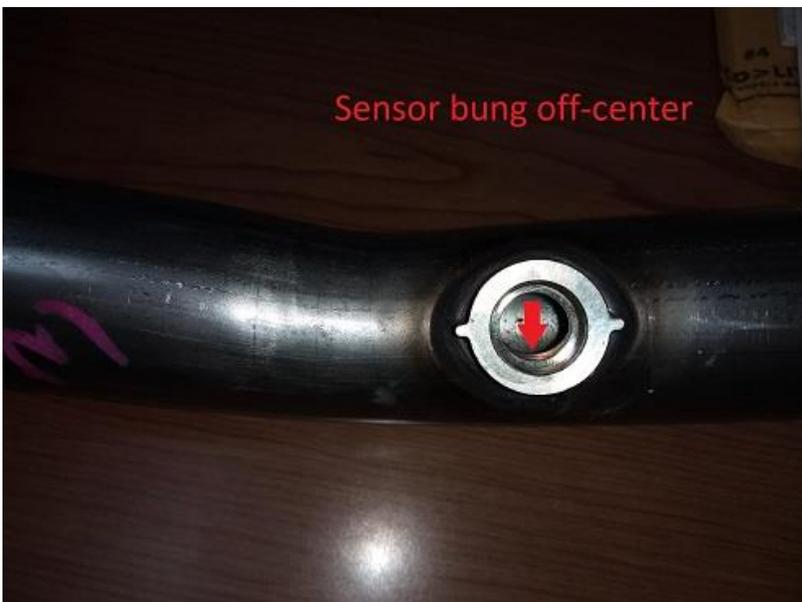
Figure 1

Some defective NOX sensor pipes in the kits when performing the 23Y8 campaign.

Inspect the bung for the new NOX sensor for being mounted off-center (see attached photo). If it is and you thread in the new NOX sensor, it will destroy the new sensor. Obtain a new pipe (with correct bung installation).
