# TECHNICAL SERVICE BULLETIN

| YEAR/MODEL | Date Of Issue | Bulletin Number | Service Campaign |
|---|---|---|---|
| 2013-2017<br>Isuzu Reach | 11/09/18 | 1001A | <input type="checkbox"/> NO <input checked="" type="checkbox"/> YES |

**Title:** Hybrid Reach front drive shaft lubrication

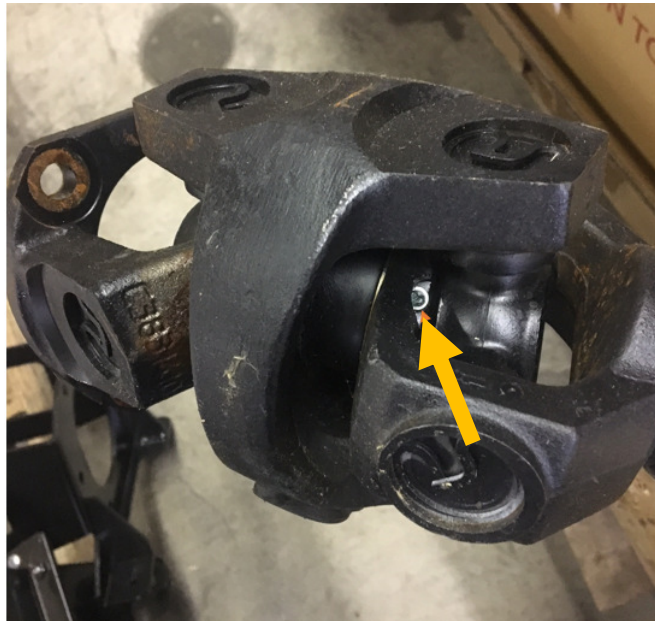
*Figure 1*

**Issue:** The XL hybrid Reach front drive shaft contains two double Carden universal joints. These joints contain a discreet flush mounted grease fitting that was not referenced in the XL owner's manual. Greasing this fitting immediately, and then every three months or 10,000 miles is imperative for the longevity of the ball and socket joint. Typically a failure of this joint would be preceded by substantial noise or vibration. Driver feedback will be critical in early detection of a joint that is not properly lubricated.

1. Raise vehicle on suitable hoist, or jack vehicle and place on stands. Place vehicle in neutral.
2. Rotate drive shaft to locate and gain access to flush mount grease fittings. Using needle style grease tip, lubricate ball and socket joint. (See figure 1)

3. Repeat for rear joint.
