## QUARANTINE NOTICE

| Reference number: | QN-07-1201 | Issued: 21 December, 2018 |
| Subject: | Differential Breather Pipe Extension | |
| Model(s): | DBS Superleggera | |

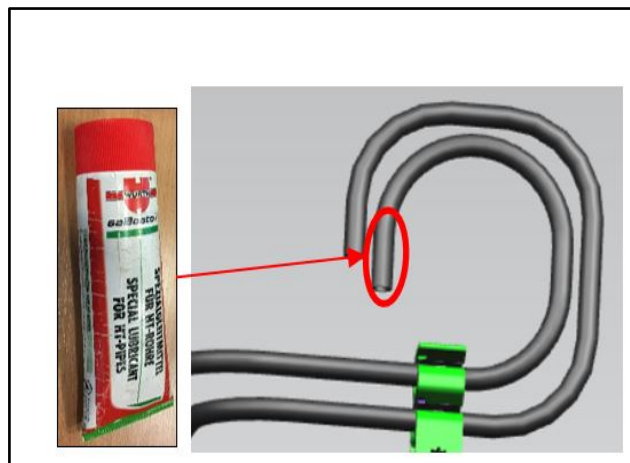
Figure 1

On some DBS Superleggera vehicles it is possible that an oil leak can occur from the differential breather pipe. To install the extension for the differential breather pipe, do the Workshop Procedure that follows:

1. Remove the rear right side wheel-arch liner (refer to Workshop Manual procedure 01.08.AK).
2. Apply a small quantity of lubricant suitable for high temperature applications to the differential breather pipe (refer to Figure 1).
