Preliminary Information

PIT5479B Diagnostic Tip - Perceived Brake Fluid Leak at Caliper Piston Boot

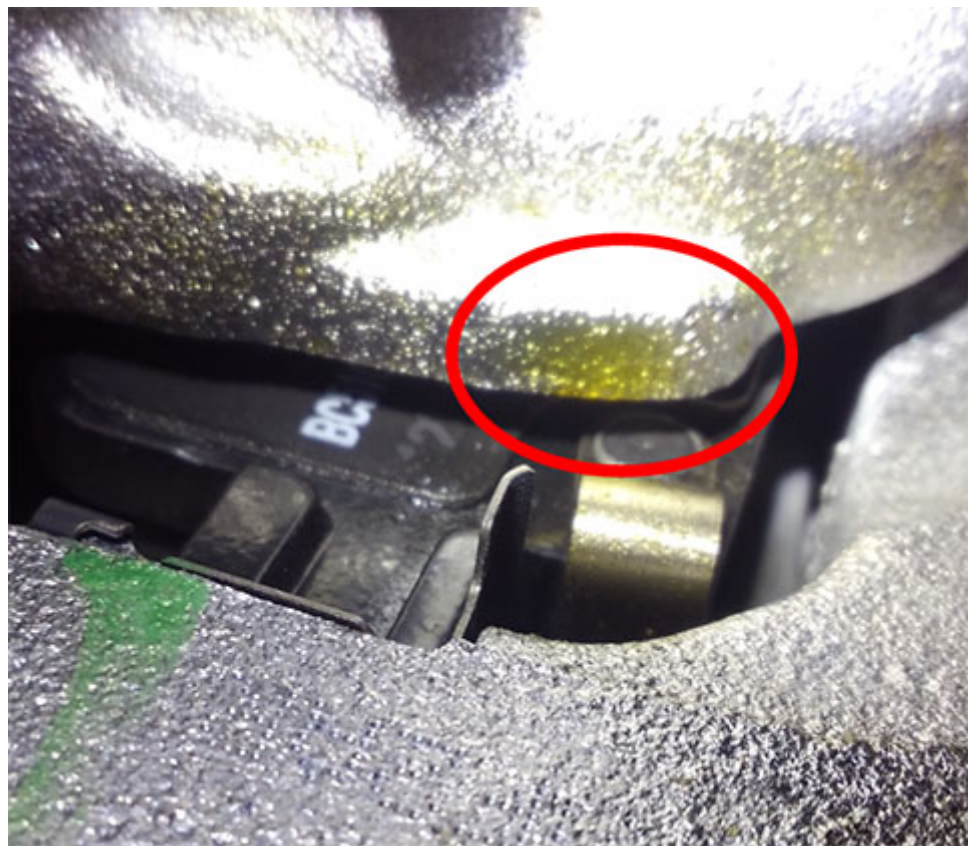
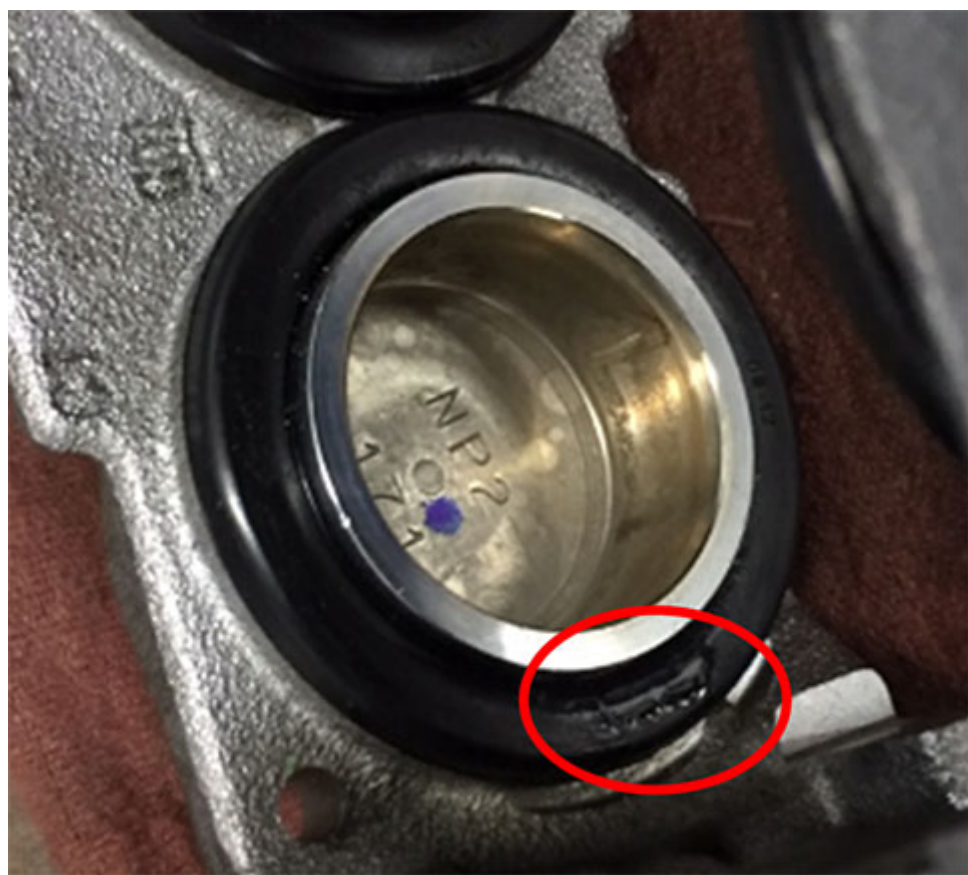
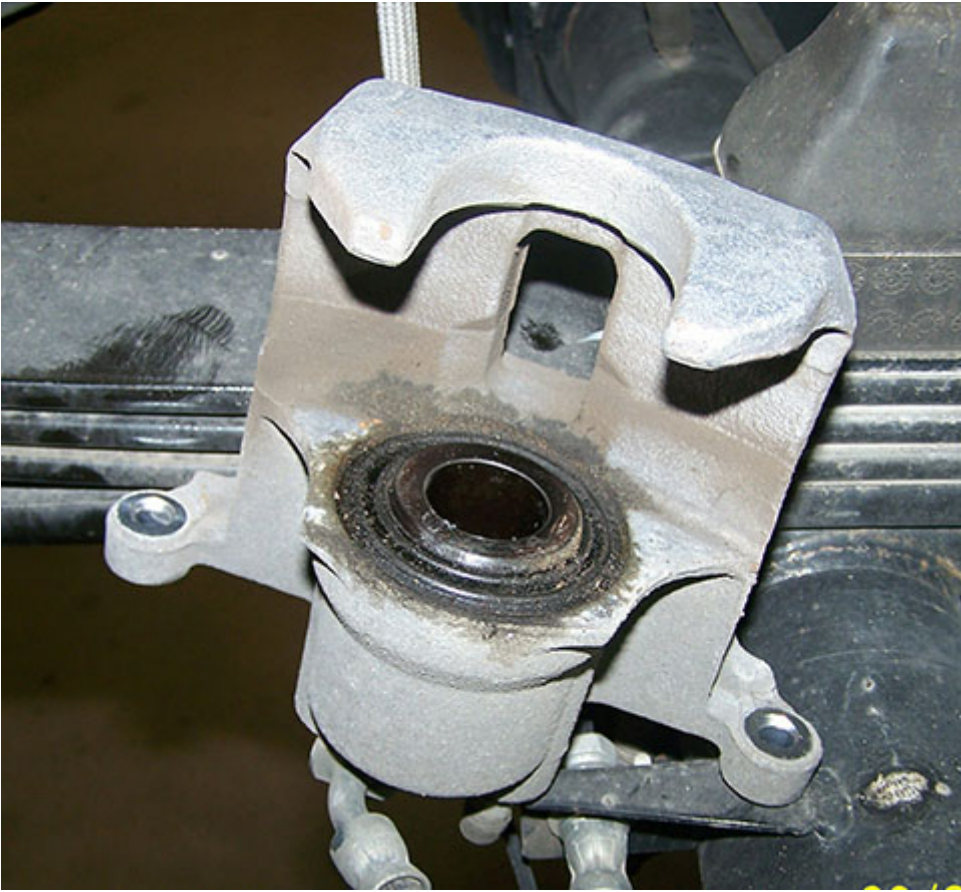
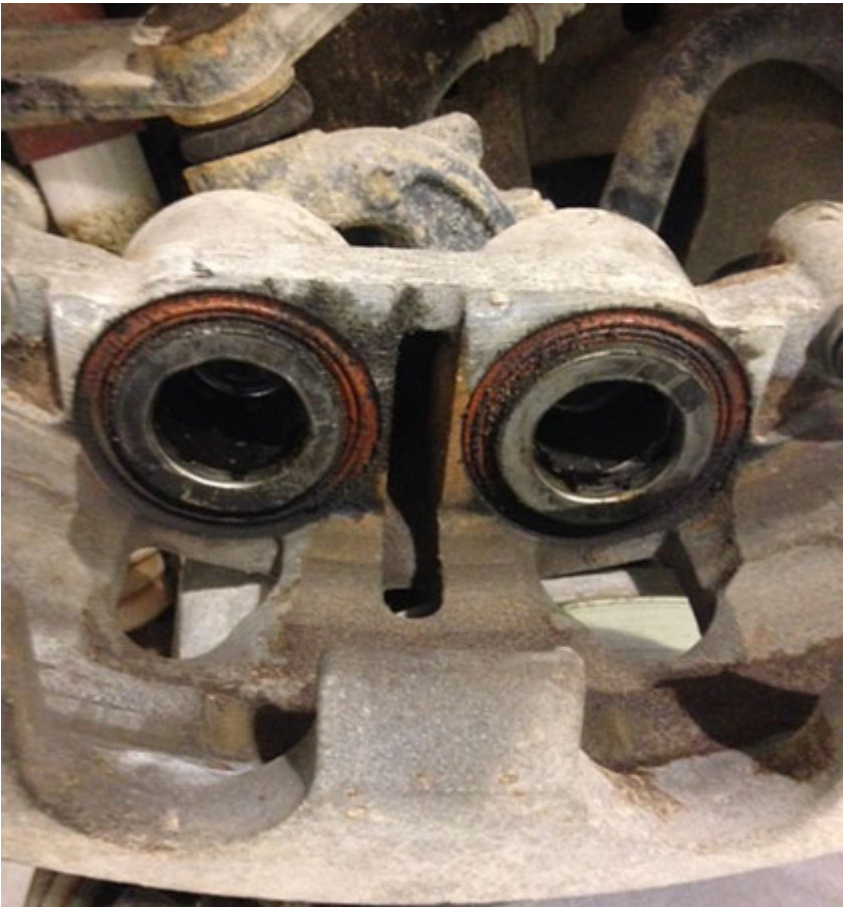
A technician may comment that, during service, it appears there is fluid leaking from the brake caliper piston area. Shown below are examples of newer low mileage vehicles and older higher mileage vehicles.

The substance shown is actually excess assembly grease from the caliper boot and piston installation. This grease can be cleaned off and the rest of the service completed.

NOTE: When diagnosing a brake fluid leak or certain DTC's for hydraulic brake circuit leaks, such as C05B0, do not confuse excessive assembly grease as a brake fluid leak. If it is uncertain what is seen is assembly grease, then clean off the excessive grease and apply the brake pedal 20 times and re-inspect for a leak.
