Bulletin No.: PIP5283A

PIP5283A Diagnostic Tip For the JATCO CVT7 Automatic Transmission RPO M4M MR8

Brand:	Model:	Model Years:	VIN:		Engine:	Transmissions:
			from	to		
Chevrolet	Spark	2014 - 2019	All	All	All	M4M MR8

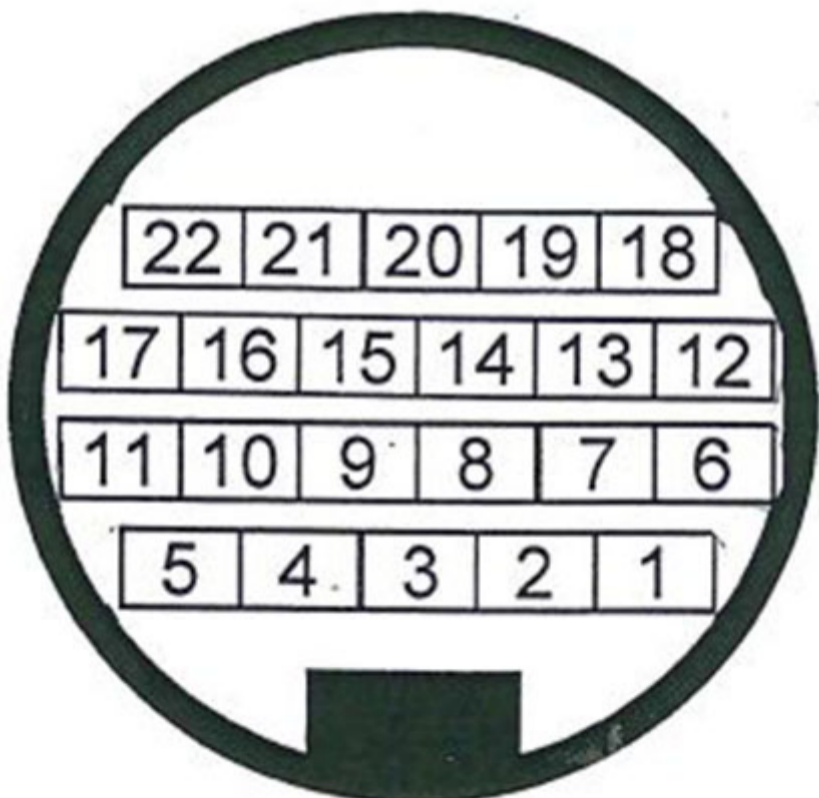
The following picture shows the pin locations inside the transmission pass thru connector which is located on the side of the transmission towards the front of the vehicle.

Please refer to this picture when testing the internal circuits or components that are located inside the JATCO CVT7 automatic transmission assembly

Note pins 5,4,3,2 and 1 are closest to the front of the vehicle.

Note: When performing a pin drag test on the harness end of the transmission connector be sure to remove the TPA or you will get a false drag test as the TPA will also cause a drag on the diagnostic test probe.
