Service Bulletin

Bulletin No.: 17-NA-153

Subject: Operating Tips for Hands Free Liftgate

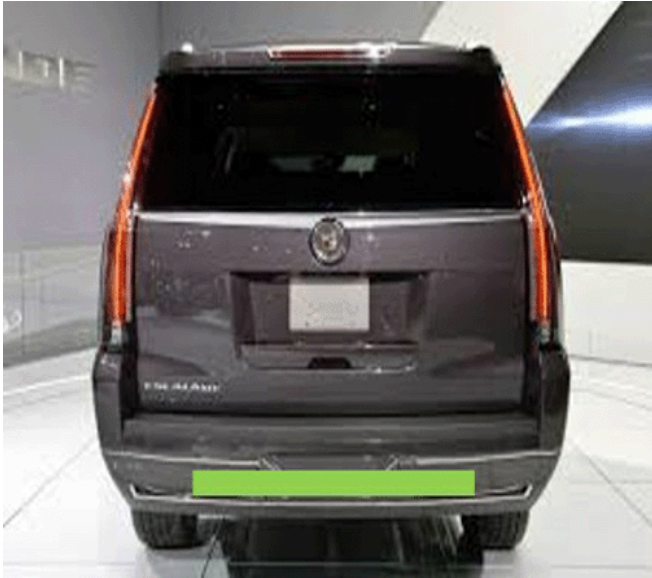
4782690

- The RKE Fob must be within the detection area, which is 3 ft (1 m) of the rear bumper.

Important: Models: Cadillac Escalade; Chevrolet Suburban, Tahoe and GMC Yukon

- Best operation will occur when the foot kick is conducted at the direct center of the kick zone. See the illustrations above for models kick zone.

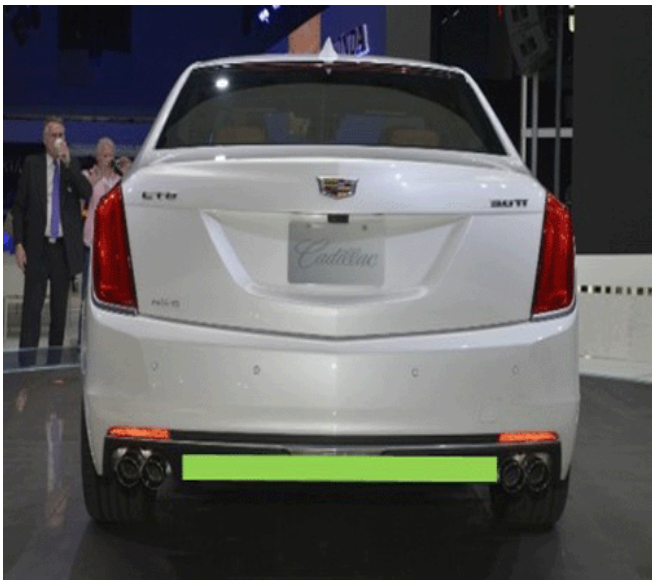
4782691

Important: Models: Cadillac CT6

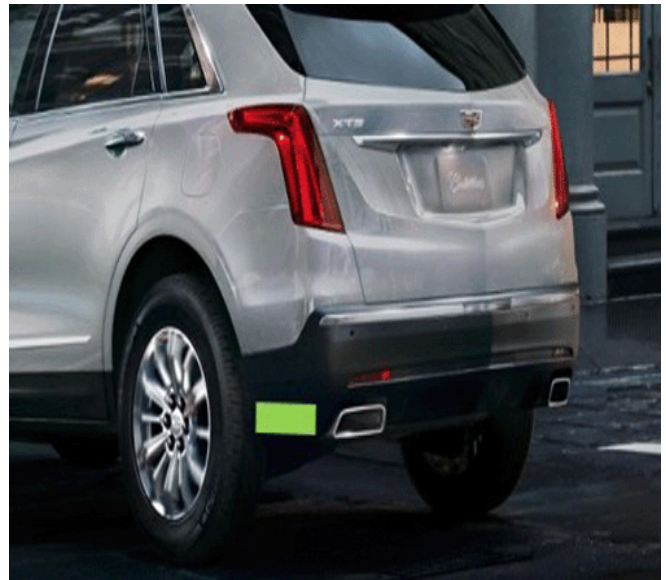
4782692

Important: Models: Cadillac XT5 and GMC Acadia

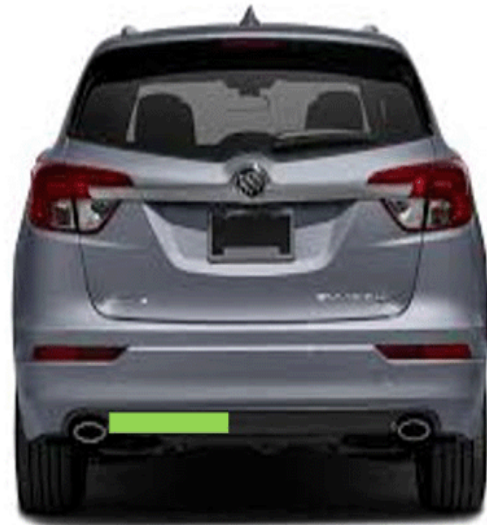
4782693

Important: Models: Buick Enclave, Envision; Chevrolet Traverse, Equinox, Blazer and GMC Terrain

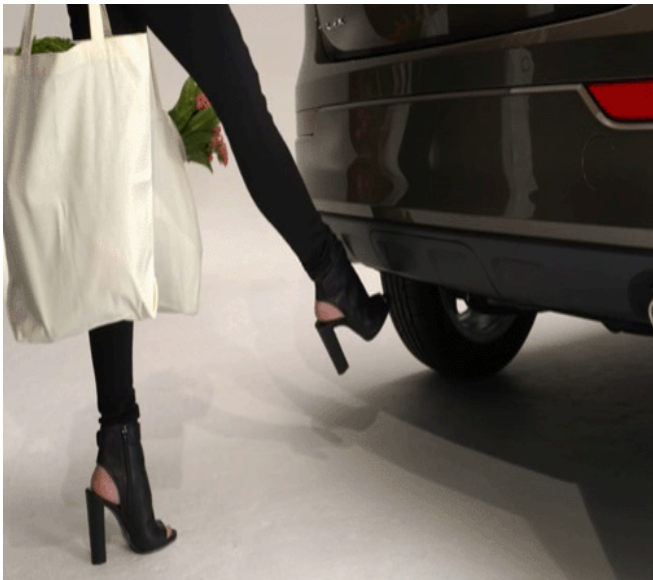
4782695

- To operate, kick your foot straight up in one swift motion under the center of the rear bumper, then pull it back. There are two antennas located in the rear bumper fascia that must be triggered for the system to detect a kick. During the kick, your foot and shin must come within 6.5 inches (16.5 cm) of the rear fascia for both antennas to be triggered and detect the kick.
- Speed of kick should be 1 second or less.

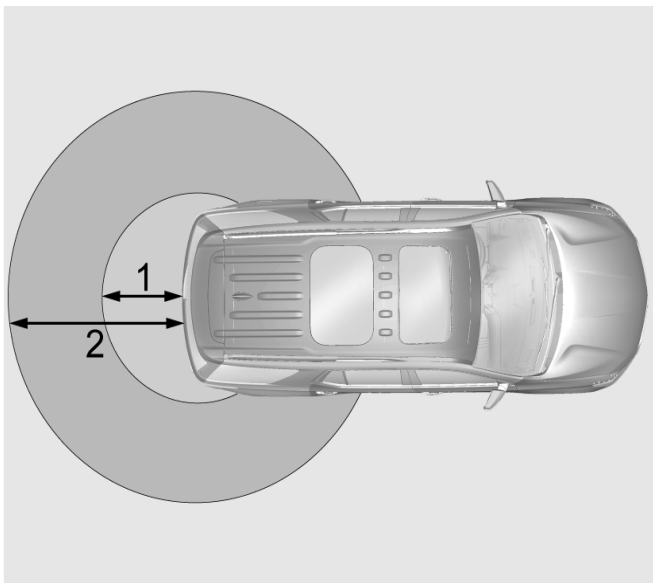
4773572

If equipped with this feature, a vehicle logo will be projected for one minute onto the ground near the rear bumper when an RKE transmitter is detected within approximately 2 m (6 ft).

- 1 m (3 ft) Hands-Free Operation Detection Zone
- 2 m (6 ft) Projected Logo Detection Zone

The projected logo shows where the kicking motion is to take place.
