Service Bulletin

Bulletin No.: PI1190B

Subject: Sunroof Sunshade Binds and/or Will Not Retract Properly

Models: 2012-2015 Buick LaCrosse
2014-2016 Chevrolet Impala (VIN 1)
2017-2019 Chevrolet Impala
Equipped with Sunroof (RPO C3U)

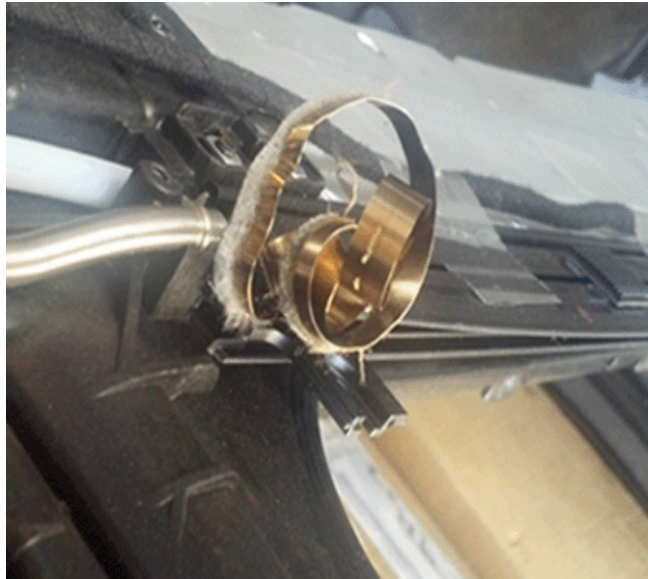
3749685

- The rolled steel tapes on the outboard ends of the sunshade may have become kinked or damaged due to improper travel of the sunshade.

Inspect the sunroof sunshade assembly for damage. If damage to the sunshade is evident, refer to the GM electronic parts catalog (EPC) for the current sunshade service part and replace the sunshade following the steps and tips below:

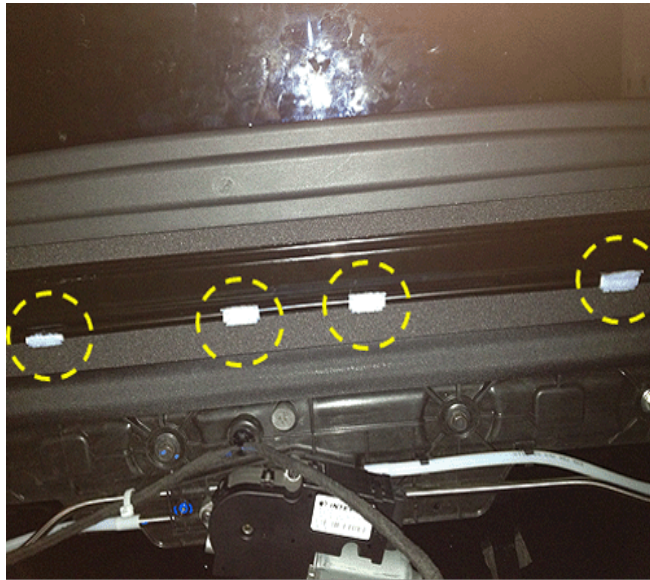
3749697

Note: The graphic above shows the current design crossmember, which has four hook and loop anti-rattle patches. The patches are shown blue in color on the above example to improve viewing. These patches will be black on the actual production crossmembers.

Important: Before reinstalling the rear crossmember, inspect that it is the current design. **If these patches are not evident, the crossmember is an earlier design and should be replaced with the service part listed in the part table below.**
