## Fuel 335 - Plumbing Vent thru Roof

There is a possibility that the vent was not completed inside the wall to extend through the roof.

Fuel 335 manufactured between June 18, 2018 and July 23, 2018 the VIN range is 5SFCG4026KE398724 – 5SFCG4029KE400000

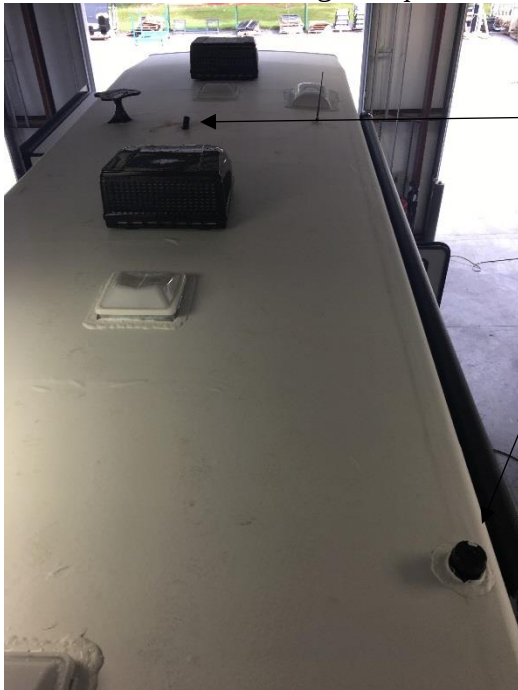
The RV in question should have 2 plumbing vents coming up through the roof, if you have 2 vents than nothing is required.

Location of the 2 Vent pipes.

**\*If only 1 plumbing vent is coming up through the roof than this bulletin applies to this RV.**

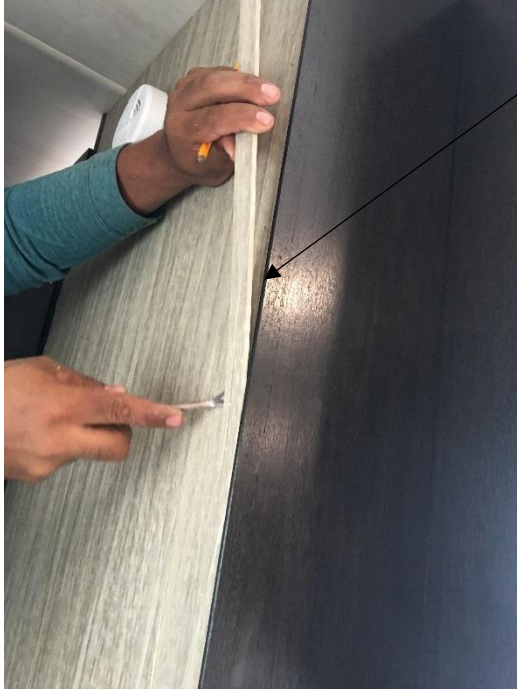
- Remove the wall panel trim on the right side, of the wall panel that is on the right side hall as you go up the stairs into the bedroom.

Remove the trim, as the panel and trim will be re-used be careful not to damage or break the trim.

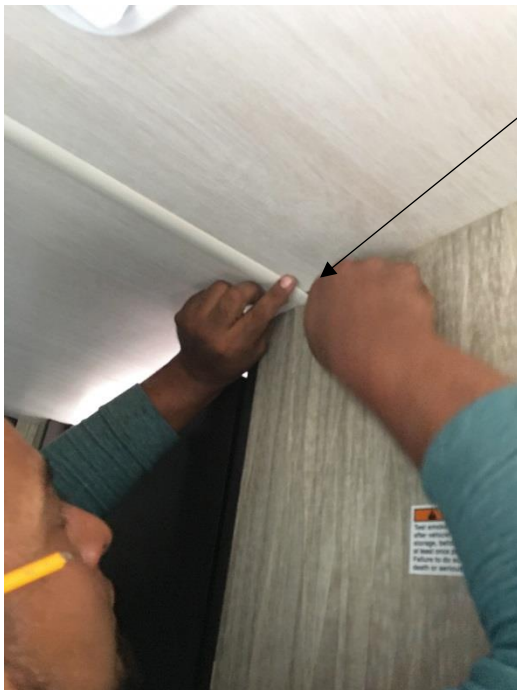
- Remove the ceiling trim.

Same as with the trim use caution as to not damage the roof trim.

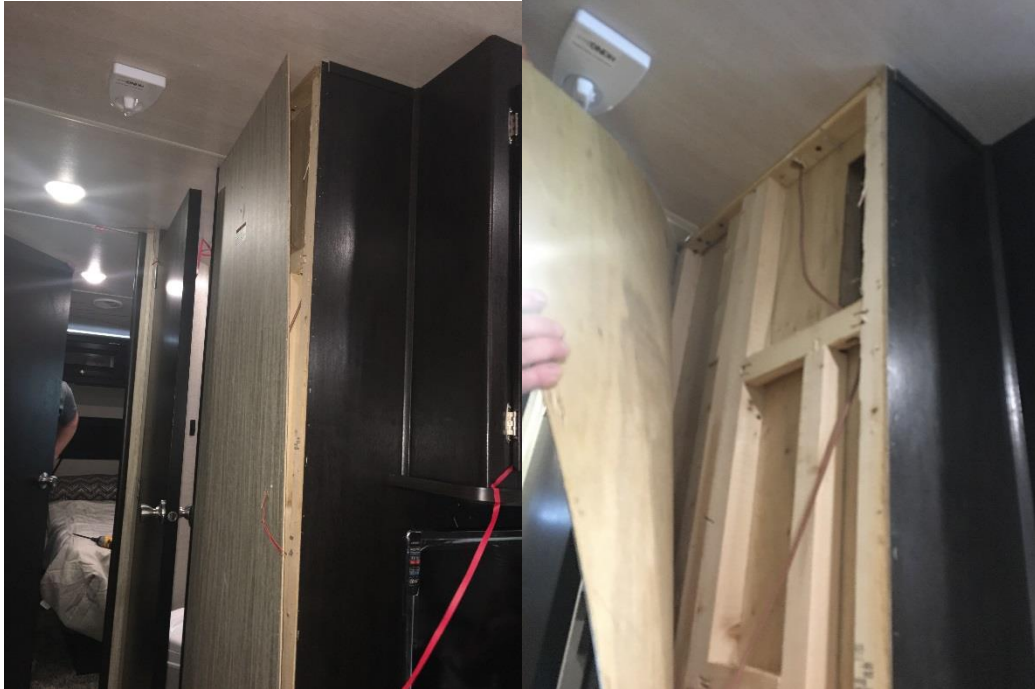
- Remove smoke detector.
- Remove thermostat screws only.
- Pop panel loose from wall.

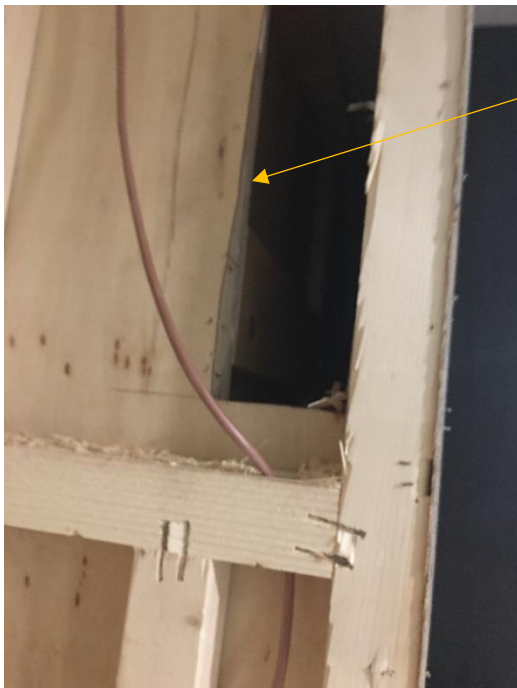
- Using a router cut hole in inside panel. Being careful not to cut into bath wall.

Using a router cut out your opening, use caution and do NOT cut into the adjacent walls.

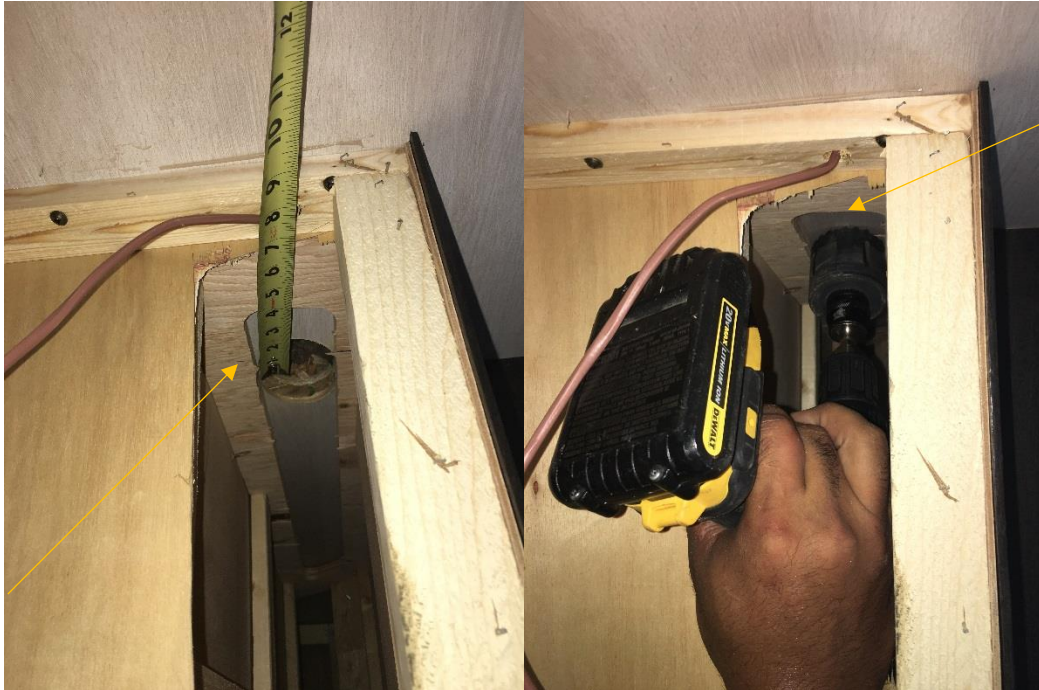
- Using 2.5" hole saw cut hole in roof approximately 9" in.

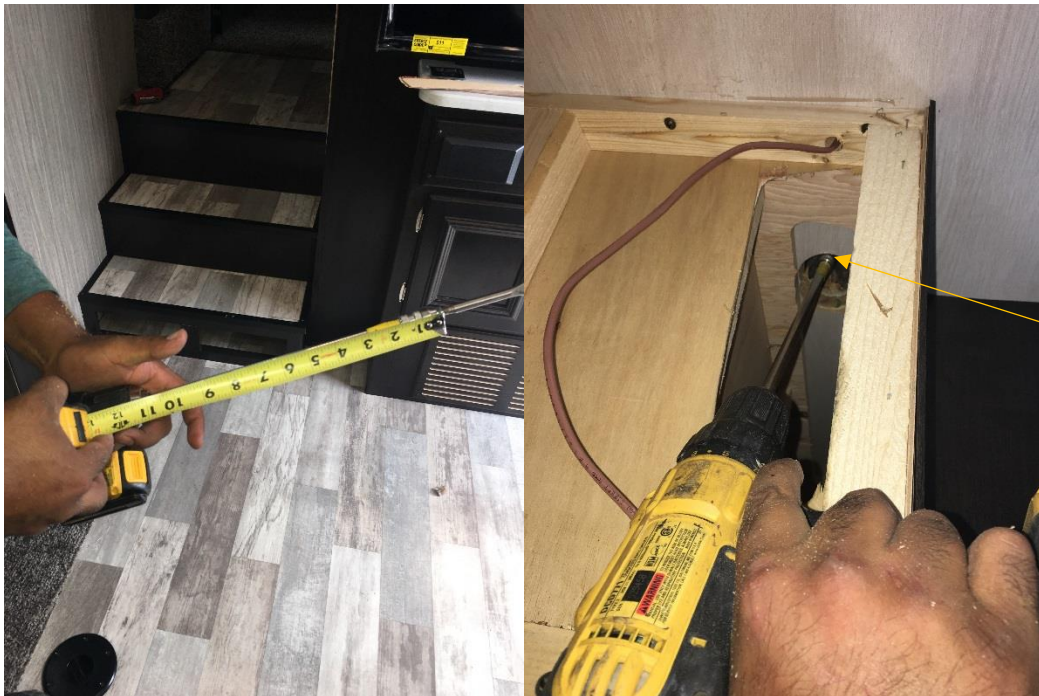
- Using a 1" paddle bit with 12" extension, push insulation to side, drill a hole through roof. Be sure to keep the bit angled and as close to the edge of the first hole

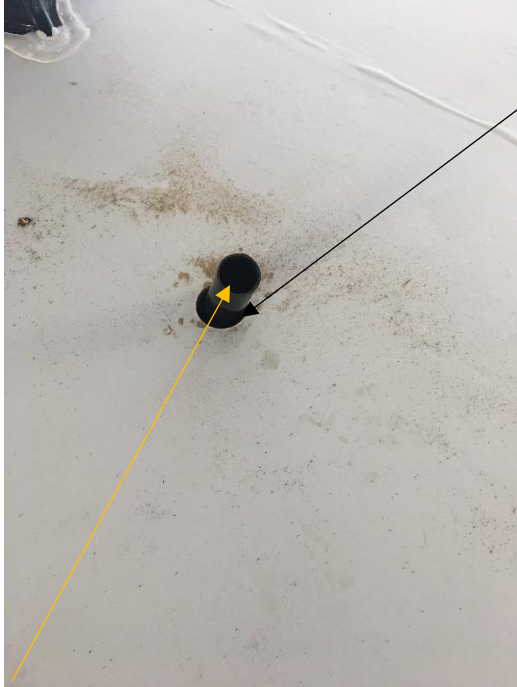
- Drill 2.5" hole in roof from the top using the hole as your center guide.

Use the pilot hole as your center to cut the 2.5" hole in roof.

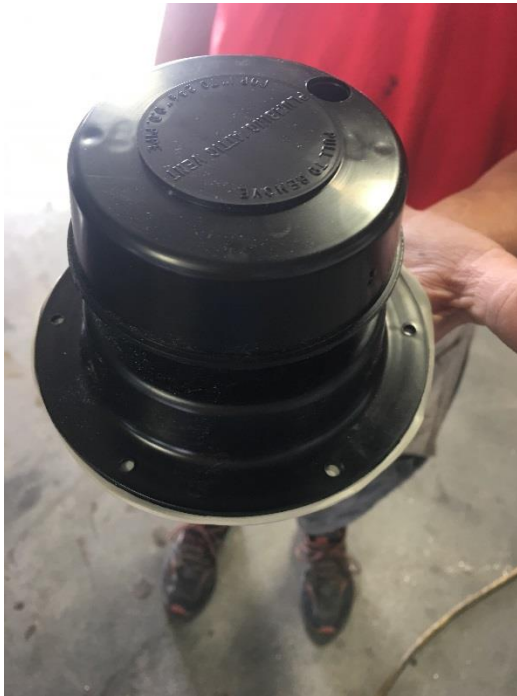
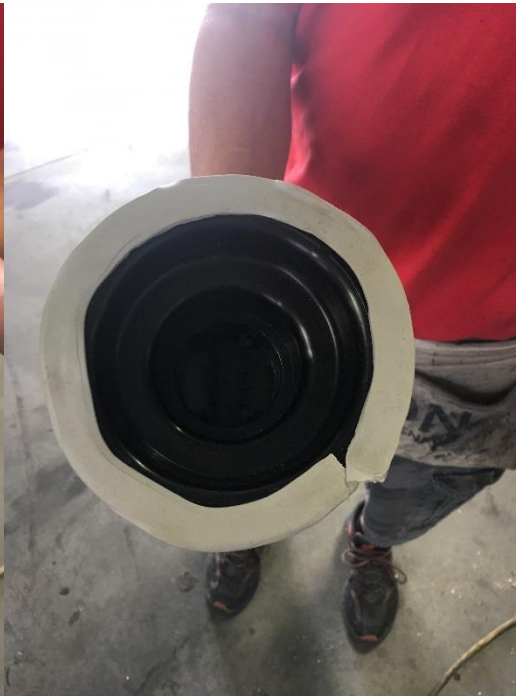
- Install 24"x1.5" vent pipe through hole and attach to existing connector in wall.
- Install vent cap and seal with self-leveling sealer. Be sure to put seal around the bottom.

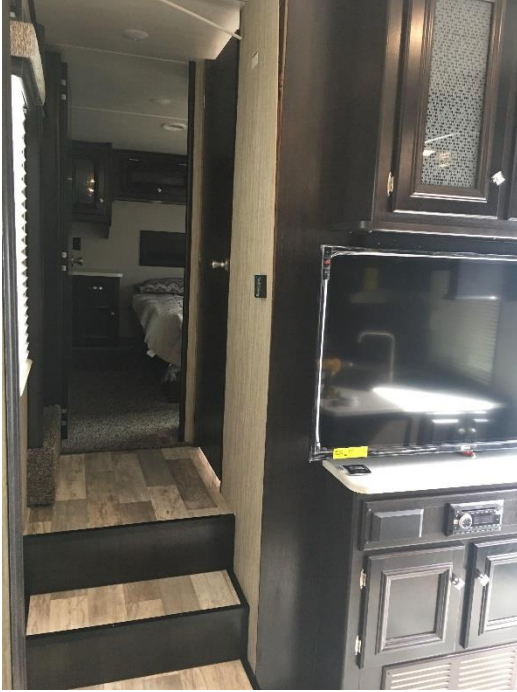
- Reinstall wall panel, trim, smoke detector and thermostat.
