**Title:** Repair Information for Damaged Headlight Connector

**Applies To:** Certain DuraStar, CE / BE Bus, WorkStar, 1300, TranStar

## **Description**

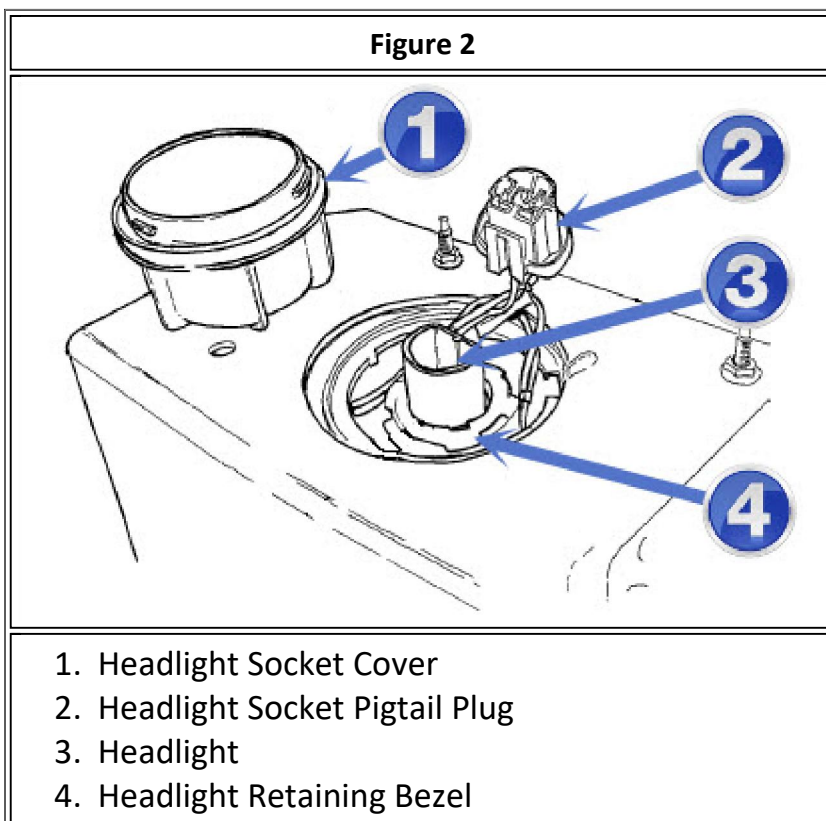
4. Remove light socket pigtail plug. See Figure 2 Item 2 below.

5. If the headlight connector, headlight body or terminals are damaged continue to Repair Steps.

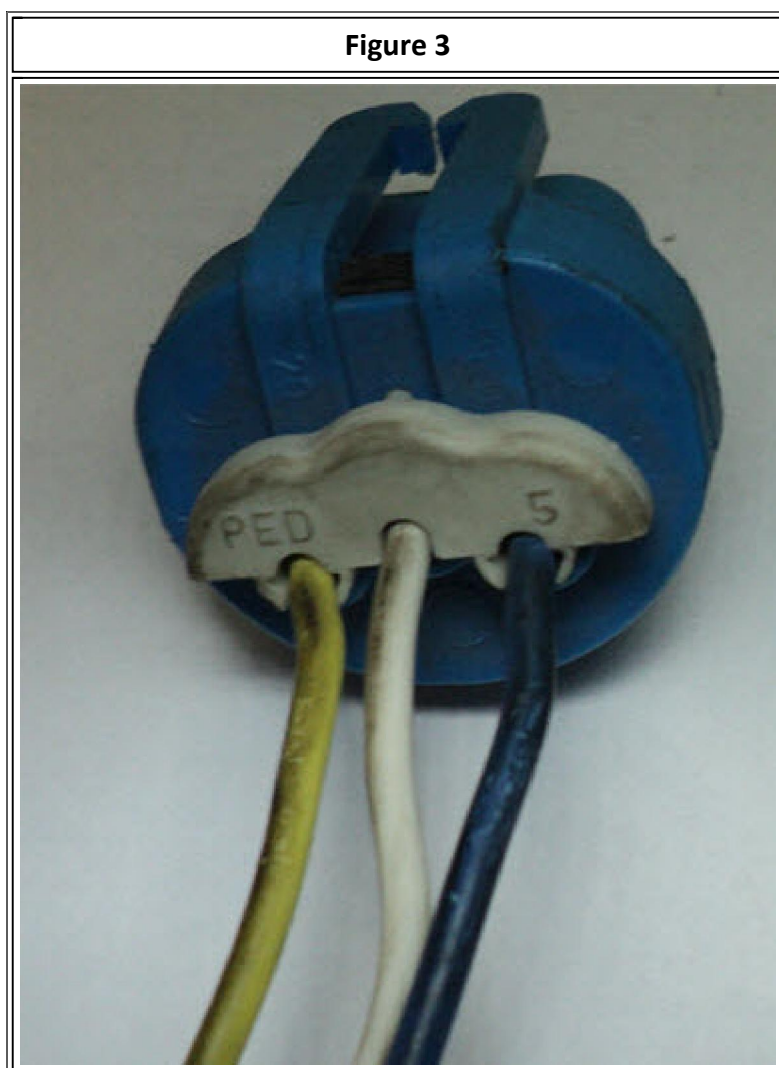
1. Use the component parts for the connector, terminals, seals and wires to pre-assemble a pigtail harness.
  - Crimp the terminal and seal to each of your 6" pieces of wire.
  - Insert the Yellow wire into cavity A of connector 3561125C1.
  - Insert the White wire into cavity B of connector 3561125C1.
  - Insert the Dark Blue wire into cavity C of connector 3561125C1.
  - Insert the Lock 3561139C1 onto the back of the connector body.
  - Install the gasket 3561925C1 onto the front of the connector body.
  - Your completed pigtail should match the OEM wiring as shown in Figure 3 below.

Replace the damaged 3 pin connector with connector 3561125C1. Replace the headlight bulb if damage is present. It is recommended to replace the headlight bulb in pairs.

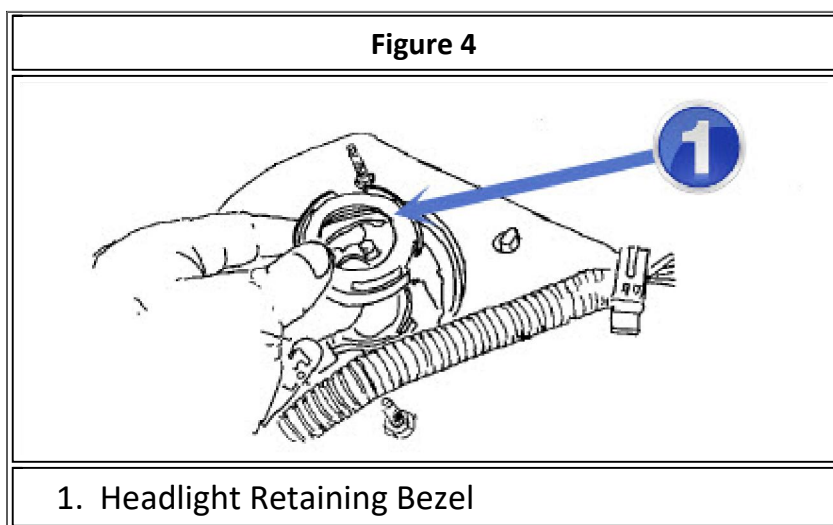
2. Replace the socket pigtail plug, with the pigtail harness you have pre-assembled.
  - Cut the 3 wires to remove the old connector.
  - Use the 3 closed barrel butt connectors 3517502C1 to crimp and solder the existing wiring to the new pigtail.
  - Follow proper wire repair procedures as outlined in [IK0800269 - Proper Wire Repair](#).
3. To replace the headlight, if required, remove the headlight retaining bezel. See Figure 4 below.

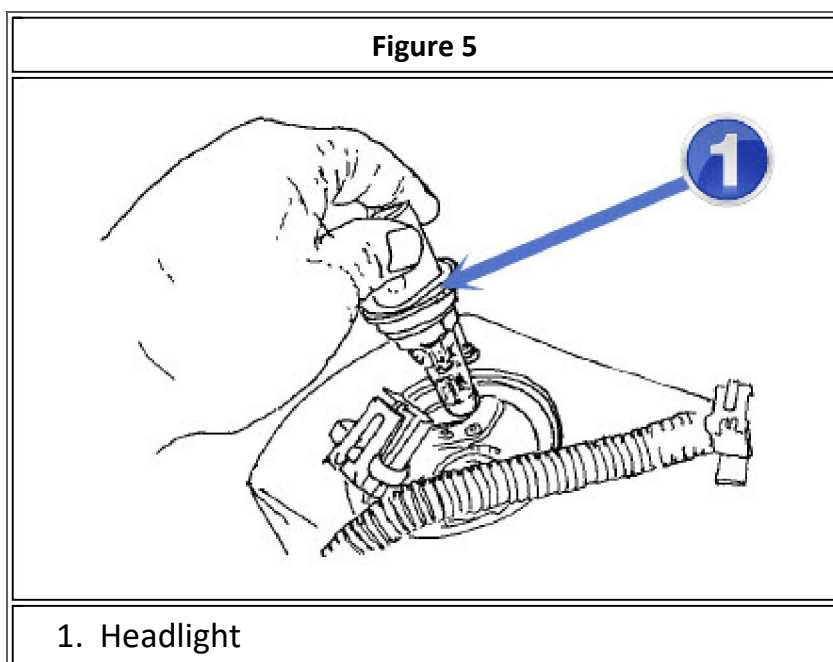
4. Remove the headlight.

- The installation is performed in opposite order of the removal procedure.
