Technical Journal

No Internet Connection With Car Modem/"SIM Card Not Inserted" message

REF NO: TJ 33633.1.2	ISSUING DEPARTMENT: Technical Service	CAR MARKET: United States and Canada	
PARTNER: 3 US 7510 Volvo Car USA		ISSUE DATE: 2018-03-20	STATUS DATE: 2018-03-26
FUNC GROUP: 3900	FUNC DESC: Media, navigation and communication	Page 1 of 8

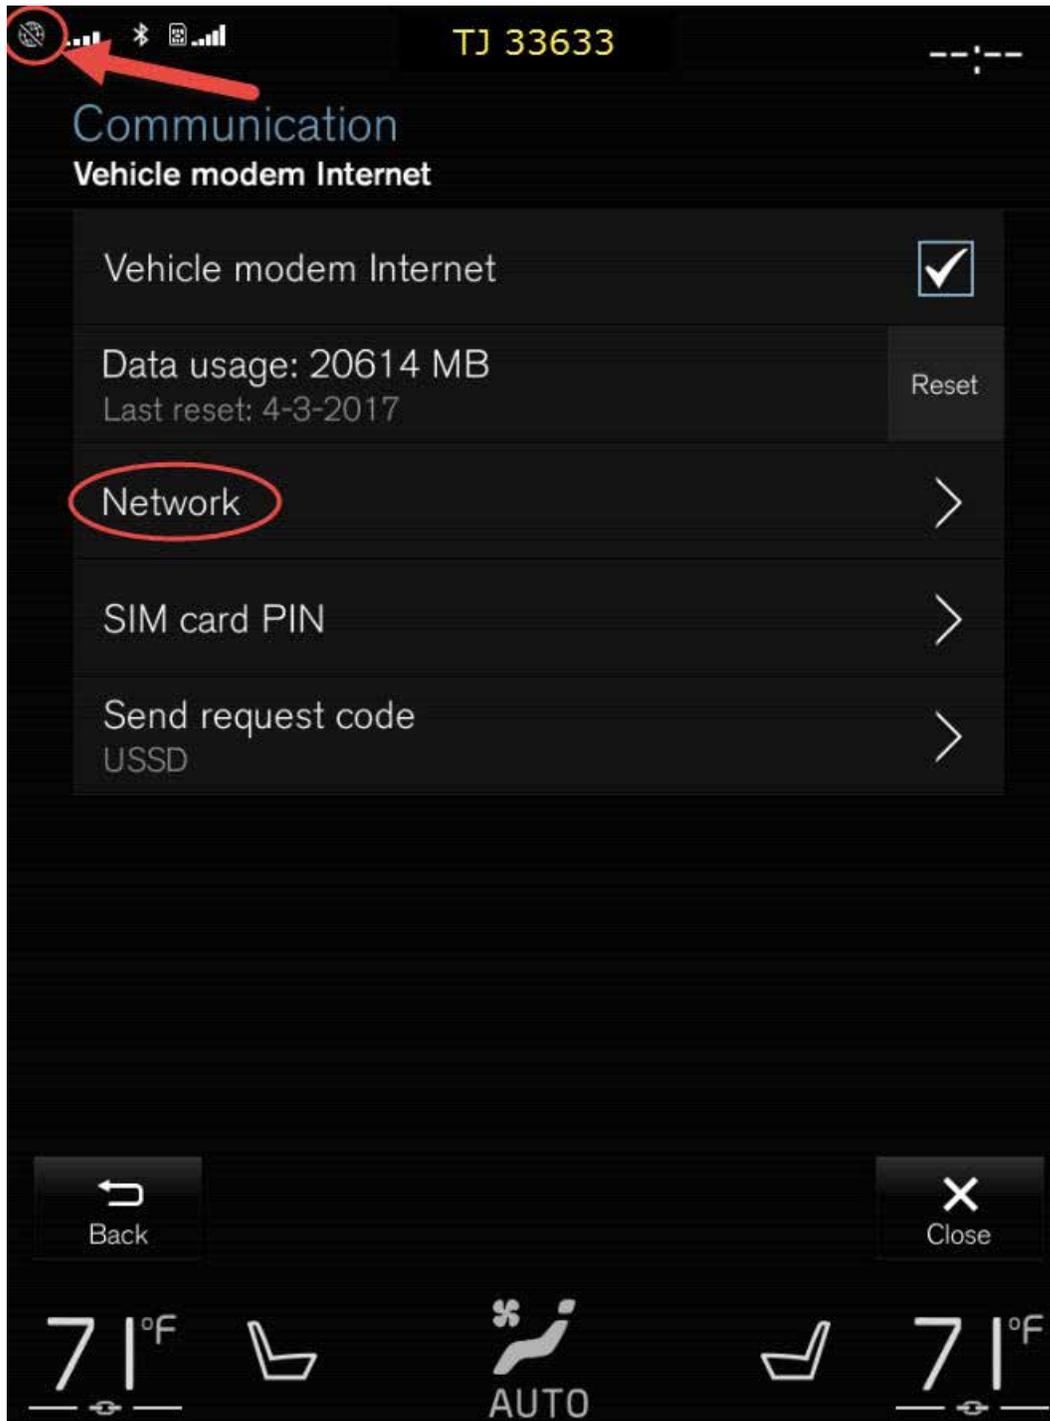
In SPA cars, the globe icon in the top left-hand corner of the screen will have a slash through it. TJ 33633_1(SPA).jpg

For SPA cars, this can be found in the Vehicle Modem Internet menu under “Network”:
TJ 33633_1(SPA).jpg and TJ 33633_2 (SPA).jpg

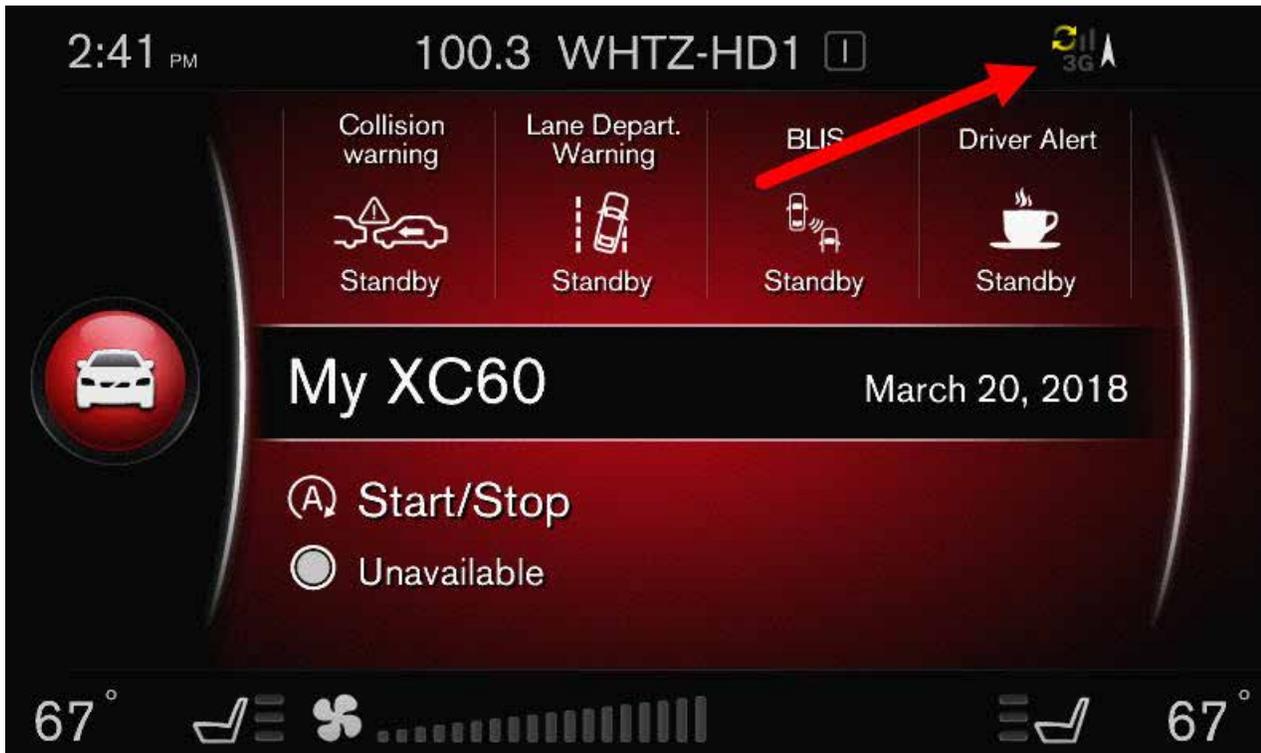
In Legacy (P3) cars equipped with Sensus Connect, the internet SIM card icon will show in the top right-hand corner of the screen with constantly rotating yellow arrows: TJ 33633_3 (P3).jpg

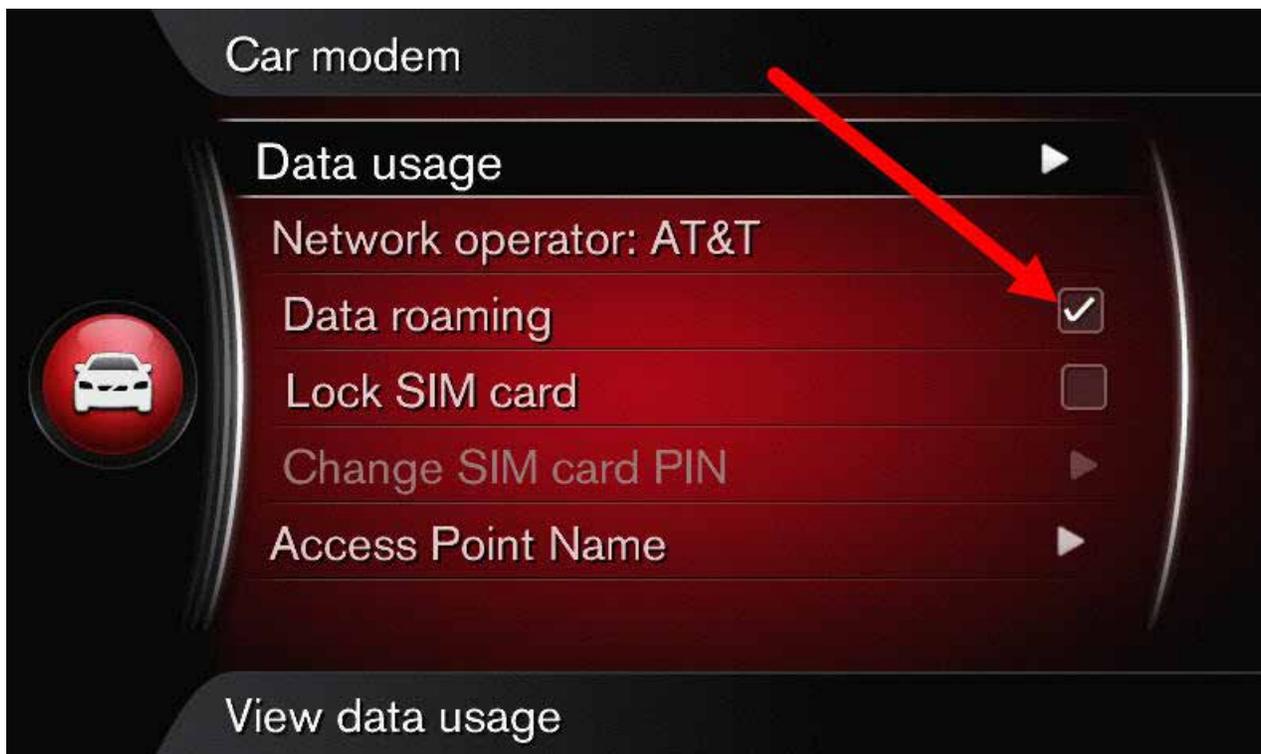
For P3 cars, the option can be found in the “Internet Settings >> Car Modem” menu:
TJ 33633_4 (P3).jpg

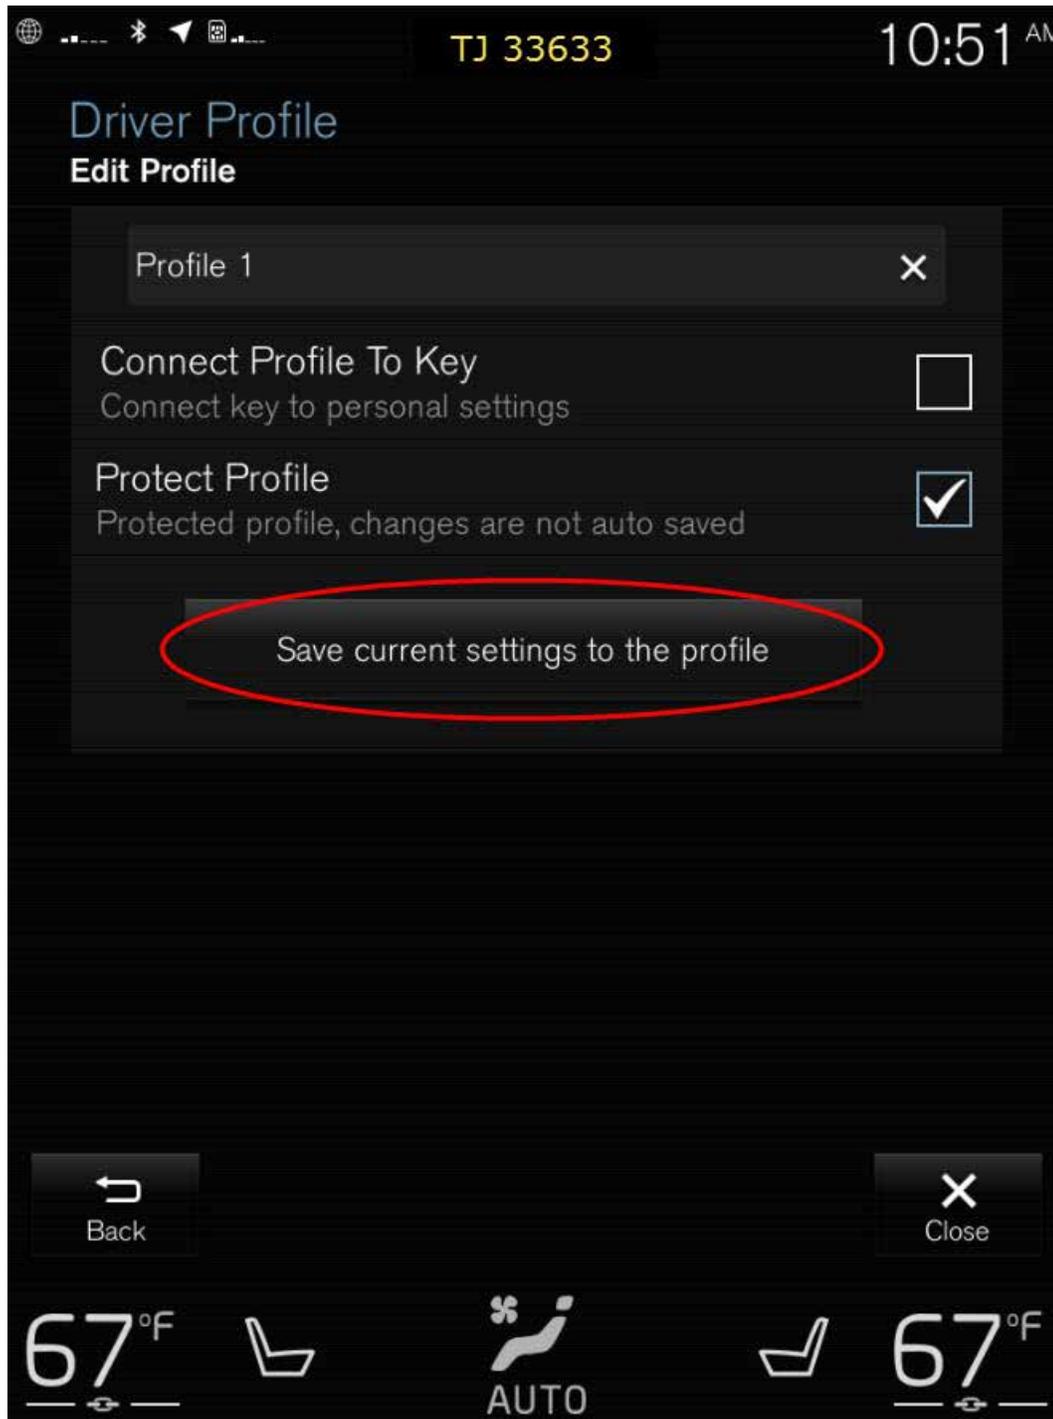
*On SPA cars, if a Driver Profile is being used by the customer and it is set to “Protected”, the settings must be saved by going into the Driver Profile settings menu and clicking “Save current settings to the profile”: TJ 33633_Locked Profile.jpg. **Failure to check this setting could result in the customer returning with the same issue.**

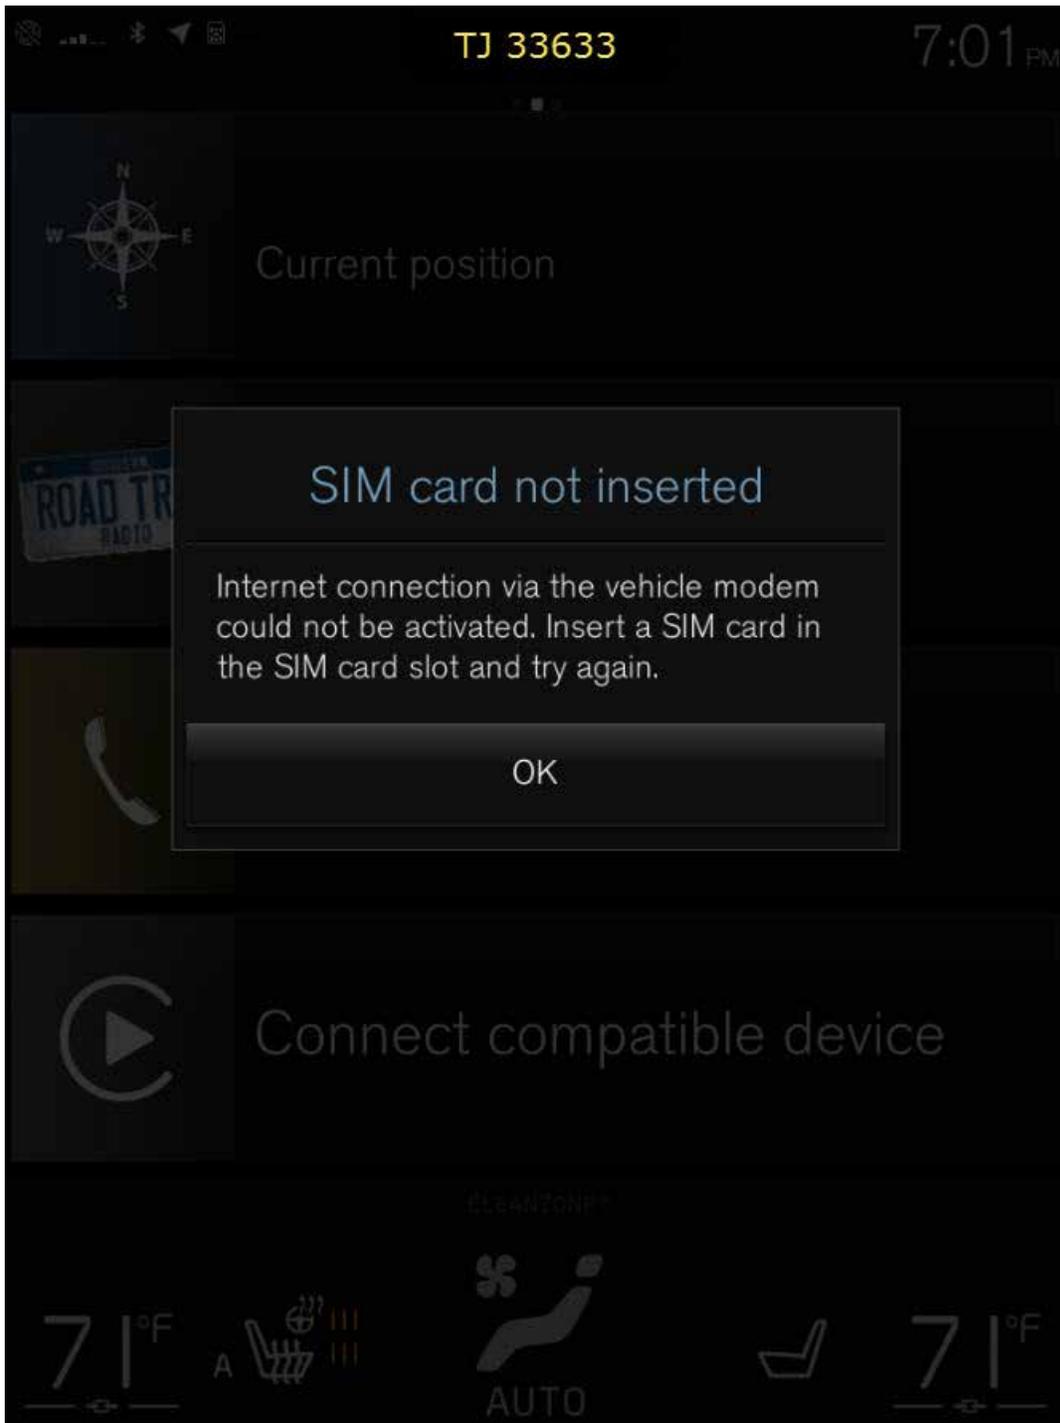
*If a message pop-up appears indicating “SIM Card Not Inserted” (TJ 33633_No SIM.jpg) click OK to ignore the message and then go into the “Communications >> Vehicle Modem Internet” menu and re-activate the Vehicle Modem Internet.

This message appears as a consequence of the SIM programming being reset by AT&T and **does not indicate a fault with the SIM card or reader**. If the connection is not restored, wait 5 minutes and try to re-enable the Vehicle Modem again.
