**Document ID:** IK1600248  
**Revision:** 0  
**Created:** 11/9/2018  
**Last Modified:** 11/12/2018  
**Author:** Frank Amstadt

**Title:** LT Cab Suspension Air Bag Lean

**Applies To:** LT Sleeper

This document will guide the user through correcting LT sleeper cab suspension air bag lean concerns, where the air bag is leaning forward or backward. Does not apply to side to side leaning air bags.

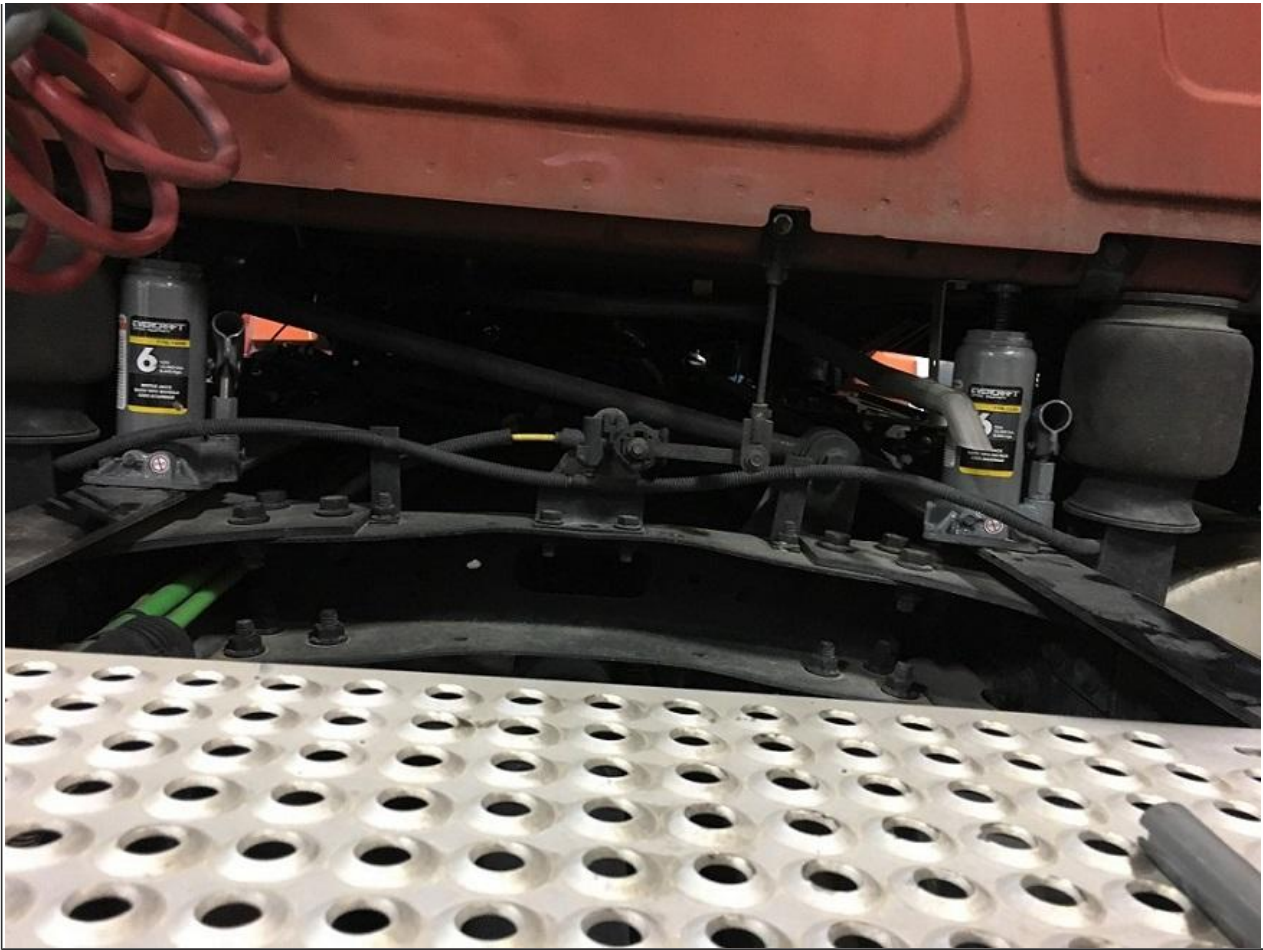
**Figure #: 2 Jacks Supporting Cab**

Item 1: Jacks installed to support sleeper cab.

1. Chock Wheels
2. Insert Jacks between frame rails and sleeper cab. Jack sleeper cab up to relieve tension on air bags
3. Measure bracket angle as shown in image 3. Zero the digital protractor on frame rail, then measure the angle of the cab air bag support brackets.
4. Loosen cab air bag support bracket bolts so there is enough give to move the bracket.

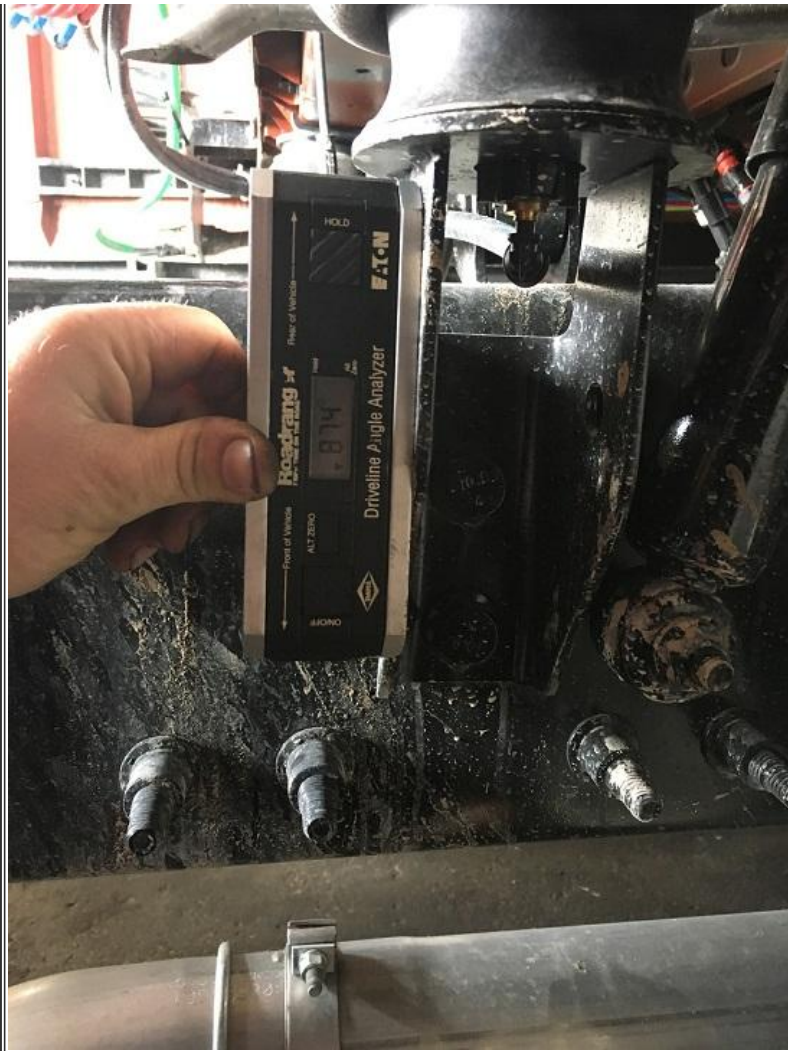
**Figure #: 3 Original Measurement**

Item 1: Digital protractor showing original lean of bracket

1. Move the cab air bag bracket to a 90 degree vertical position in reference to the frame rails.
  2. Tighten the cab air bag support bolts to specified torque above.
  3. Remove jacks and check/adjust the cab air ride setting per LT Technician Manual.
-
