SS 1033628 New Cascadia Ground Strategy - Steering Wheel Clockspring Failures

Applicable Vehicles

All New Cascadia models (P4).

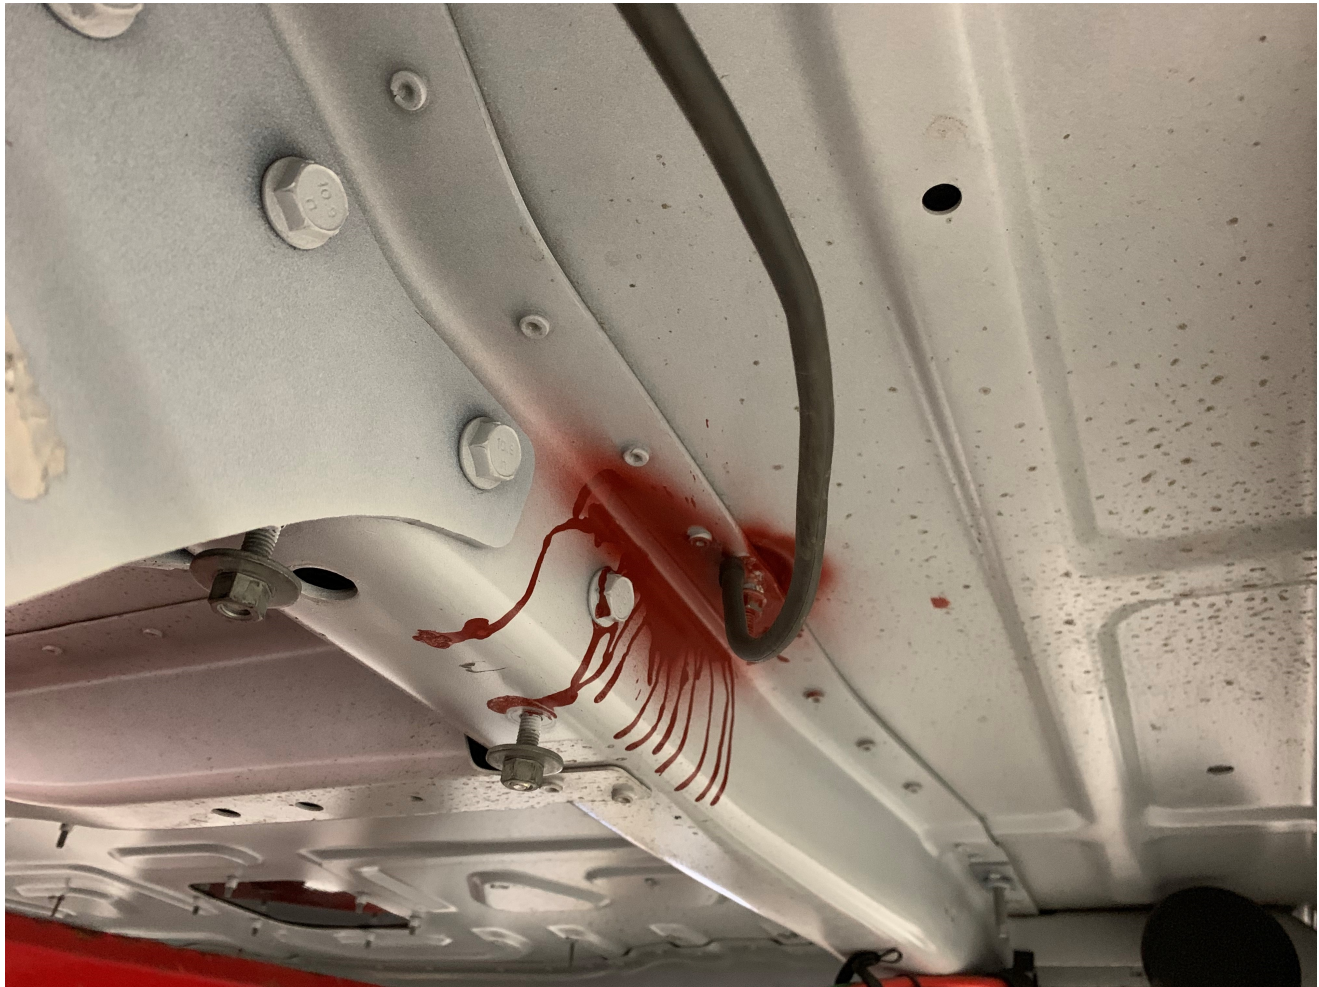
Inspect the GNDP cab skin stud, and repair as necessary.

Verify that the GNDP skin stud on the underside of the cab is clean and torqued correctly. Disassemble and inspect the stud for overspray on the flat surfaces. Torque the stud 14 lbf·ft (19N·m). Repaint the connection, as necessary.

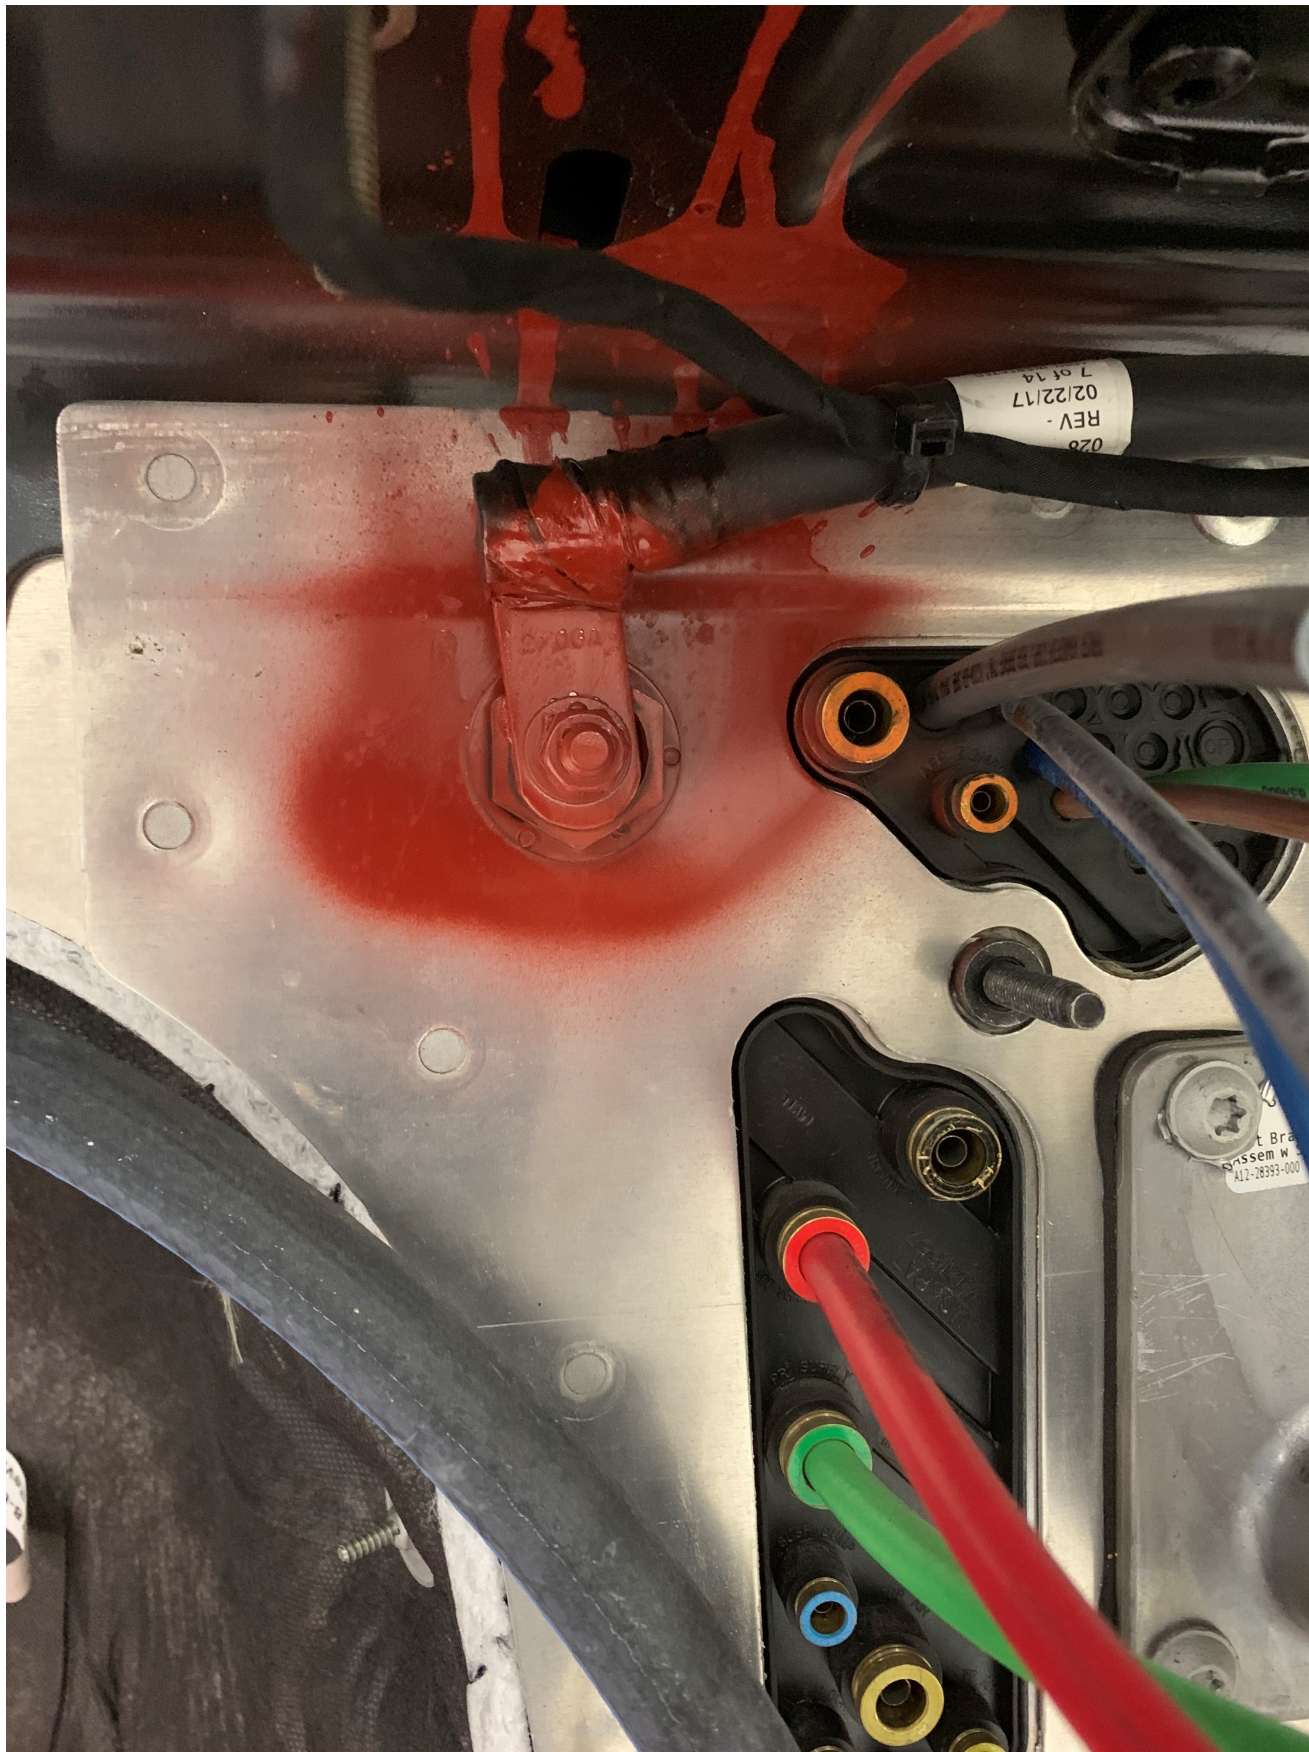
Inspect the GNDE pass-through stud on the engine side of the frontwall, and repair as necessary.

Verify that the GNDE pass-through stud on the engine side frontwall is clean and torqued correctly. Disassemble and inspect the stud for overspray on the flat surfaces. Torque the stud 14 lbf·ft (19 N·m). Repaint the connection, as necessary.

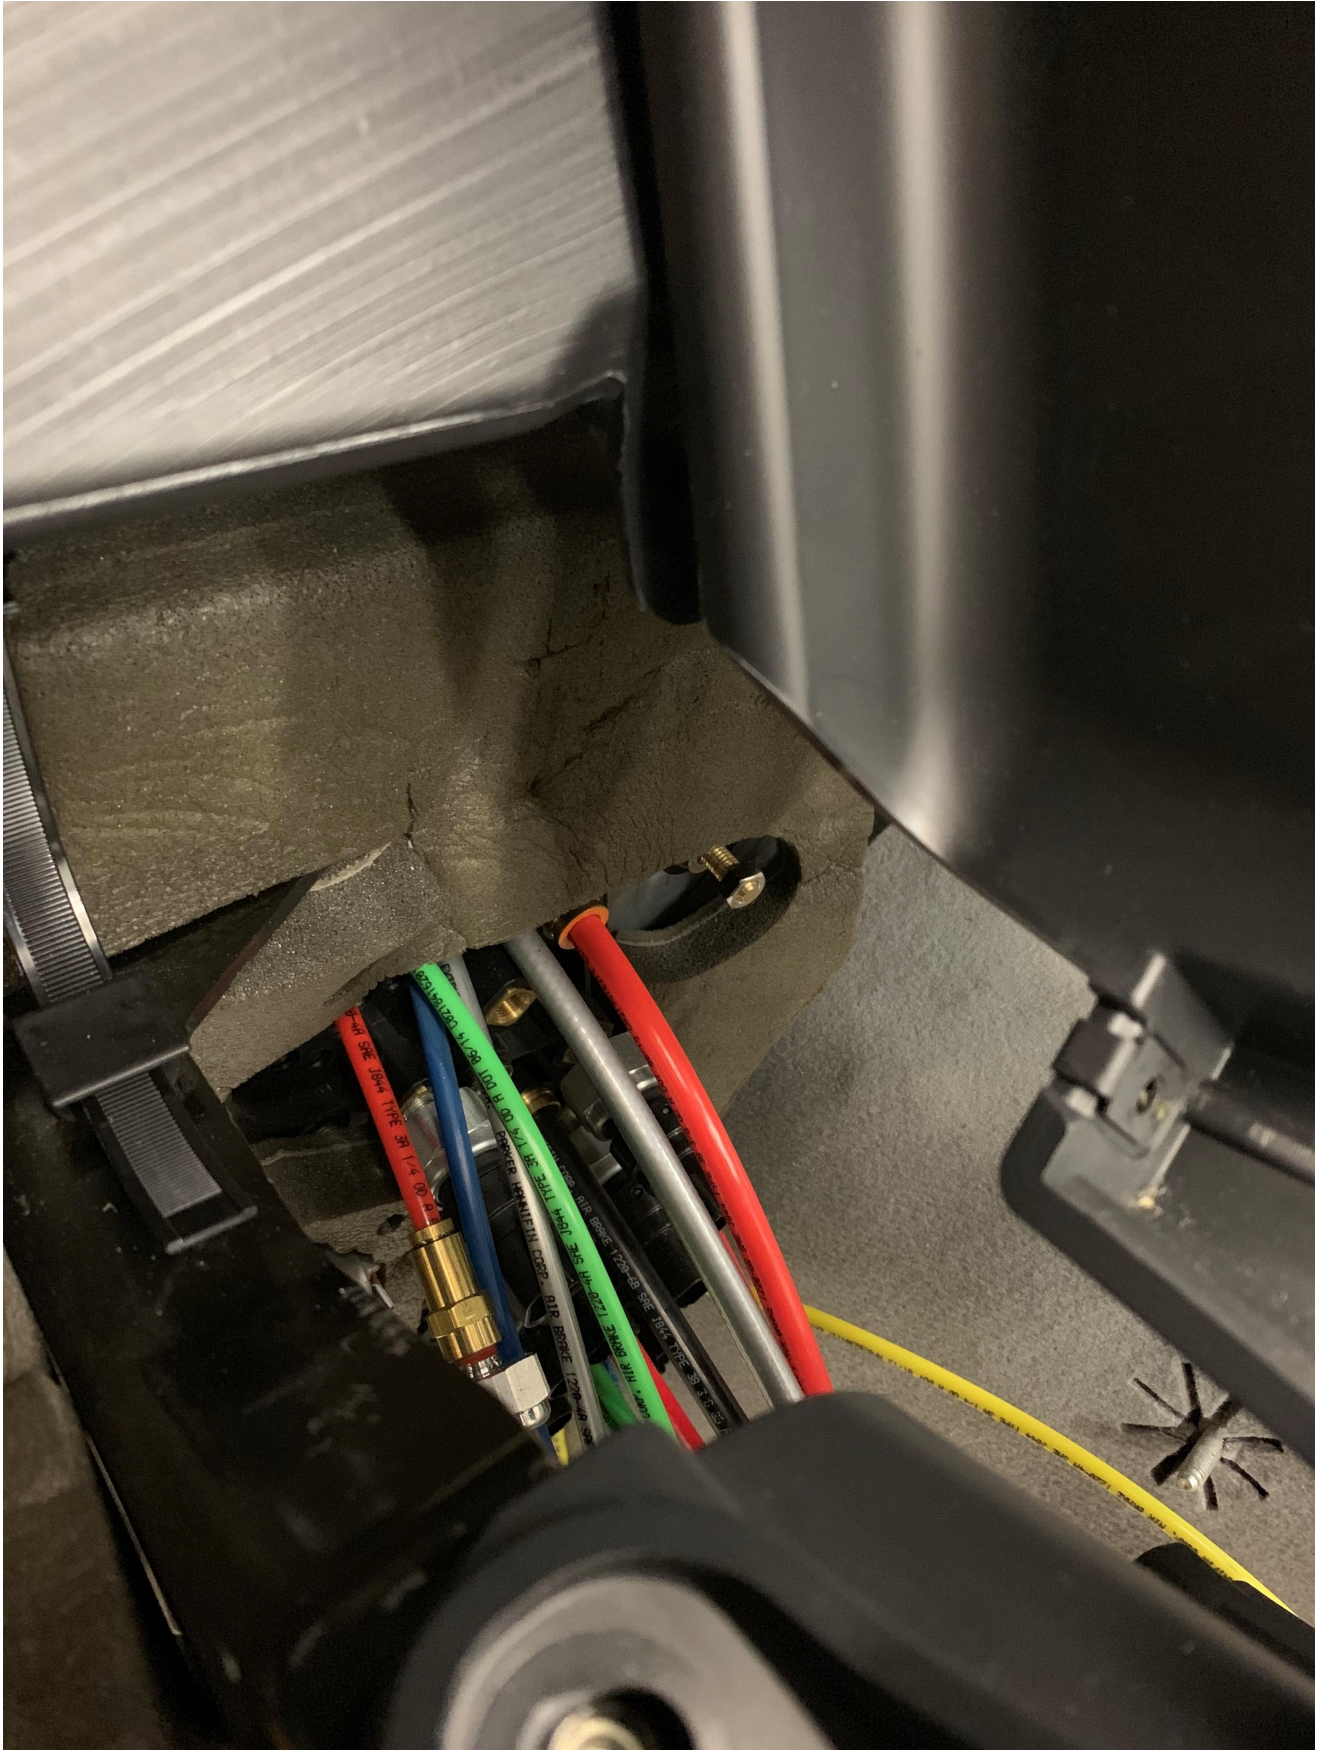
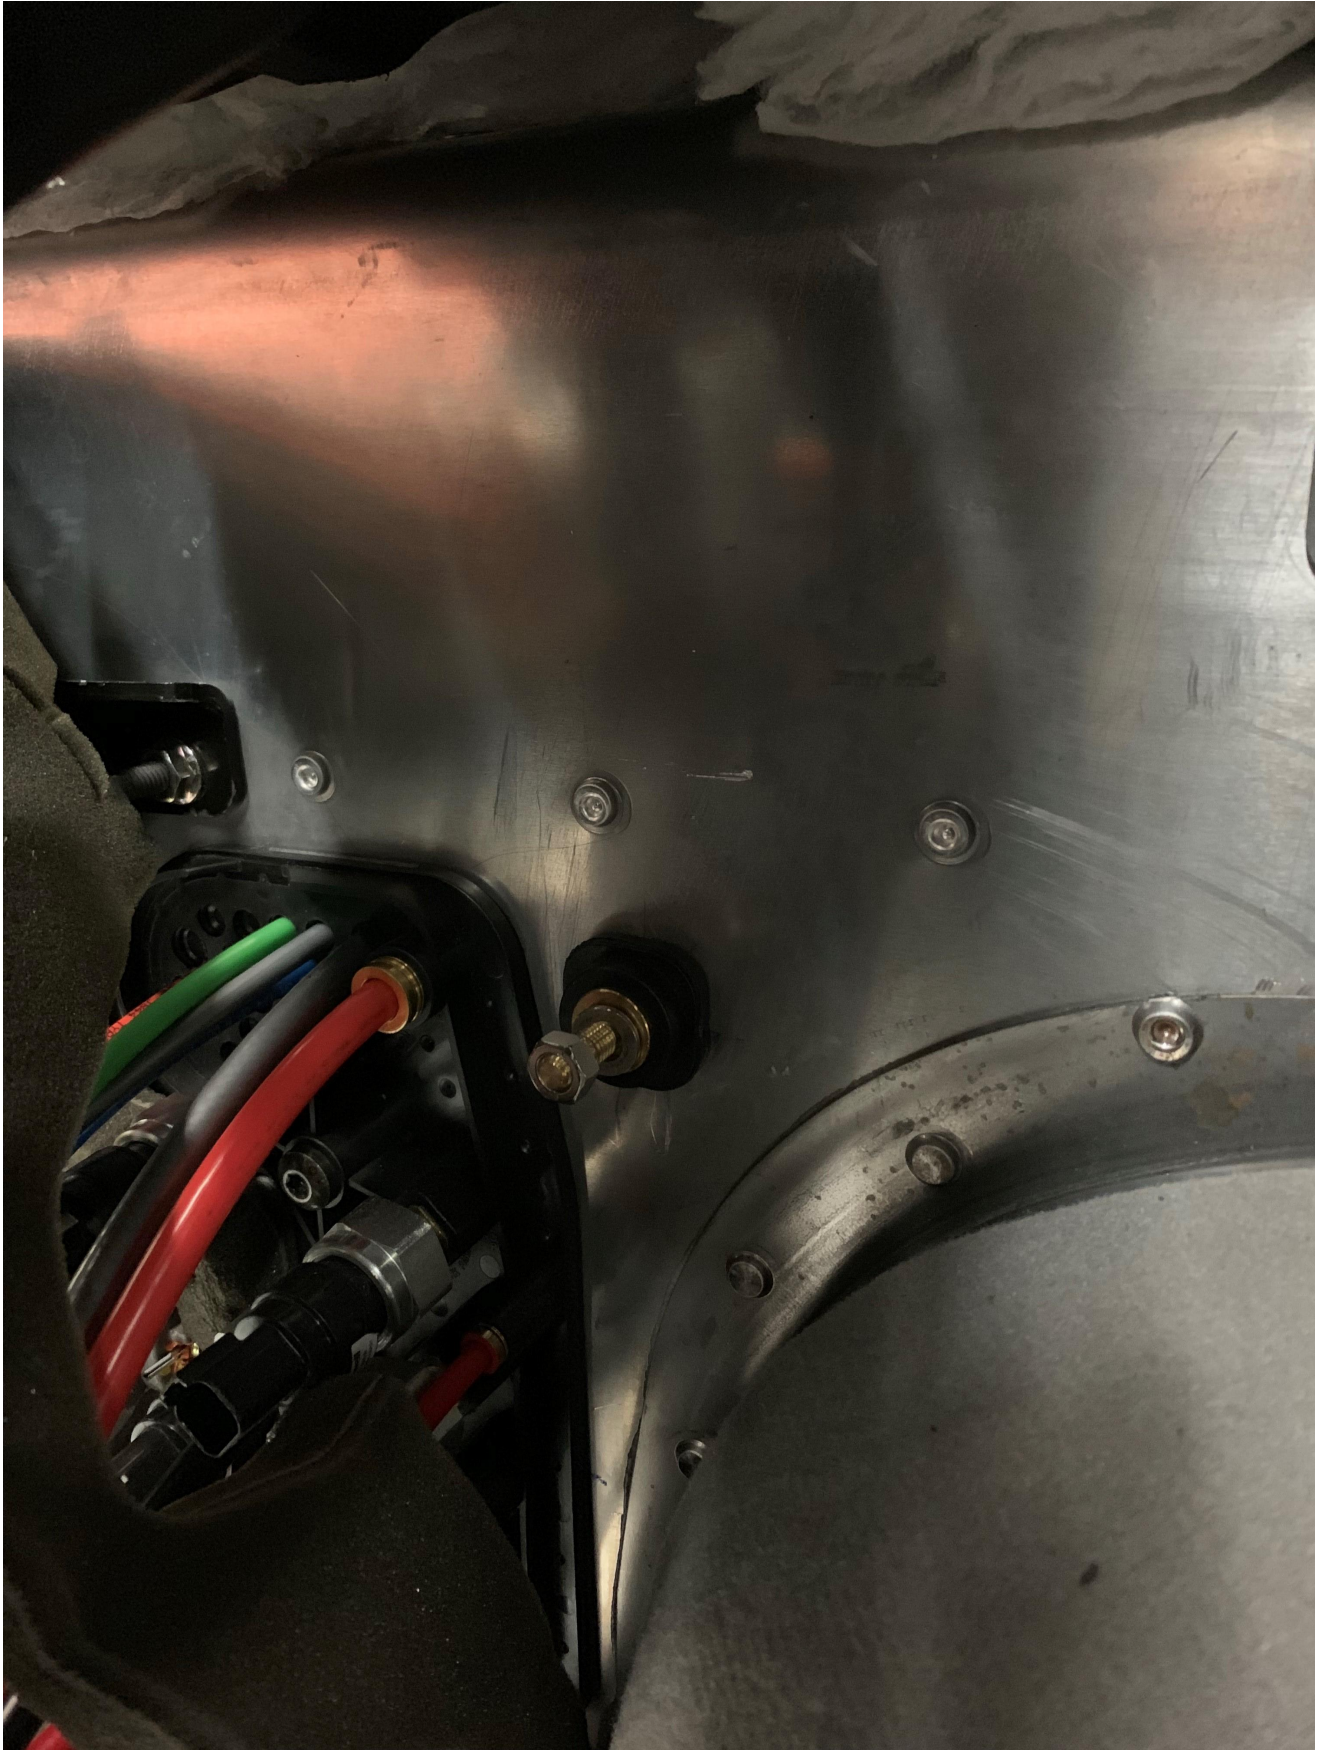
Inspect the GNDE pass-through stud on the cab side of the frontwall, and repair as necessary.

Inspect the GNDE pass-through stud inside the cab, wiggle the cable to check for movement, and service if loose. Torque the stud 14 lbf-ft (19 N·m).

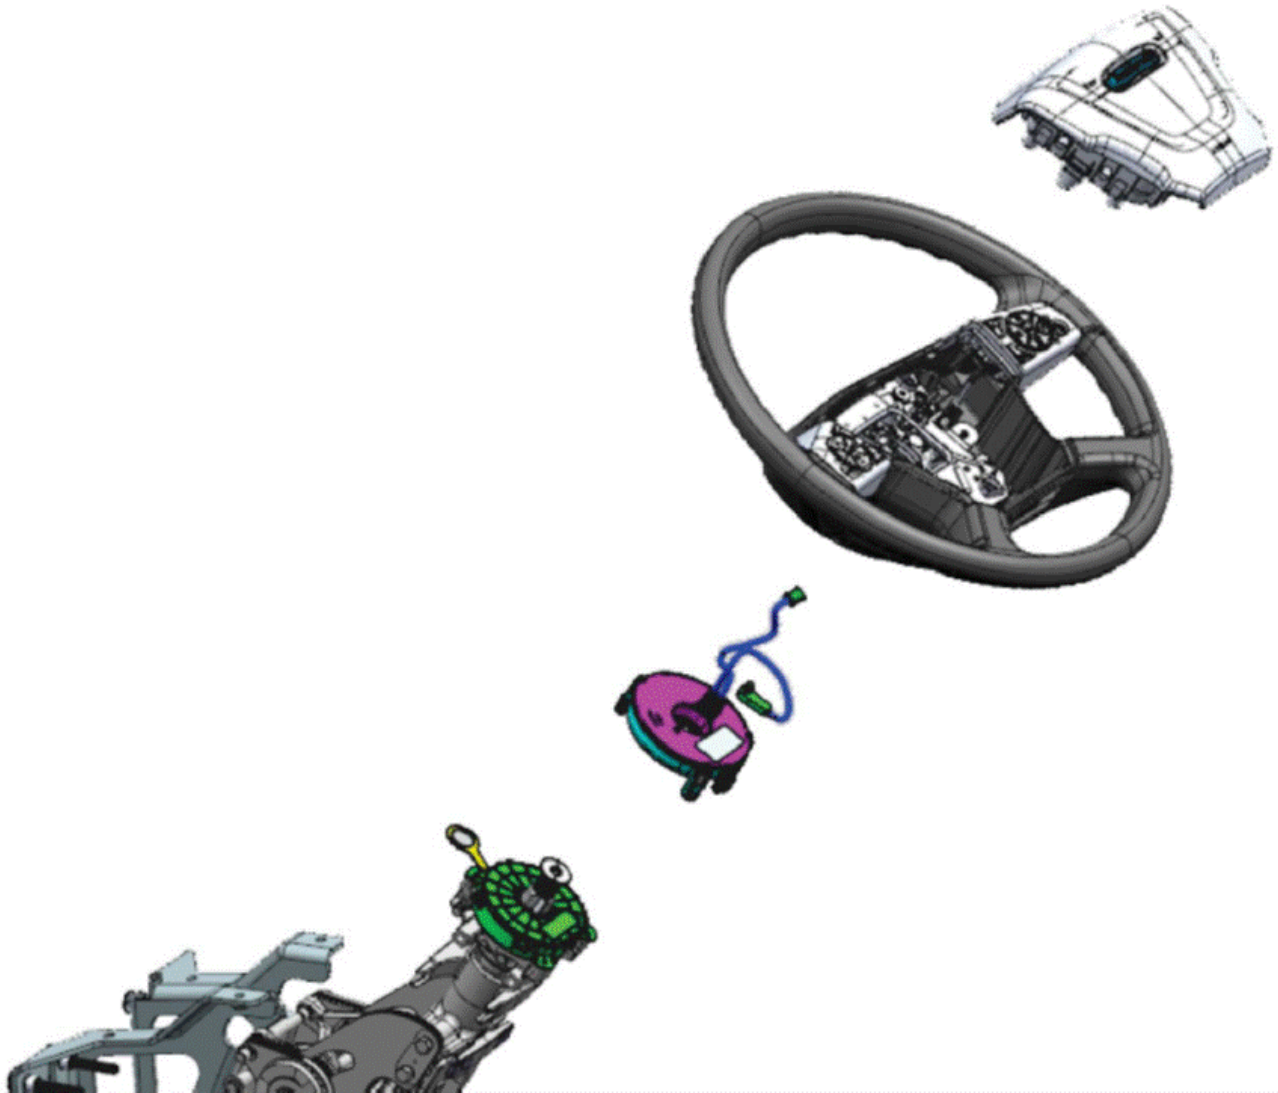
Remove the fasteners that attach the airbag to the steering wheel.
Remove the airbag.

Disconnect the clockspring connector from the right hand (RH) switch pod.
Use a 10 mm hex driver to remove the steering wheel bolt. Retain the bolt.

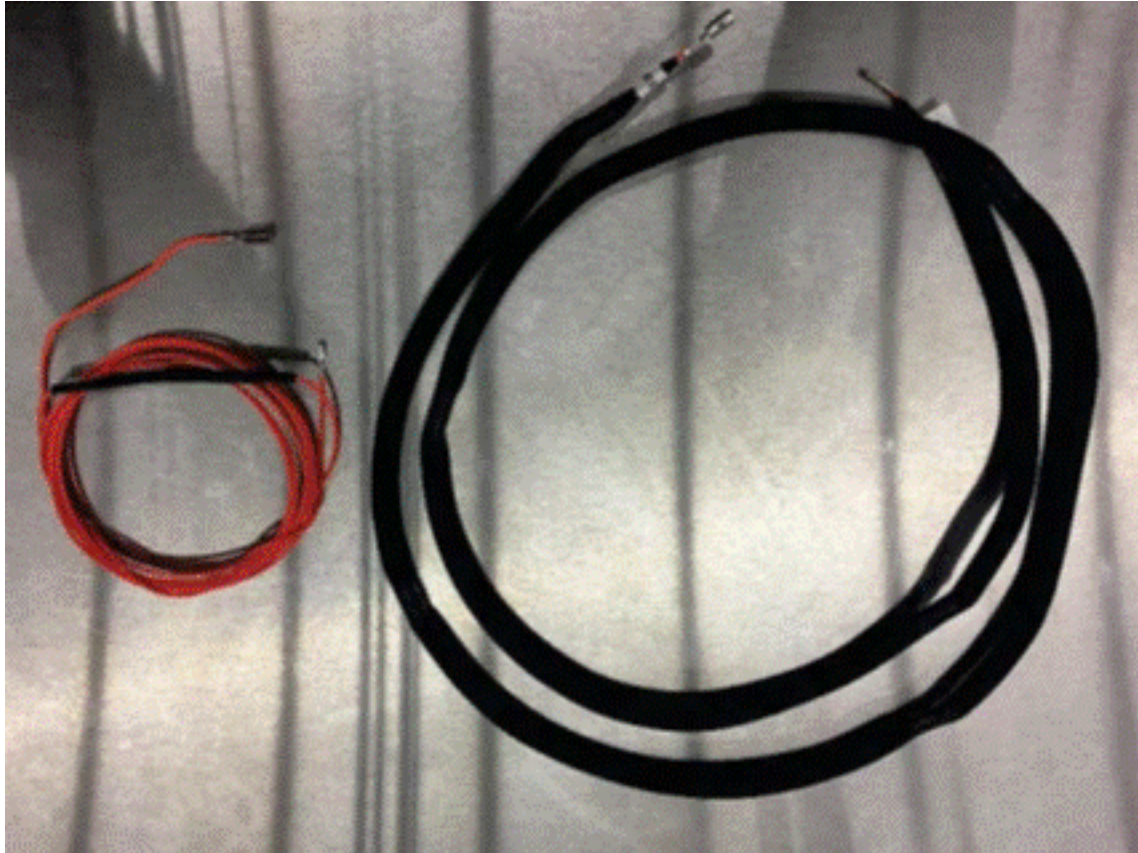
Install a ground diode jumper (part number A66-16268-000).

Before installing the diode harness, make sure that the harness wrapped with fiber wrap.
Disconnect connector X4 on the sSAM.
Connect the diode circuit to connector X4, pin 6.

IMPORTANT: Use electrical tape, NOT TIE STRAPS to secure the harness.

Route the jumper between ASAM and steering wheel, following the dash harness and securing using electrical tape to the existing harness.

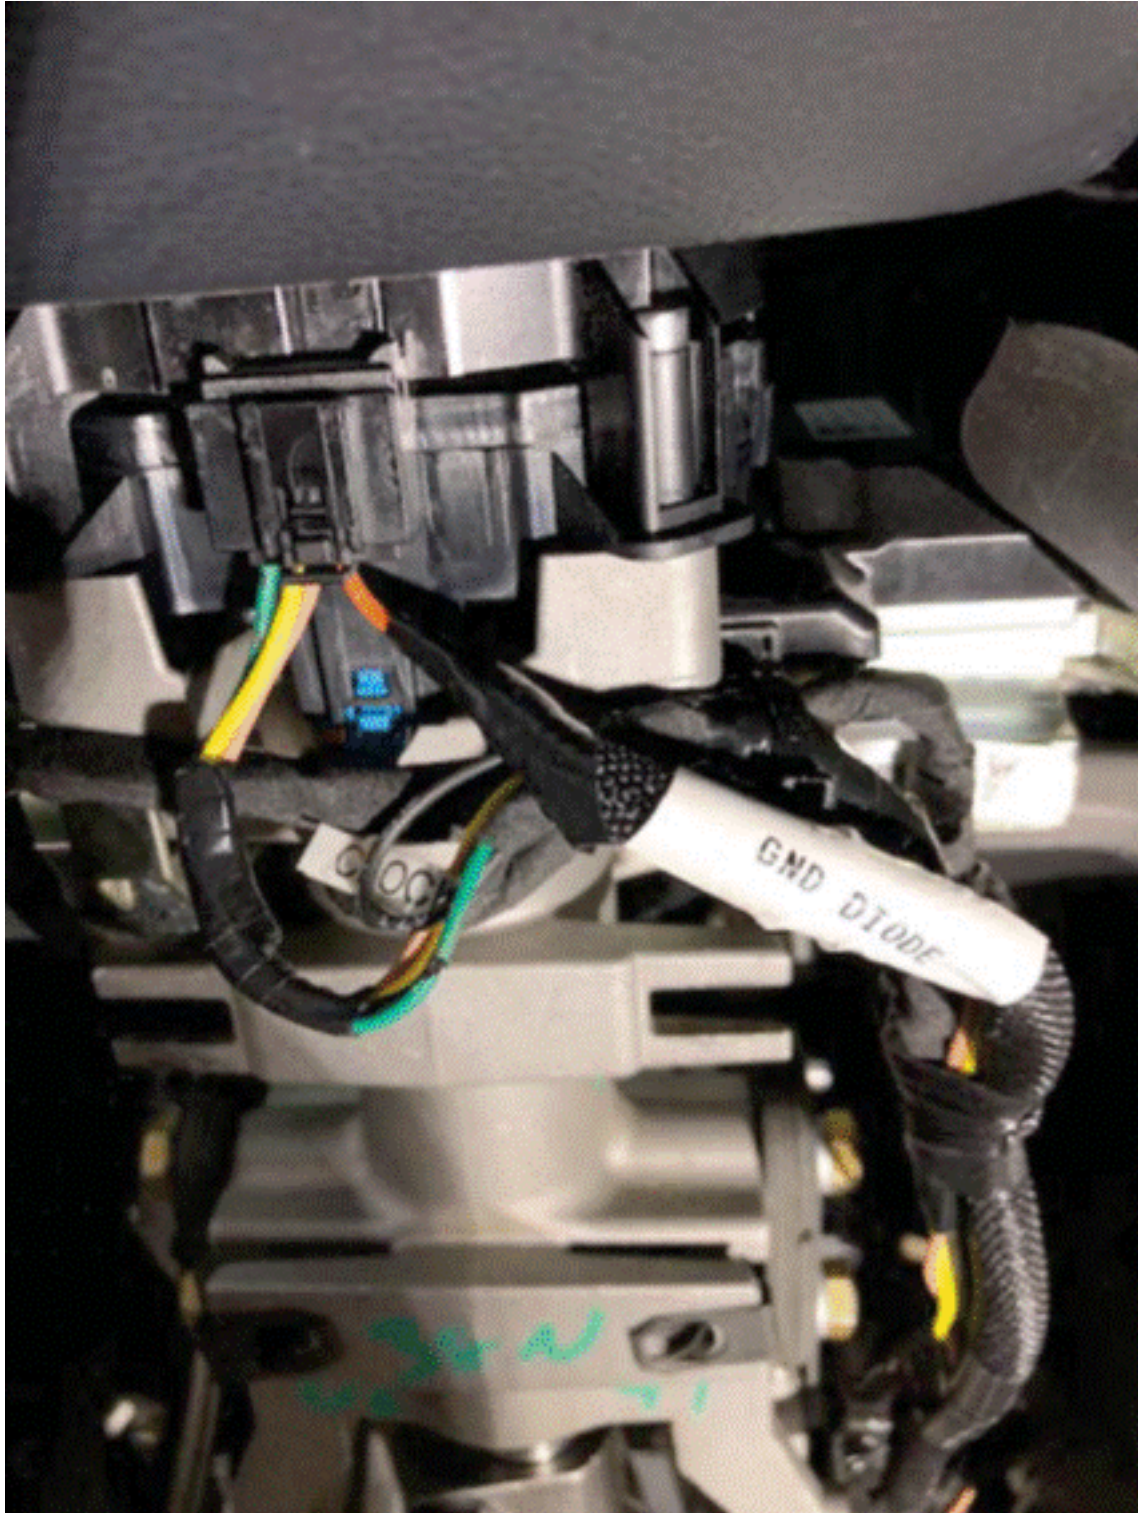
Connect the clockspring connector.
