# Service Campaign Bulletin

Campaign No. 2018090015, November 2018

SUBJECT: **Model G65 AMG vehicles (463 platform)**  
**Model Year 2018**  
**Replace left air filter housing with bleed line**

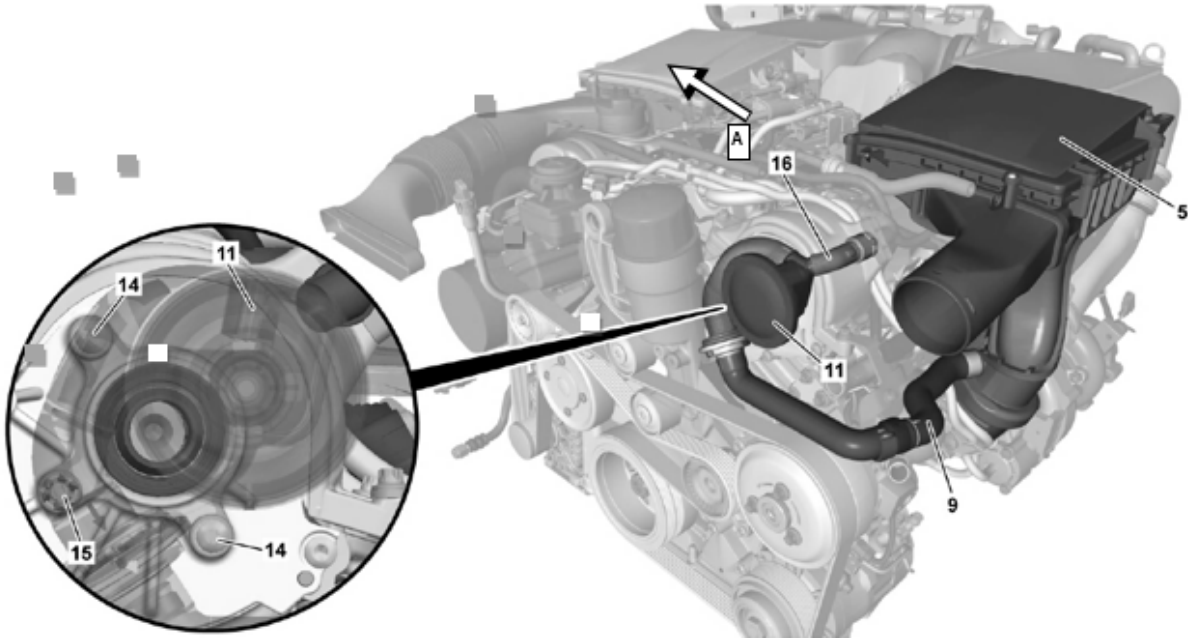
Figure 1

Daimler AG ("DAG"), the manufacturer of Mercedes-Benz vehicles, has determined that on certain MY18 G65 AMG vehicles, the purge air line for the left air filter housing may not meet US market specifications. An authorized Mercedes-Benz dealer will replace the left air filter housing on the affected vehicles.

1. Replace left air filter housing (A, figure 1) with bleed line (AR09.10-P-1150MUC).
