RECREATIONAL VEHICLE SERVICE CAMPAIGN

Service Advisory: 18-332

SERVICE ADVISORY # 18-332

Coleman Water Heater Switch

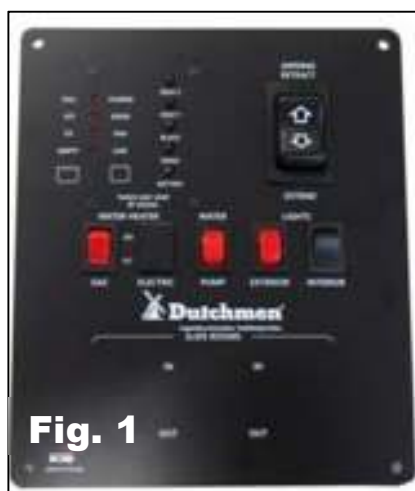
Fig. 1

Locate and remove monitor panel near main entrance door, Figure 1.

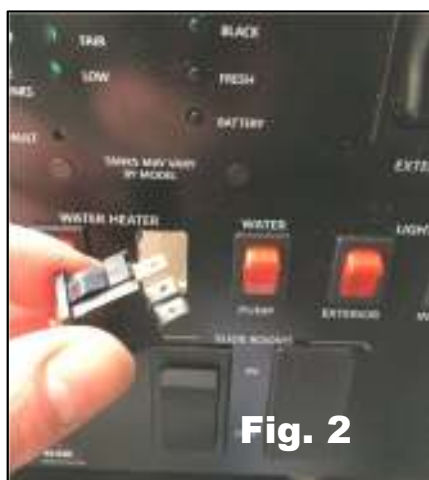
Fig. 2

Remove switch plug in the W/H electric switch location, see Figure 2, and install the KRV # 115566 – Switch – Monitor Panel Small – Illuminated Red in its place with brass-colored blade at the top. See **Step 3** for wiring instructions.

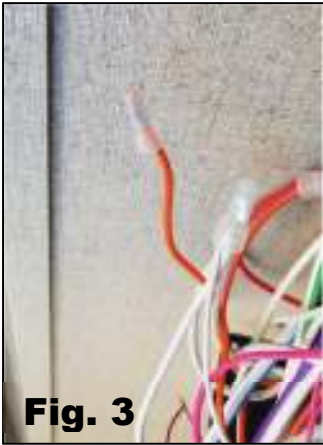
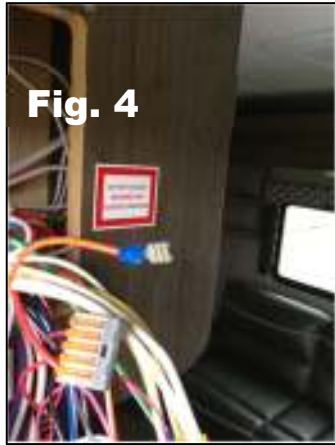
Locate single-capped 14 ga orange wire at the incoming wire bundle, Figure 3. Remove cap, strip end of wire, and install quick slide terminal KRV # 267575 – Terminal – Quick Slide – 14-16 ga – Insulated, Figure 4.

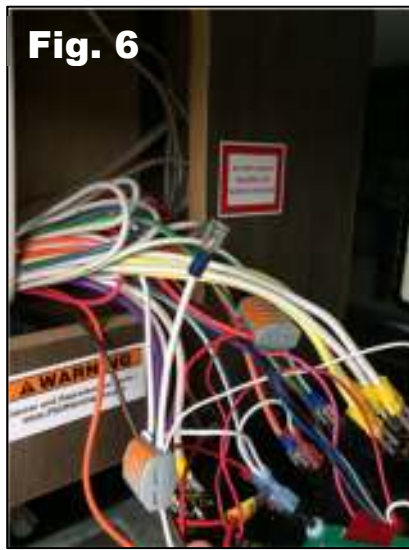
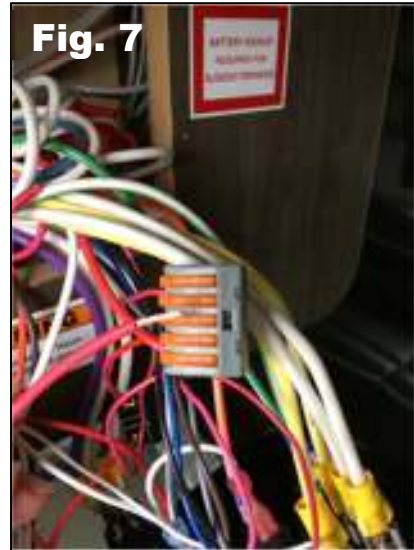
Strip both ends of locally obtained red and white 14 ga wires and install one quick slide terminal KRV # 267575 – Terminal – Quick Slide – 14-16 ga – Insulated on one end of each wire. Then install the bare stranded ends from each of the red and white 14 ga wires into the Wago connectors that has the corresponding color of wire, Figures 5, 6, 7.

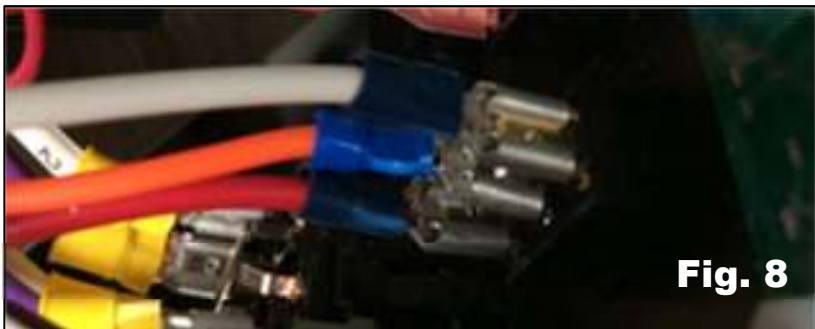
Connect wires into back of switch, the order being from top down (brass blade is at the top) white, orange, red, Figure 8
