Title: Gasoline Engine Bus Fuel System Issues

Applies To: PSI Gasoline Bus

This article identifies known fueling issues on the PSI 8.8 Gasoline Engine for Bus.

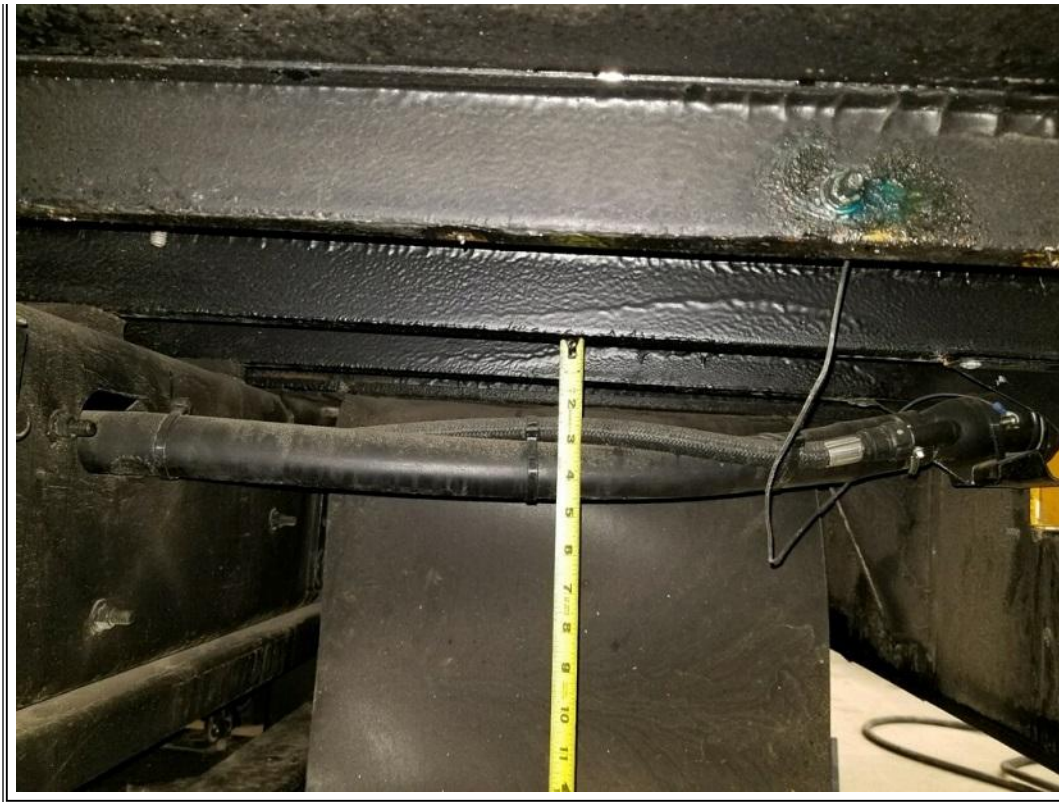
| Step | Action | Decision |
|---|---|---|
| 3 | <b>DIAGNOSTIC:</b><br>Inspect the fuel fill hose for excessive droop.<br><br>Acceptable droop <a href="#">Figure 4</a><br>Unacceptable droop <a href="#">Figure 5</a><br><br><b>YES/NO QUESTION?</b><br>Is the fuel fill hose withing acceptable droop range? | <b>Yes:</b> Go to Step 4 |

Figure 4 - Acceptable Fuel Fill Hose Droop

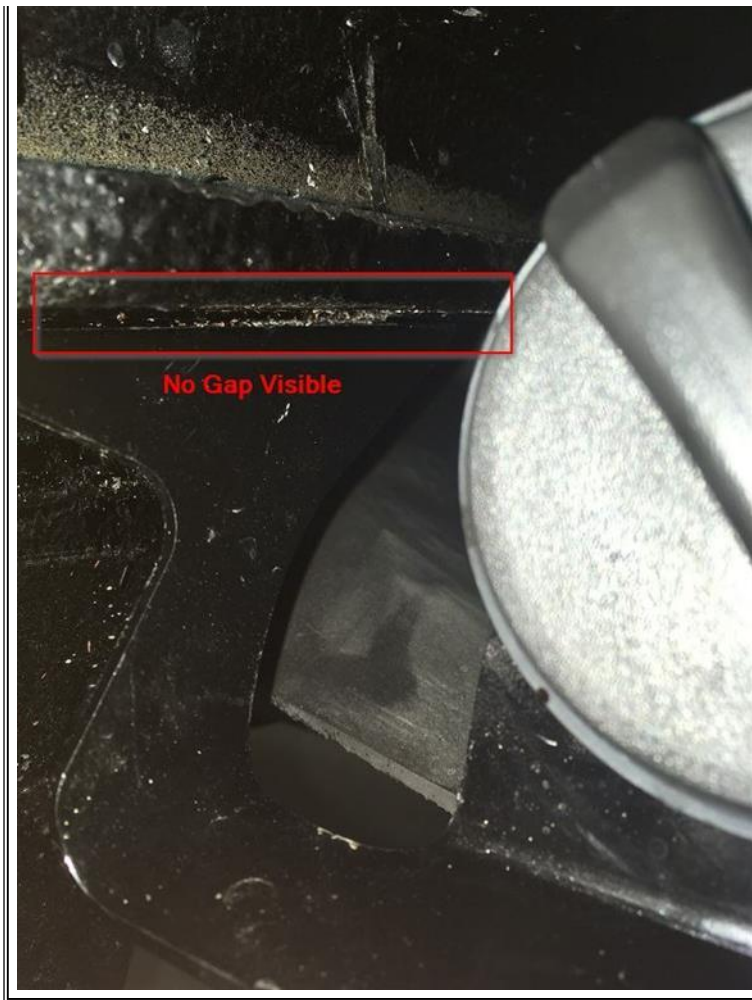
| Step | Action | Decision |
|---|---|---|
| 4 | <b>DIAGNOSTIC:</b><br>Check the gap between the fuel fill receiver bracket and the sill<br><br>Acceptable - <a href="#">Figure 6</a><br>Unacceptable - <a href="#">Figure 7</a><br><br><b>YES/NO QUESTION?</b><br>Is there excessive gap noticed? | <b>Yes:</b> Go to <a href="#">Repair Steps</a> for Fill Receiver Bracket Repair |

**Figure 6 - Acceptable Fill Receiver Bracket Gap**
