| L636-A.05.18 | <b>To:</b> Official After Sales Network<br><b>Subject:</b> Application LTE handy kompensor label<br><b>Date:</b> 09 November 2018<br><b>Pages:</b> 3 | |

L636-A.05.18

Application LTE handy kompensor label

Urus

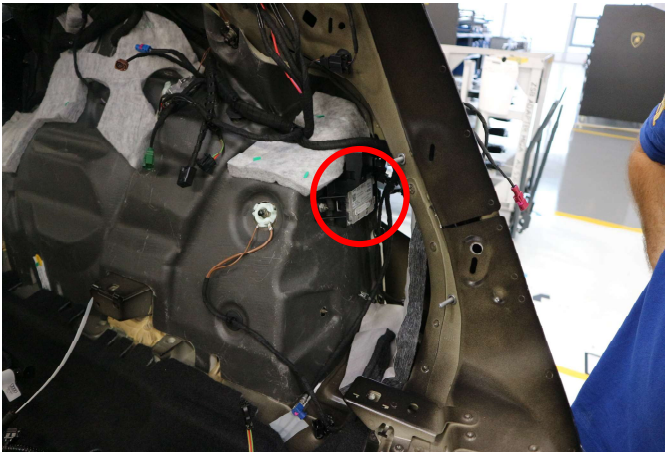
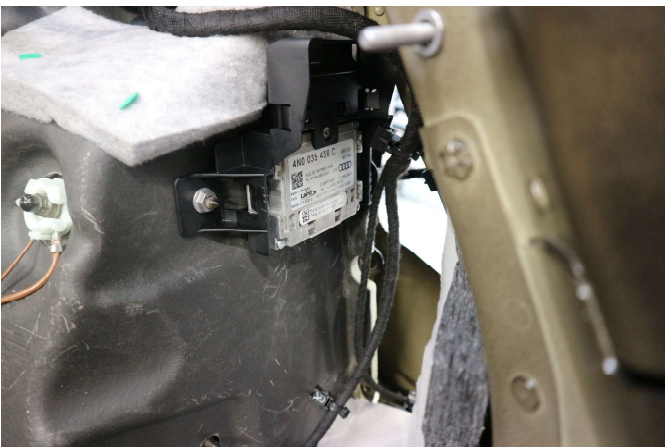
2. Once the cover has been disassembled, identify the control unit (circled in the image).

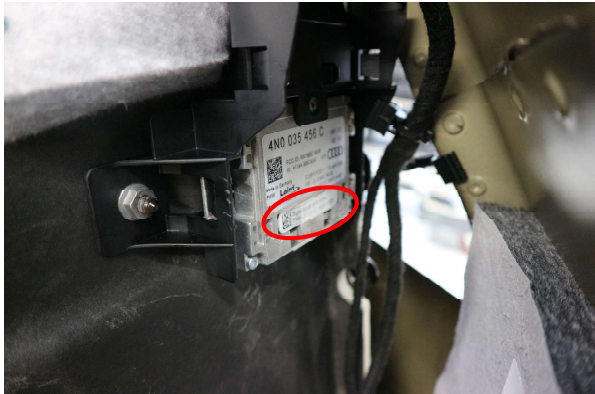
3. Remove the label from the control unit (Label circled and named "Signal Booster serial number" in the image).

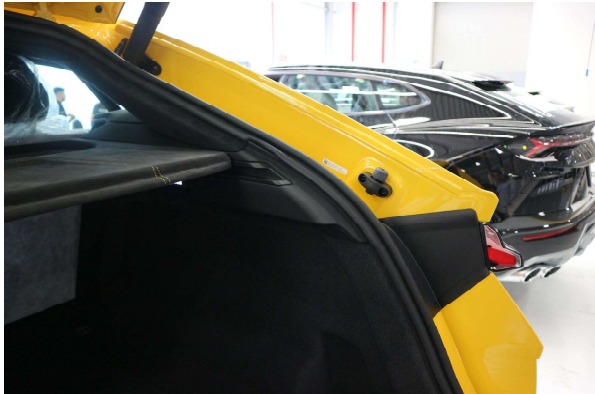
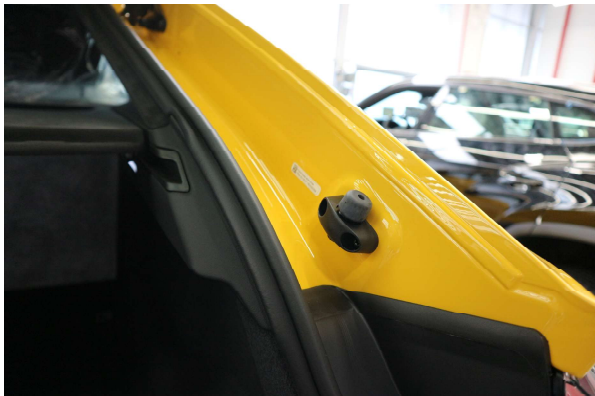
4. Apply the label on the body (See the image).
