L62X-  
A.07.18

To: Official After Sales Network  
Subject: BoSe wire rework  
Date: 16 November 2018  
Pages: 10

**Campaign description.**  
BoSe wire rework

**Model.**  
Huracàn

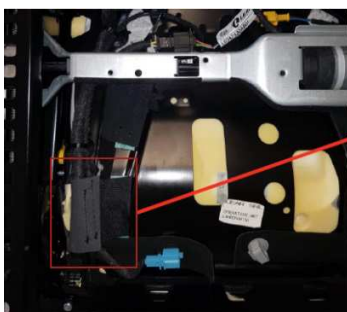
1. Unhook pattern and open it.

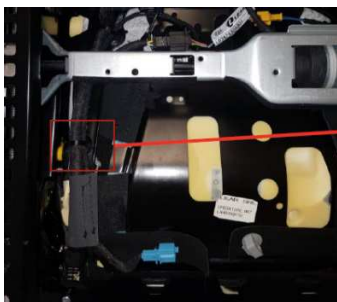
2. Use clamp to cut tie strip #1.

**Warning: Pay attention not to damage wiring harness.**

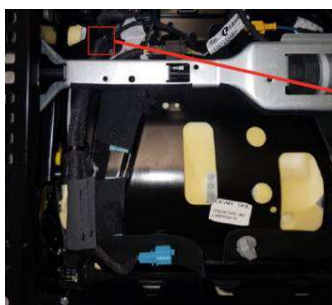
3. Use clamp to cut tie strip #2.

**Warning: Pay attention not to damage wiring harness.**

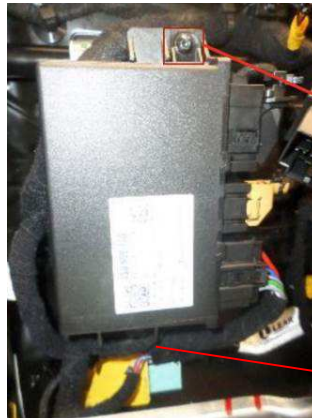
4. Use torque wrench/screwdriver to remove bolt #1.

5. Remove bolt #2.

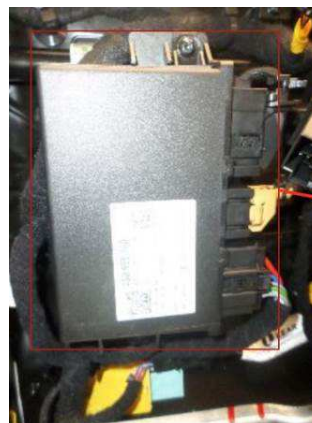
6. Remove ECU.

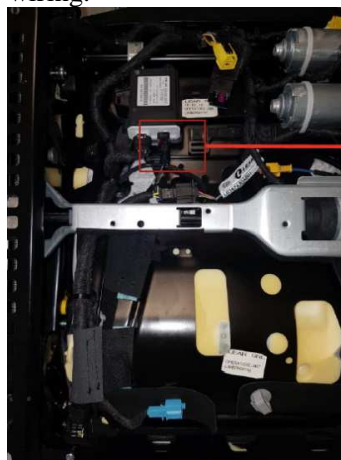
7. Use fork to unplug the Body sense connector and extend wiring.

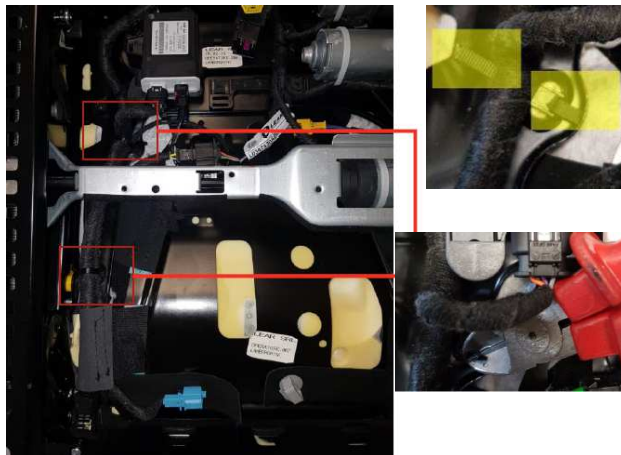
8. Use clamp to cut pin bulging edges.

**Warning:** Pay attention not to damage wiring harness.

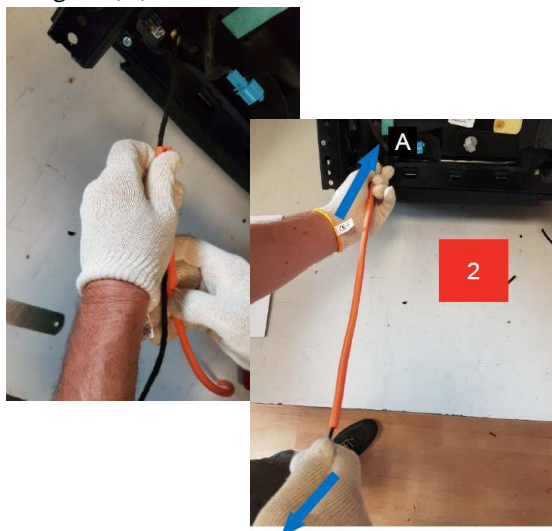
9. Wrap Body sense wiring with TwistTube and push tube according to image 2 until reach wire extremity as shown in figure (A).

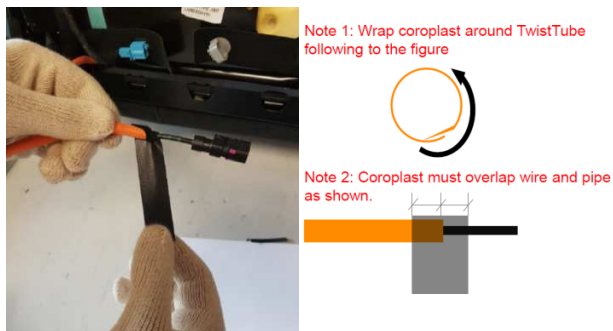
10. Wrap 80 mm Coroplast 800 to fix TwistTube on connector side.

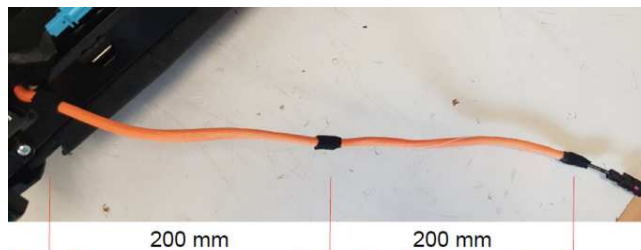
11. Add 2 protection points spaced 200 mm.

Note: Wrap coroplast around TwistTube following to the figure

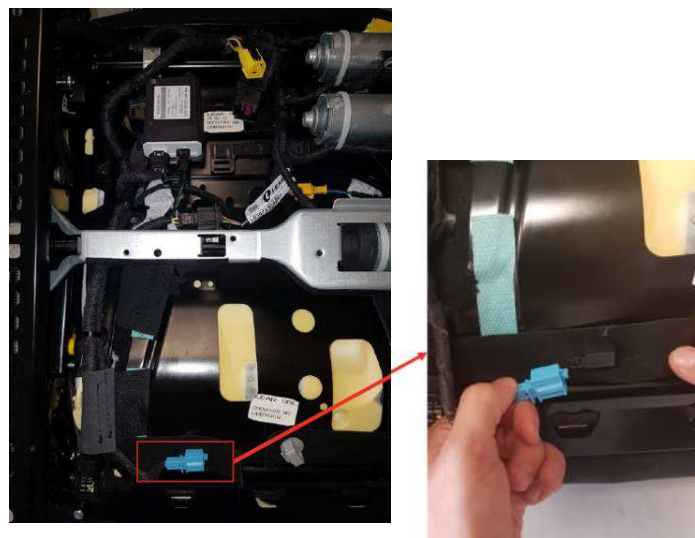
12. Remove wire connector.

Note: Pay attention not to remove the clip.

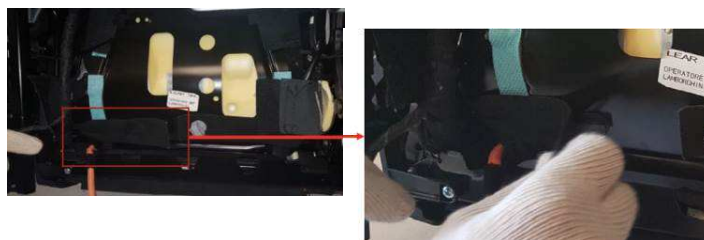
13. Detach pattern.

Note: Pay attention not to remove the clip.

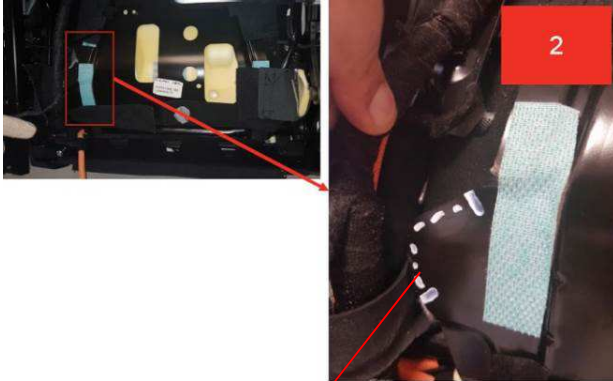
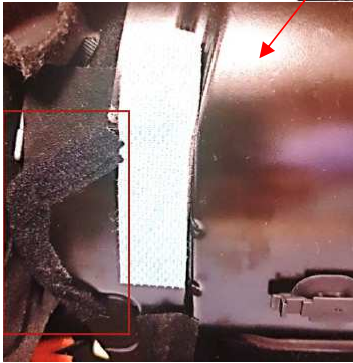
14. Add 80 mm Coroplast 800 to protect metal pan portion shown in figure 2.

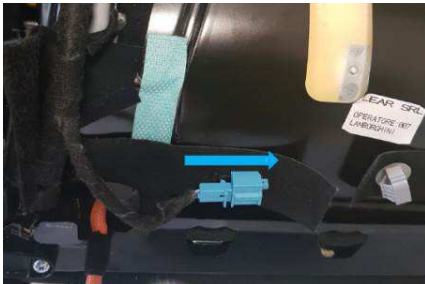
15. Close the pattern and insert the pin following the arrow.

Note: Pay attention not to remove the clip.

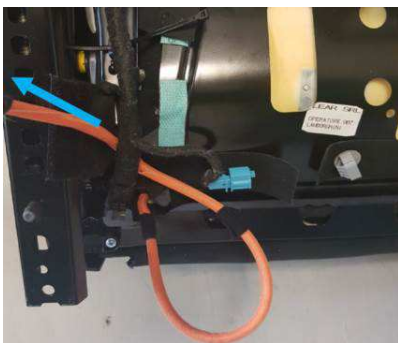
16. Relocate Body Sense wire.

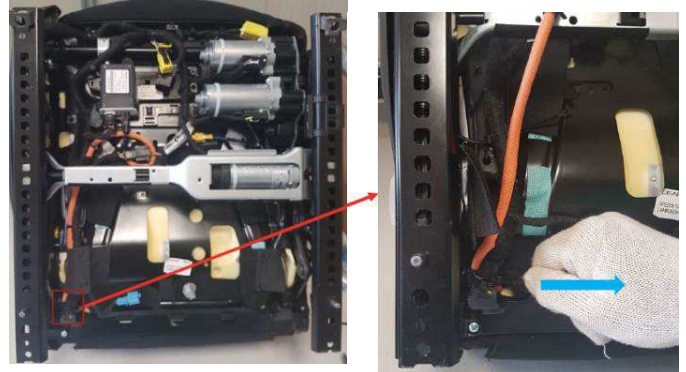
17. Fix and pull strip #1.

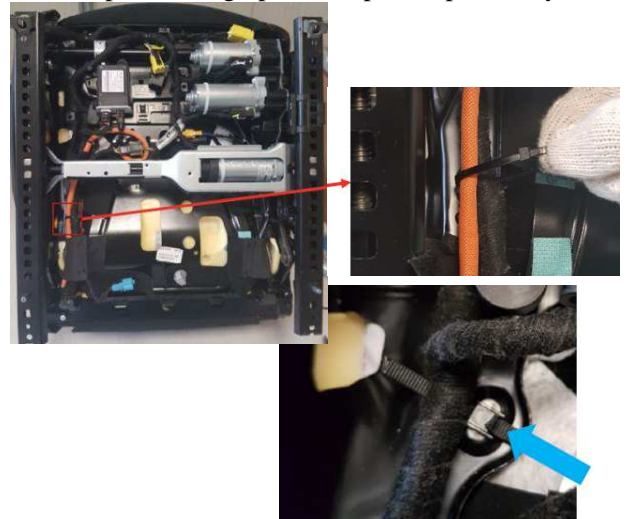
18. Put strip #2 through previous plastic pin cavity.

Note: Only slightly close the strip, do not tighten it completely.

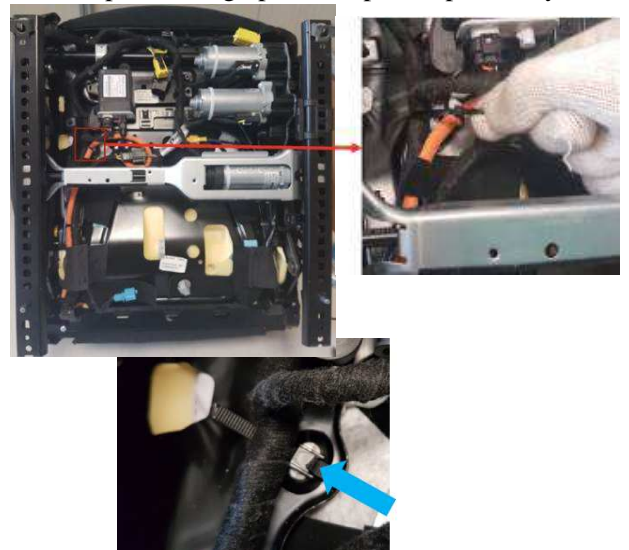
19. Put strip #3 through previous plastic pin cavity.

Note: Only slightly close the strip, do not tighten it completely.

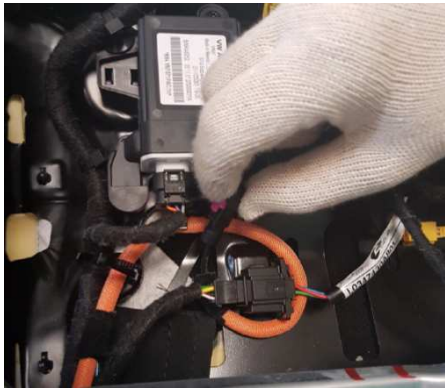
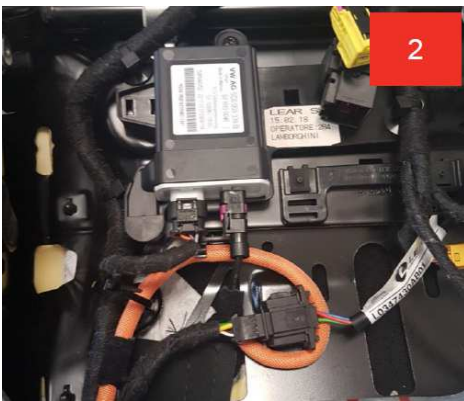
20. Relocate wiring and plug Body sense connector.

Note: Wiring must have the path shown in figure 2.

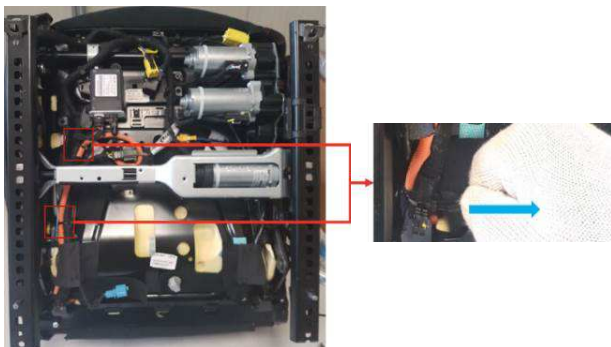
21. Pull strips.

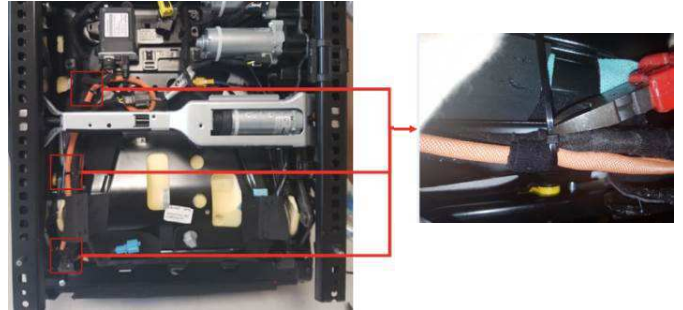
22. Cut leftover strip portion as shown.

**Warning:** Pay attention not to damage wiring harness.

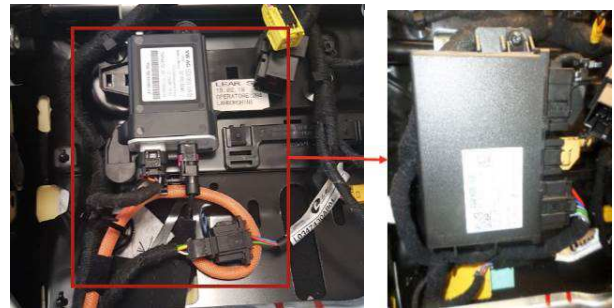
23. Mount ECU.

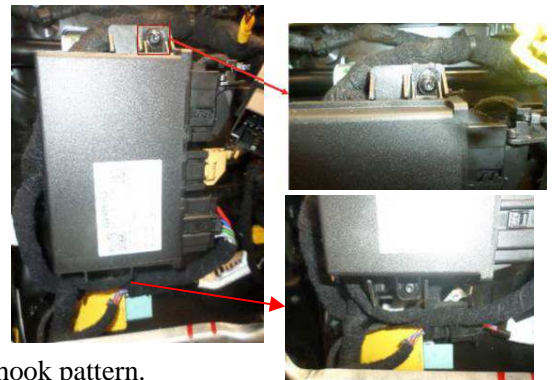
24. Install and tighten ECU bolts with torque wrench to 2.5 Nm .

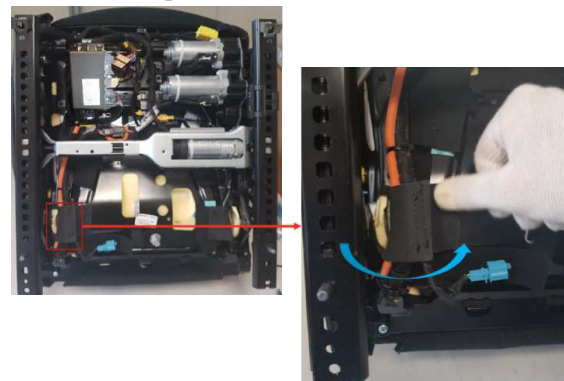
25. Close hook pattern.

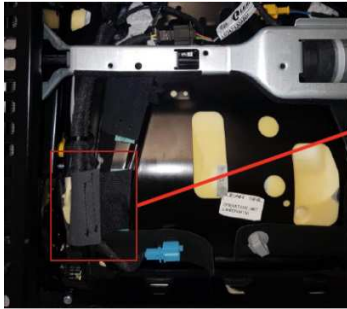
1. Unhook pattern and open it.

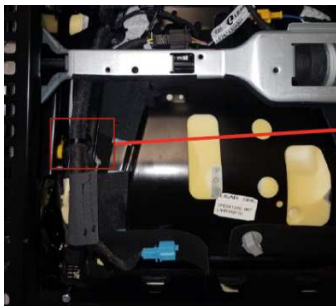
2. Use clamp to cut tie strip #1.

**Warning: Pay attention not to damage wiring harness.**

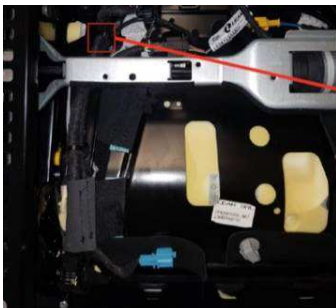
3. Use clamp to cut tie strip #2.

**Warning: Pay attention not to damage wiring harness.**

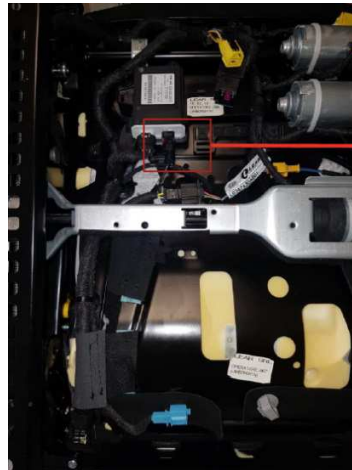
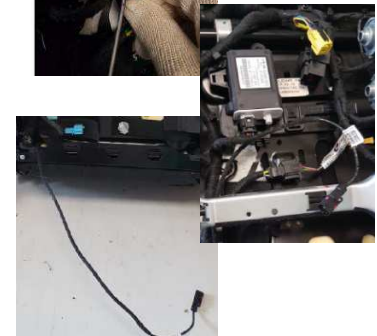
4. Use fork to unplug the Body Sense connector and extend wiring.

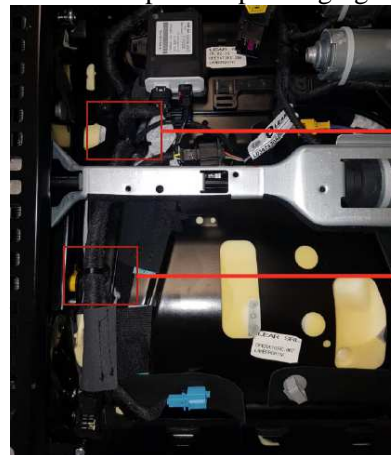
5. Use clamp to cut pin bulging edges.

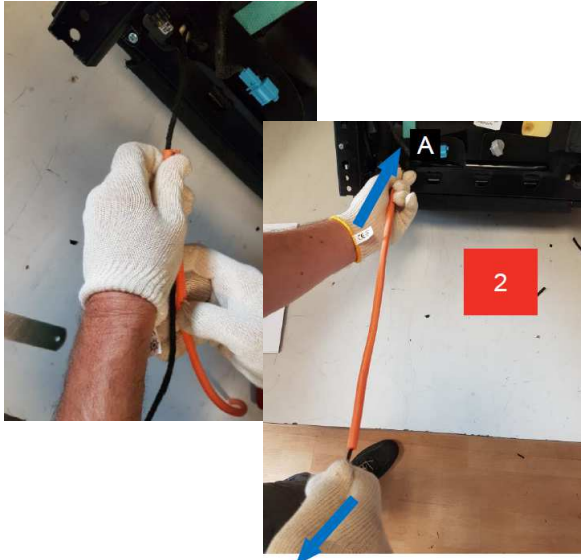
6. Wrap Body sense wiring with TwistTube and push tube according to image 2 until reach wire extremity as shown in figure (A)

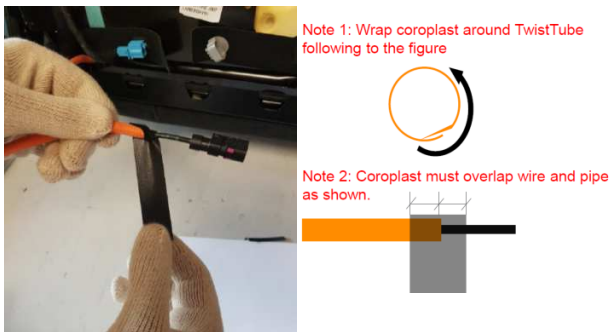
7. Wrap 80 mm Coroplast 800 to fix TwistTube on connector side.

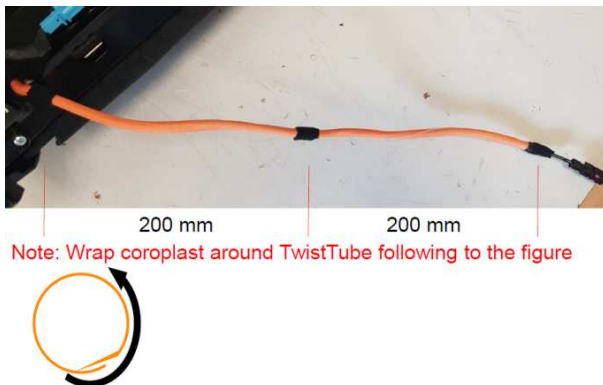
8. Add 2 protection points spaced 200 mm.

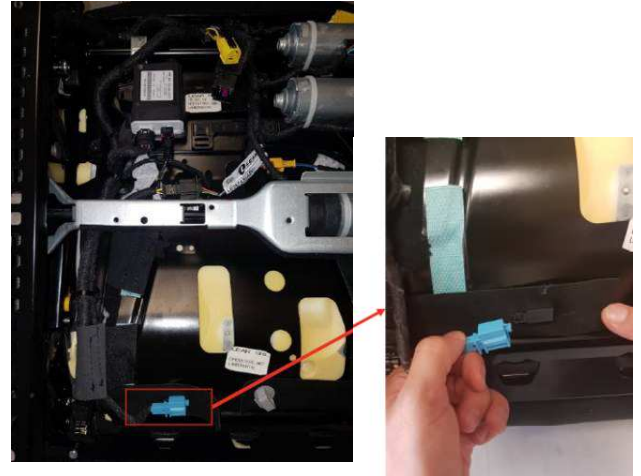
9. Remove wire connector.

Note: Pay attention not to remove the clip.

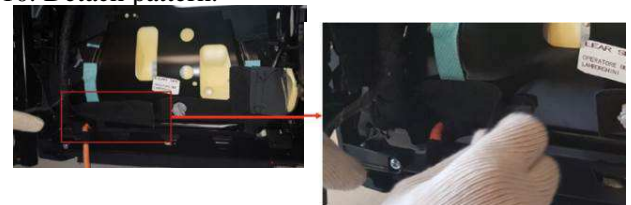
10. Detach pattern.

Note: Pay attention not to remove the clip.

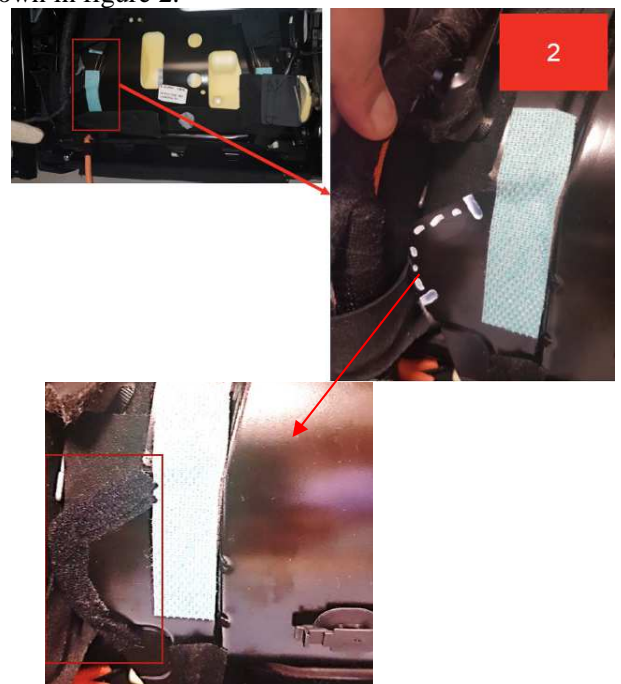
11. Add 80 mm Coroplast 800 to protect metal pan portion shown in figure 2.

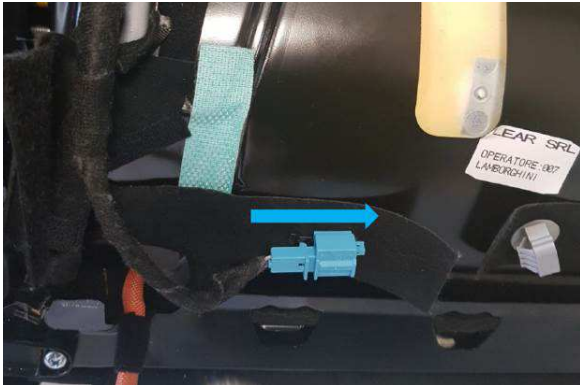
12. Close the pattern and insert the pin following the arrow.

Note: Pay attention not to remove the clip.

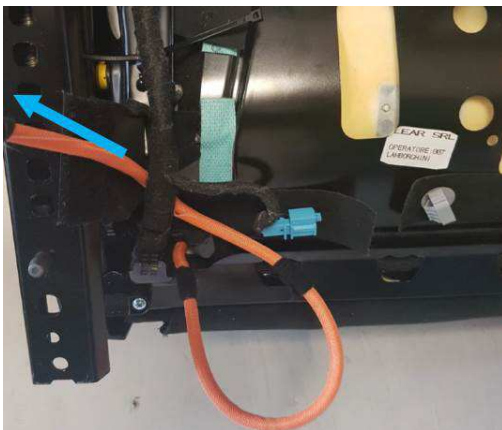
13. Relocate Body Sense wire.

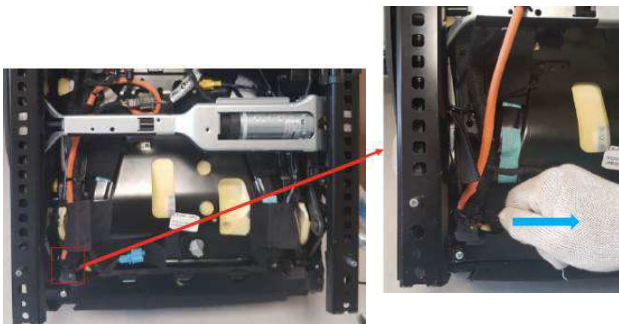
14. Fix and pull strip #1.

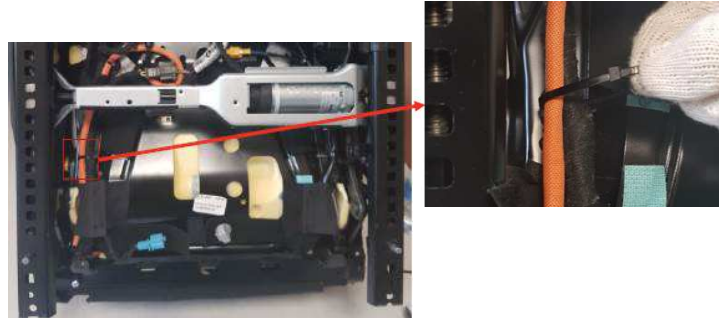
15. Put strip #2 through previous plastic pin cavity.

Note: Only slightly close the strip, do not tighten it completely.

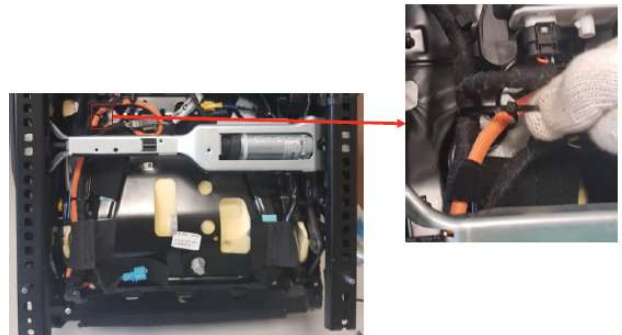
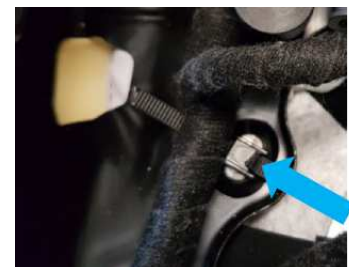
16. Put strip #3 through previous plastic pin cavity.

Note: Only slightly close the strip, do not tighten it completely.

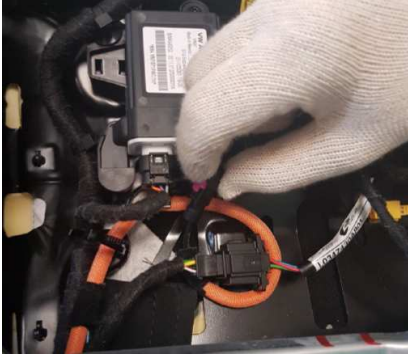
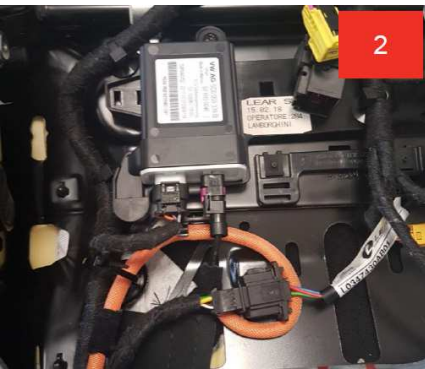
17. Relocate wiring and plug Body sense connector.

Note: Wiring must have the path shown in figure 2.

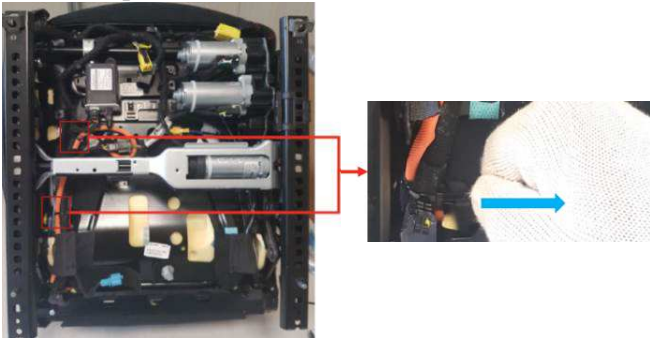
18. Pull strips.

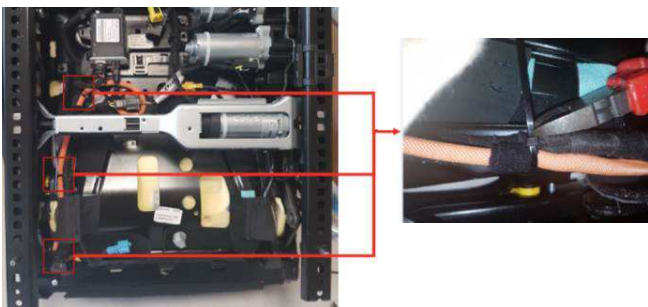
19. Cut leftover strip portion as shown.

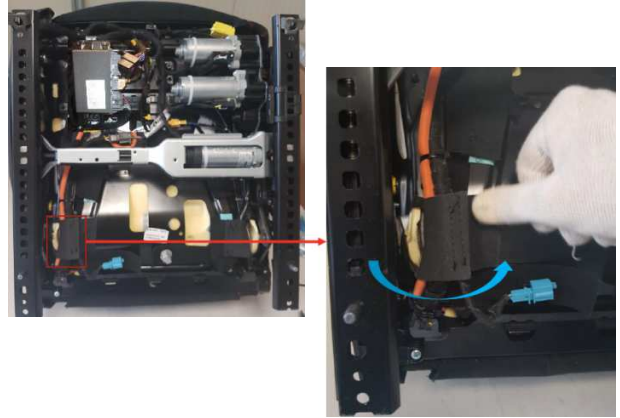
20. Close hook pattern.
