Location: Powertrain Transmission – Rear Axle

Concern: Clutch oil leak from the clutch oil filter cover

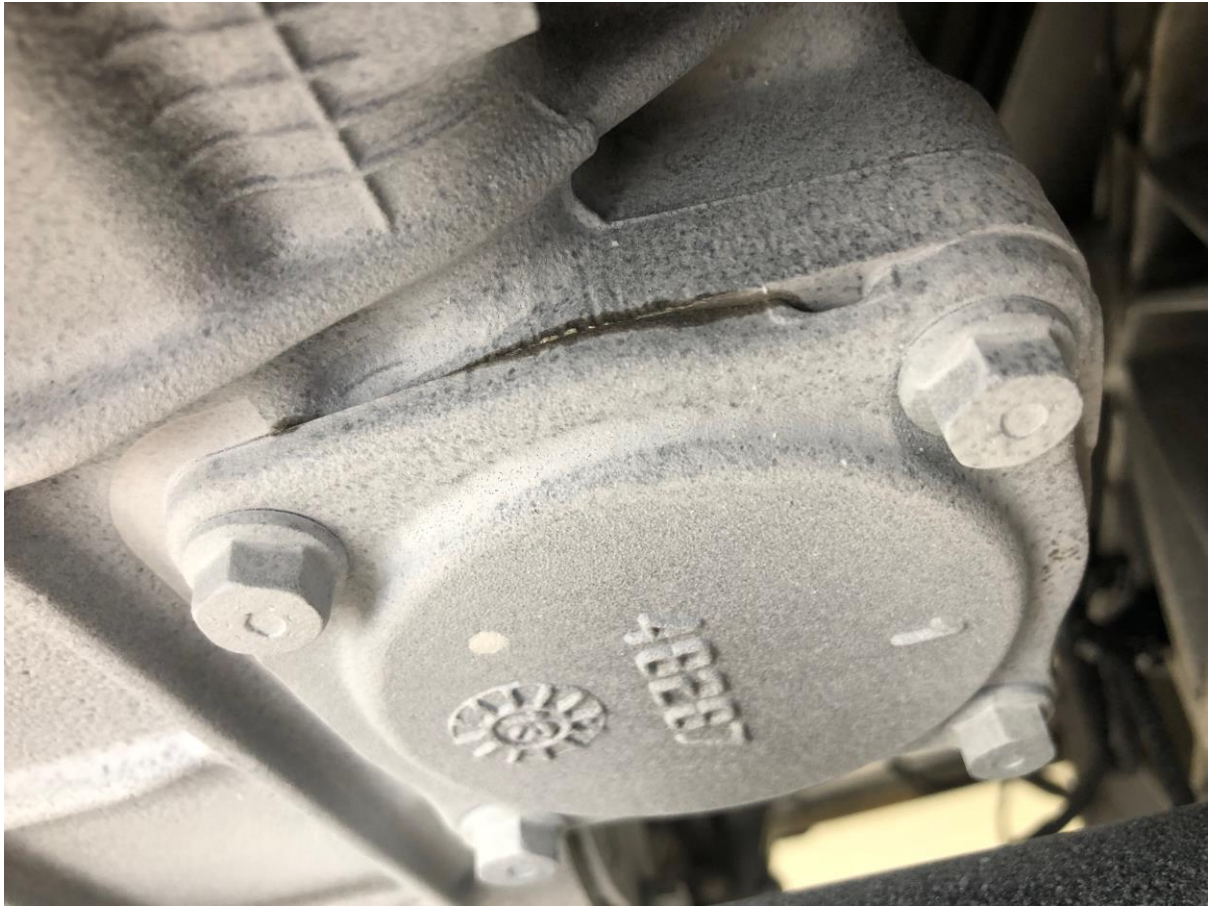
If a leak from the clutch oil filter cover has been identified (as shown in the image below), follow the steps included in this document before considering replacing any parts.

1. Capture images of the area with the leak
2. Clean up and dry the transmission
3. Apply leak detector spray in the area that has previously leaked
4. Bring vehicle to operating temperature (test drive if necessary)
5. Inspect the transmission to confirm the source of the leak (if still present)
6. Capture new images of the leak
7. If the leak is confirmed that is from the cover, proceed to the next step. If no further leaks have appeared no further action is required
8. If the leak continues, unscrew the 4 bolts to remove the cover
9. Clean the surface thoroughly to ensure is completely free of clutch oil

10. Check the condition of the O-ring and then check if there is porosity on the clutch housing where the O-ring fits

- If the area is not porous, proceed to Step 14
- If the area is porous, proceed to Step 11

11. Apply a metal filler leaving an excess thickness for the sanding process - [click here for reference product](#)

12. Allow the filler to dry completely as per the specific instructions of the product used

13. Sand the excess compound in 2 phases with different grit sizes, coarse and fine

14. Replace the O-ring and reassemble - the O-ring must be replaced each time the clutch oil filter cover is removed

15. Apply Loctite 242 on the clutch oil filter bolts before assembly to seal possible porosity inside the threaded holes as well
