# Service Bulletin

Date: 29 January 2018  
Re: Brembo front brake master cylinder float  
Product: **F4 RR – F4 RC**

## RECALL NOTICE:

Recall 2814-18RC01

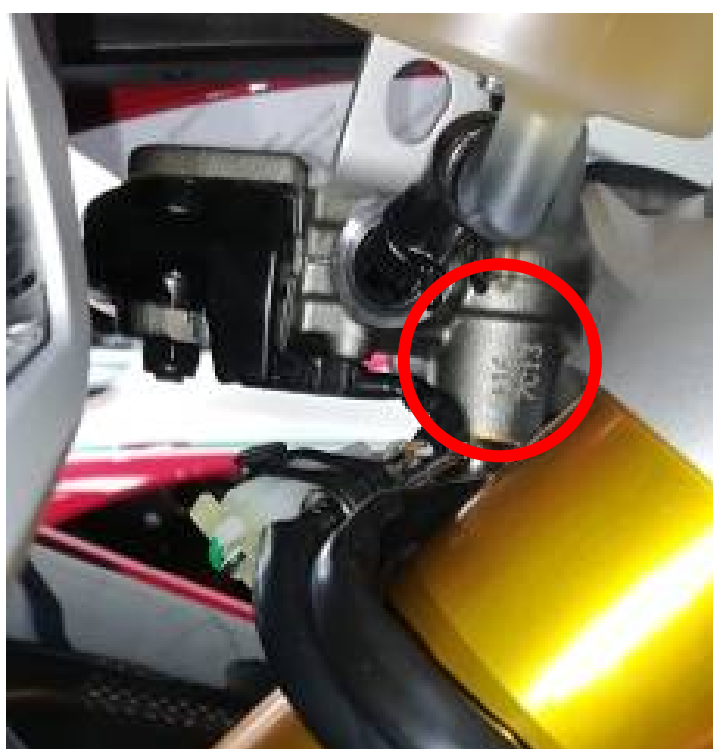
Check the number relating to the production batch of the master cylinder stamped on the body of the same and indicated in the figure:

Units included in the following ranges must be subjected to the float replacement intervention:

**from 5C20 to 5M31**

**from 6A01 to 6M31**

**from 7A01 to 7H31**

**NOTE: the numbers and letters that form the identification number of the production batch are sequential**

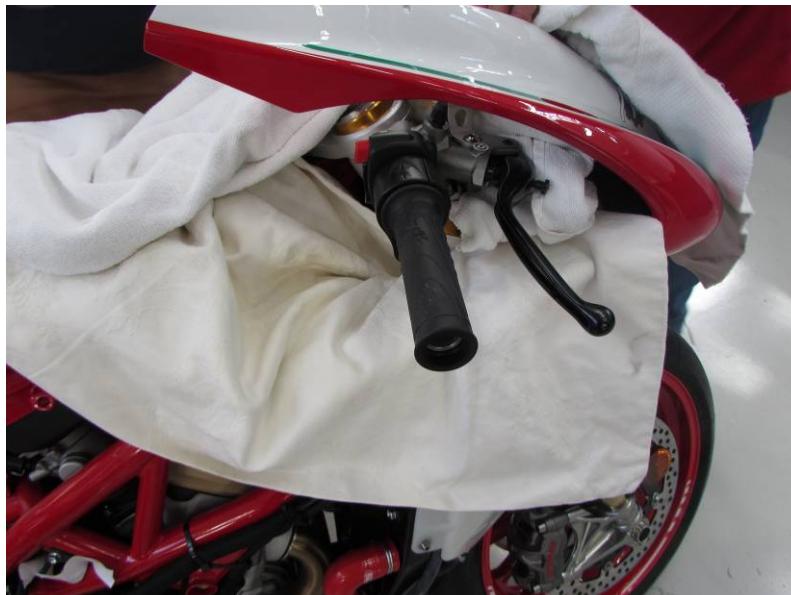
- Adequately protect the work area:

NOTE: In case of accidental dripping, immediately clean the affected area with water.

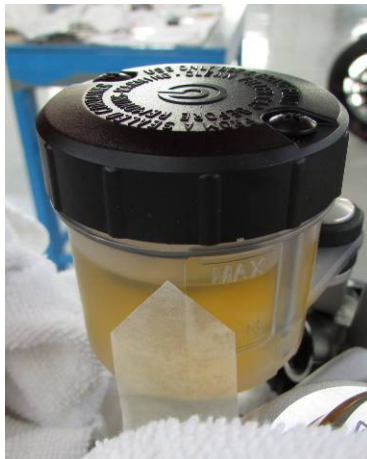
- With the motorcycle positioned on the side stand and steering turned to the right side, in order to have the upper edge of the front brake fluid reservoir parallel to the ground, mark with tape the brake fluid level inside as shown in the following photo:

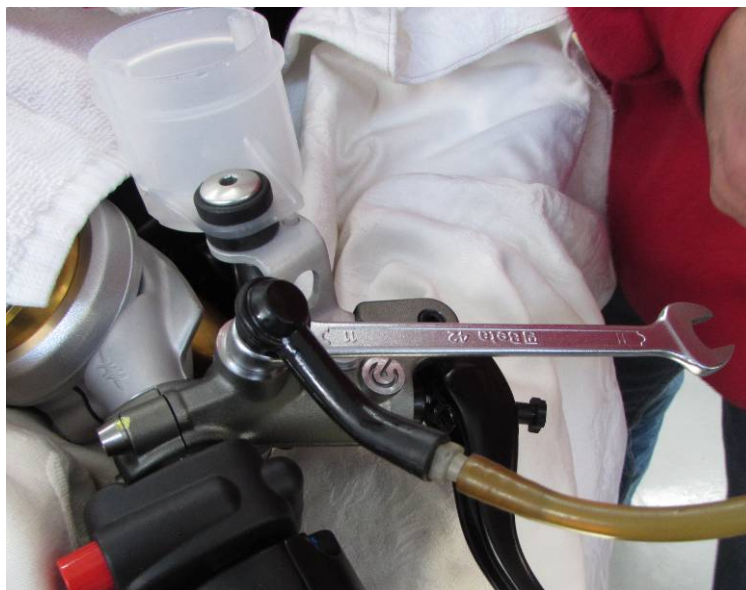
- Remove the plexiglass of the fairing.
- Remove the brake fluid reservoir cap.
- Completely suction out the fluid inside the reservoir.
- With the steering turned to the right, position a suitable collection system and open the bleed screw and suction out the brake fluid inside the front brake master cylinder body; actuate the lever 3 times with the bleed screw open to eliminate any residual fluid:

- Close the bleed screw momentarily.
- Remove the brake lever.

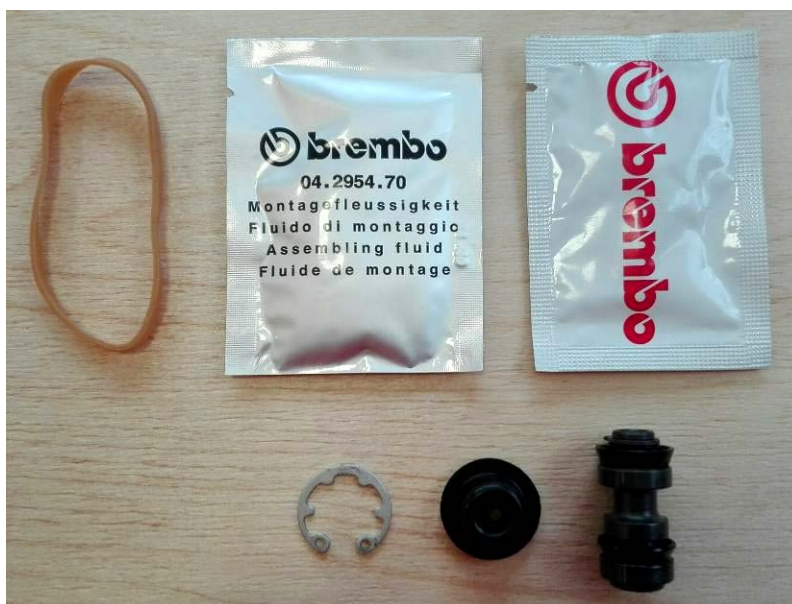
- take a kit code 8000C5738.

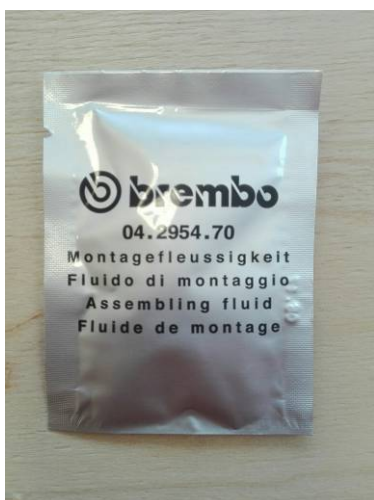
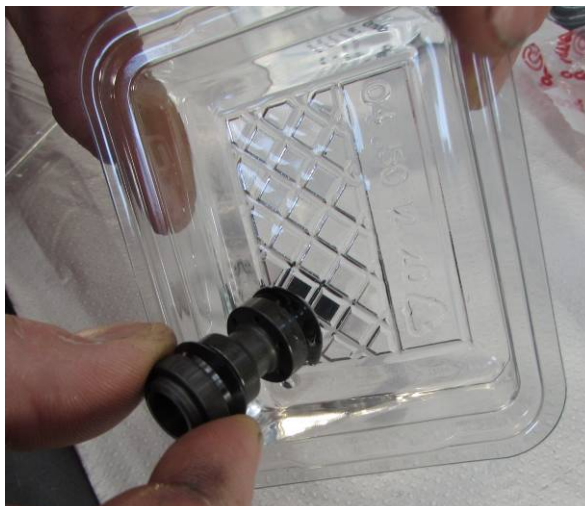
- Take the new float from the kit provided and lubricate it with the fluid provided in the kit near the two rubber seals already installed on the float:

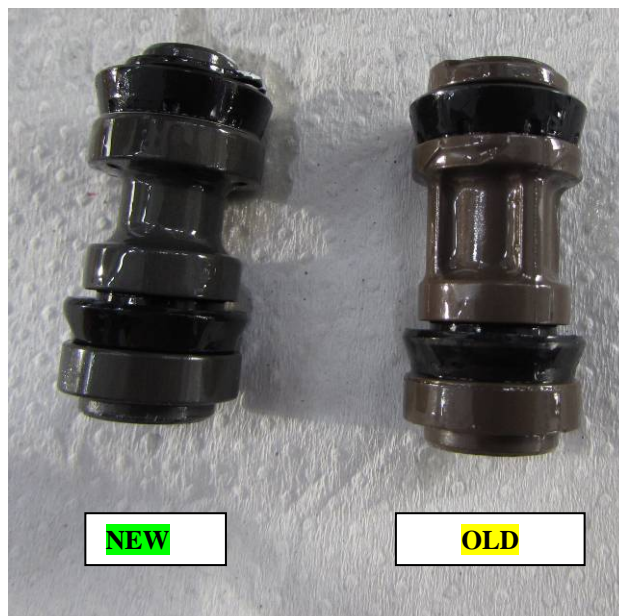
Please pay attention to the identification of the old and new float:

**NOTE: the old float must not be reused in any way and must be immediately destroyed.**

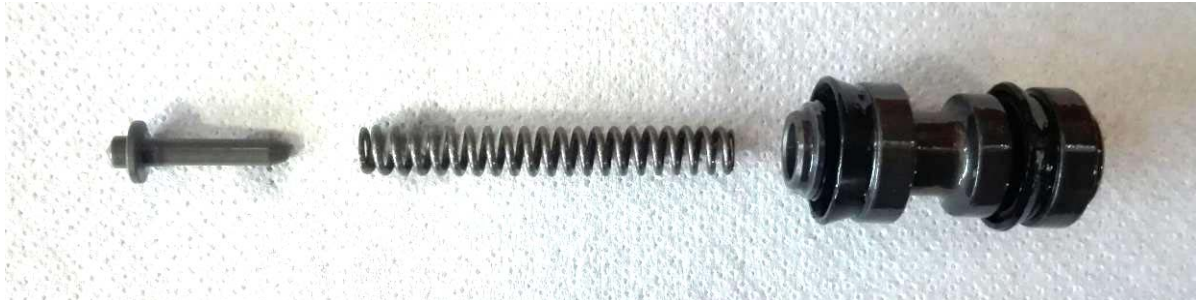
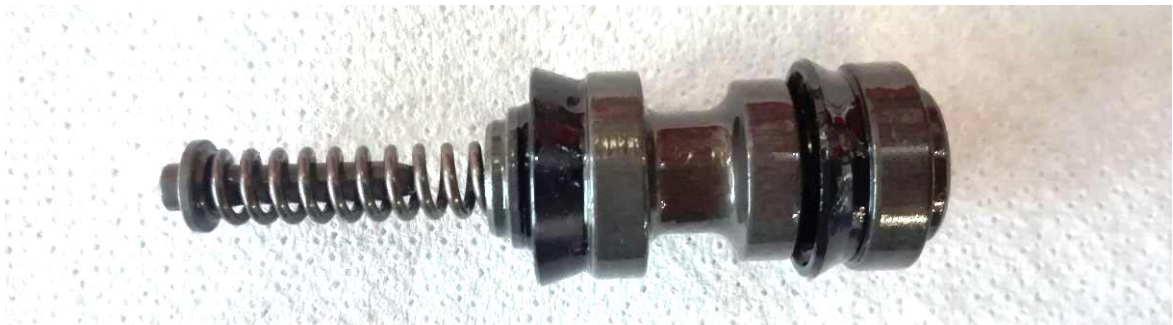
- Clean the area of any residual fluid or impurities.
- Insert the new float, adequately lubricated, with the spring and its guide, taking care to insert it without forcing and perpendicularly.

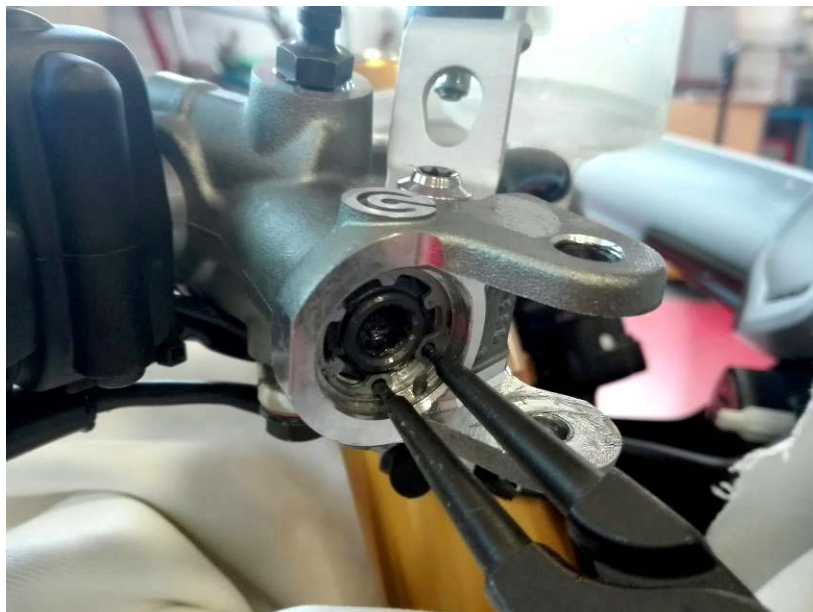
- Manually actuate the float a few times, verifying that there is no anomalous friction.
- Fit the new Seeger ring supplied with the kit and subsequently rotate it inside its seat in order to check its correct positioning:

- Actuate the float again manually to check it slides freely inside the cylinder.

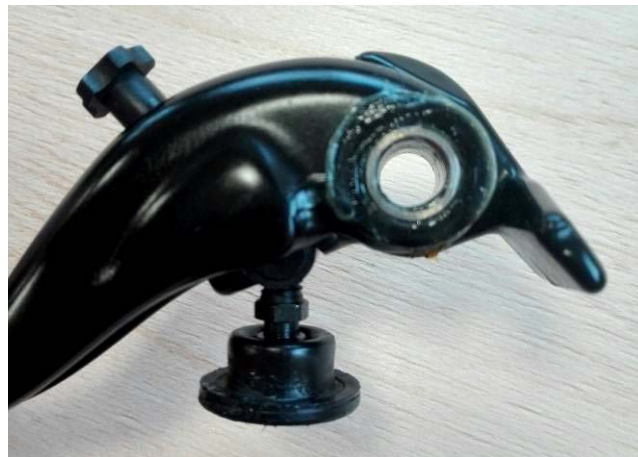
- Fit the new boot seal supplied in the kit on the lever pin:

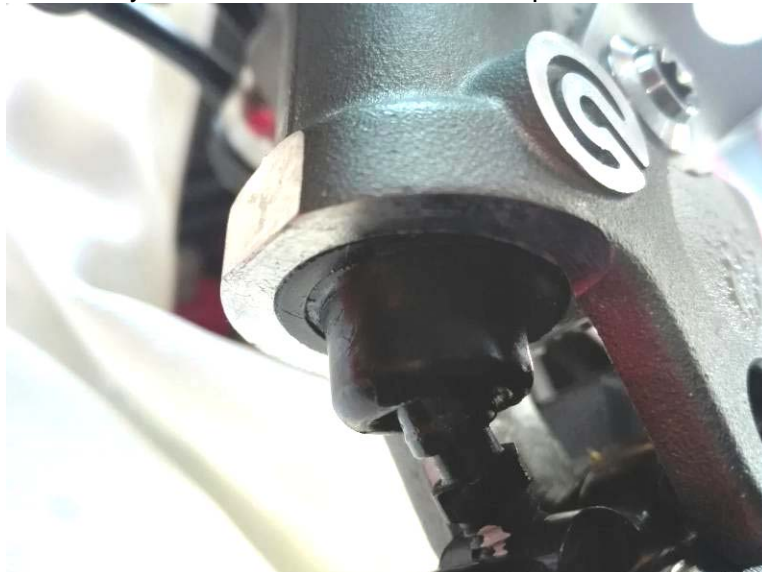
- Insert the boot seal in its seat on the cylinder body, taking care to check that the seal surface and the surface of the cylinder body with which it is in contact are parallel in all their points.

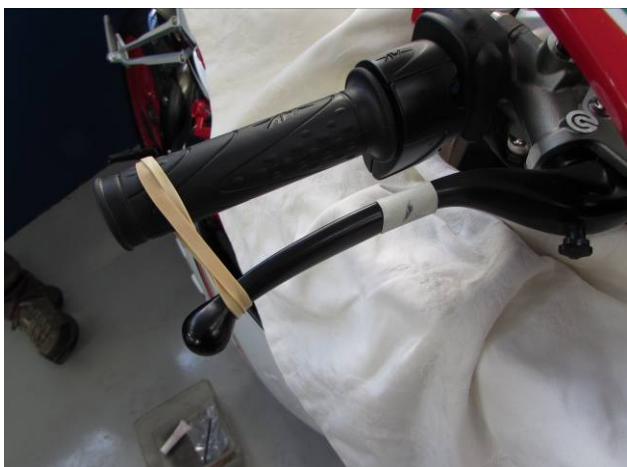
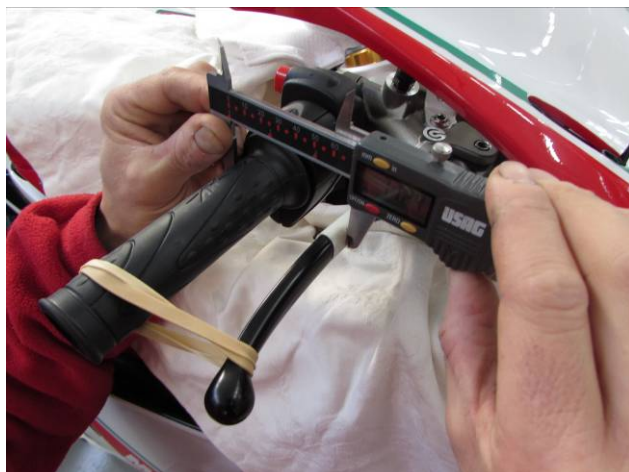
- Apply a strip of adhesive tape at the height indicated in the photograph on the lever of the front brake, mark it with a felt-tip pen and apply the elastic supplied with the kit to the brake lever with a double loop; measure the distance of the lever from the hand grip in the previously marked area and keep the elastic applied for 10 min:

- After 10 minutes check again the distance of the lever from the hand grip: the maximum allowed yield of the lever is 3mm. In the event of a higher yield, repeat the bleeding operation of the brake master cylinder.
- Thoroughly clean all the areas involved in the operations described above.
- Perform a dynamic test of the bike to verify compliance.
- Complete the Warranty Request procedure by entering the repair date.
