Service Bulletin

Subject: Rear wheel rim

Product: **Brutale 800 Dragster RR**

MV AGUSTA MOTOR S.p.A.
Technical Service Department
Recall 2813

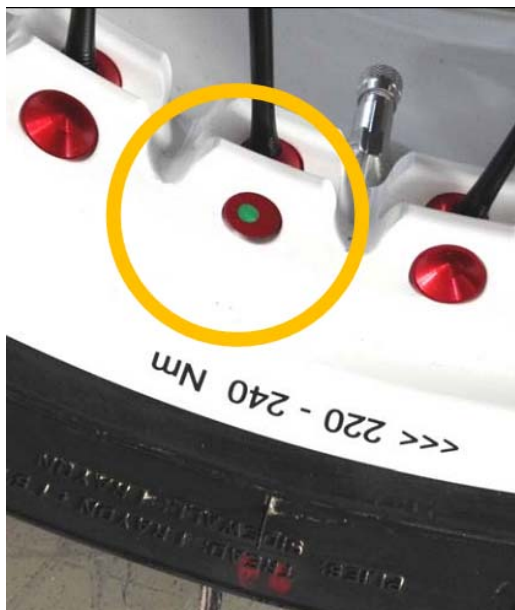
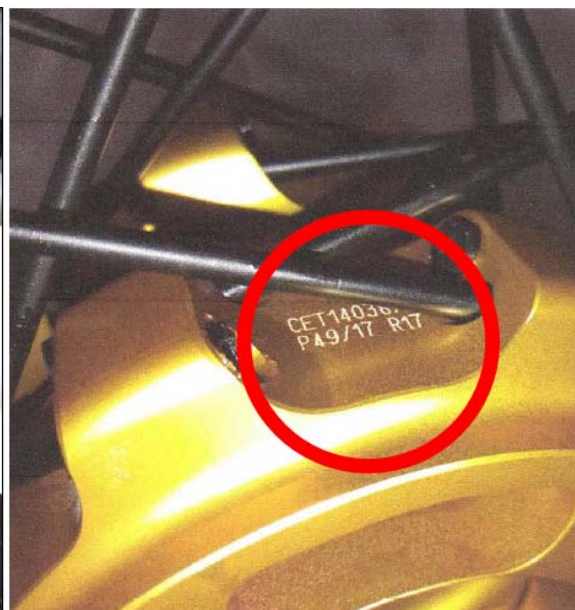
- Take the new rear wheel received and identified with green stamp / dot and / or the "R17" stamp on the rear hub as in the following pictures:

- Install the new rim while respecting the specifications in the workshop manual.
- Run a dynamic test of the motorcycle to verify its conformity.
- Package the non compliant rear wheel rim previously removed and contact MV Agusta Spare Parts: Ms. Emanuela Bottelier (emanuela.bottelier@mvagusta.com) or Mr. Filippo Macalli (filippo.macalli@mvagusta.com) to organize the component's return to MV Agusta.
- Complete the Warranty Request Procedure by entering the repair date.
