# Technical Journal

**End pieces available for luggage cover**

<b>REF NO:</b> TJ 33514.1.0	<b>ISSUING DEPARTMENT:</b> Technical Service	<b>CAR MARKET:</b> United States and Canada	
<b>PARTNER:</b> 3 US 7510 Volvo Car USA		<b>ISSUE DATE:</b> 2018-03-27	<b>STATUS DATE:</b> 2018-04-04
<b>FUNC GROUP:</b> 8510	<b>FUNC DESC:</b> Upholstery for wall/door, side, rear she	Page 1 of 7

<b>Title</b>	Cargo compartment cover	<b>Page</b>	1 ( 5 )
<b>Action</b>	Product fix	<b>Operation number:</b>	85108-2

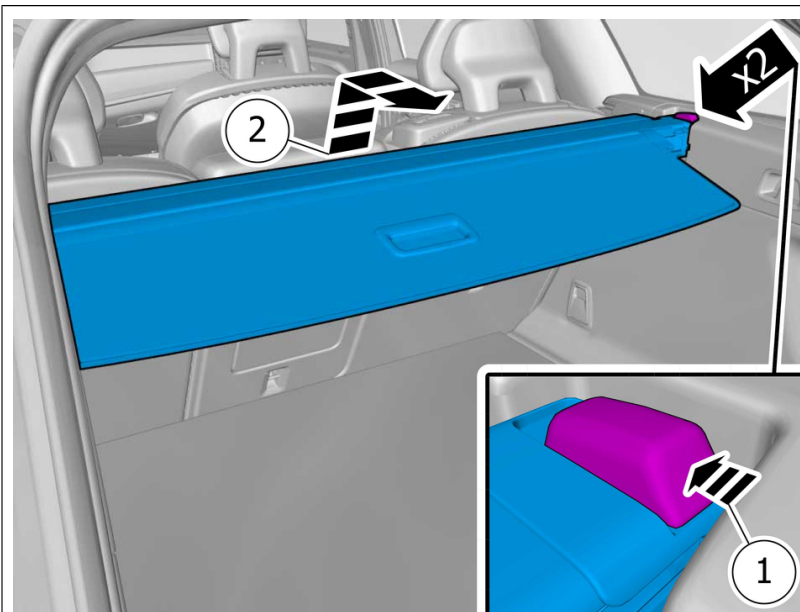
Remove the marked part.

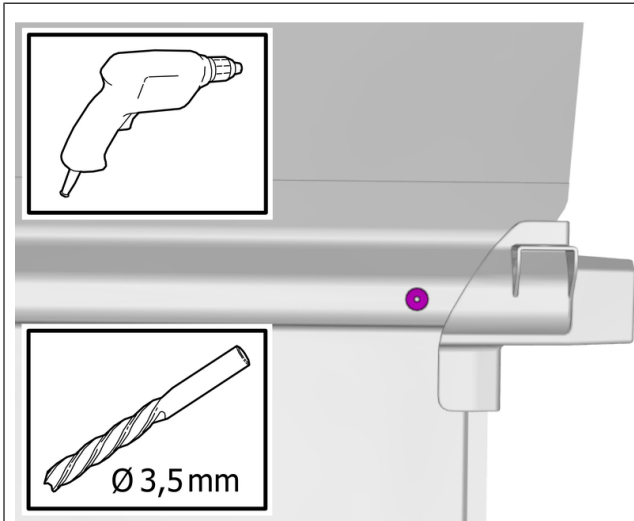
**Caution! Observe caution when carrying out this step.**

Use a drill with the stated size  
Remove the fastener.

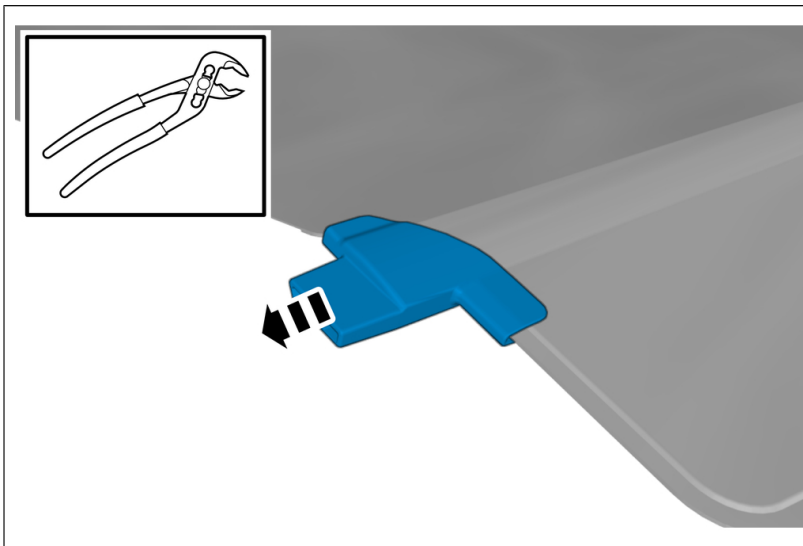
Remove the marked part.

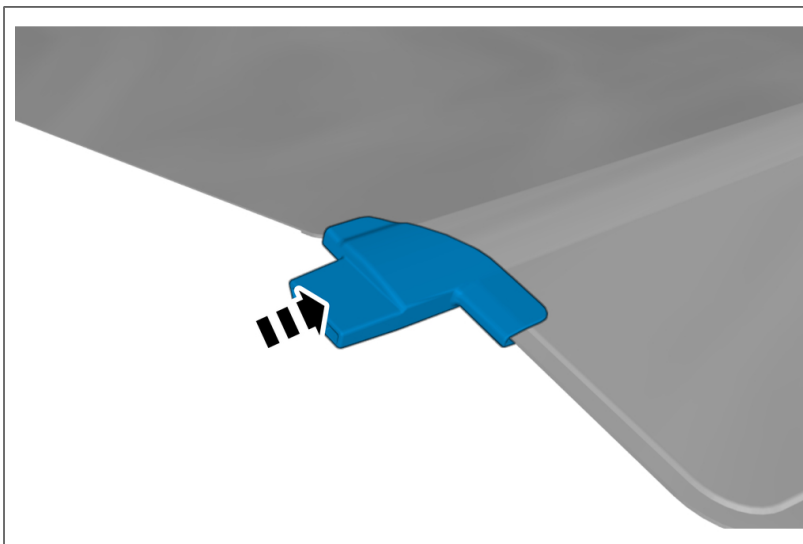
Install the marked component.

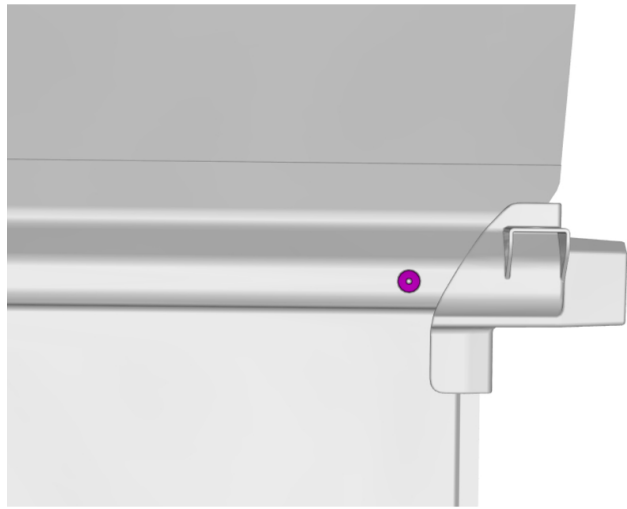
**Note! Only use the specified material.**

Install the marked component.

**Use:** Pop rivet pliers

To install, reverse the removal procedure.
