# Technical Service Bulletin

SUBJECT:		No: <b>TSB-19-35-002</b>	
<b>KNOCKING SOUND FROM REAR DISC BRAKES</b>		DATE: <b>January 2019</b>	
		MODEL: <b>See below</b>	
<b>CIRCULATE TO:</b>	<input type="checkbox"/> GENERAL MANAGER	<input checked="" type="checkbox"/> PARTS MANAGER	<input checked="" type="checkbox"/> TECHNICIAN
<input checked="" type="checkbox"/> SERVICE ADVISOR	<input checked="" type="checkbox"/> SERVICE MANAGER	<input checked="" type="checkbox"/> WARRANTY PROCESSOR	<input type="checkbox"/> SALES MANAGER

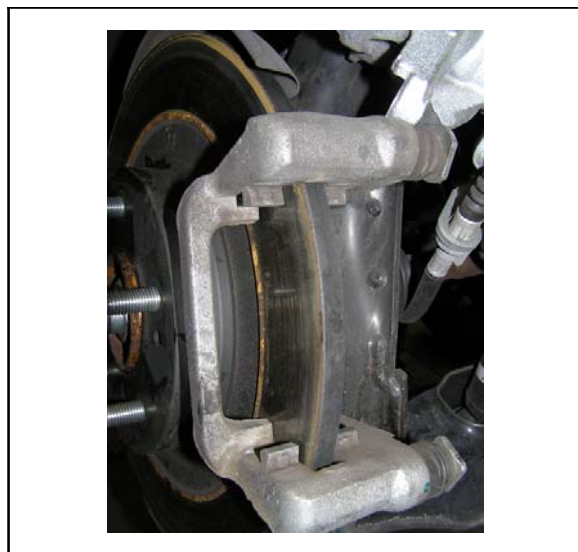
1. Remove the rear brake pad assemblies, upper clips, and lower clips from the caliper support. For instructions, refer to the applicable Service Manual, Group 35 - Service Brakes / 35A - Basic Brake / On-Vehicle Service / Brake Pad Replacement.

2. Clean the brake pad assembly and the clip mounting area of the caliper support with a brush.

**NOTE: Left rear shown in photo.**

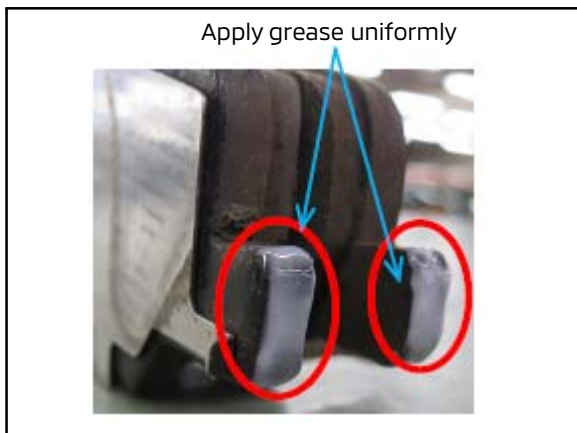
4. Apply the grease included in the new clip set to the application area of the brake pad assembly, as shown in the diagram below.

- **Apply approximately 0.2 g of grease per application area.**

**!! IMPORTANT !!** Apply grease uniformly so that the base of the brake pads are completely covered with grease, as shown.

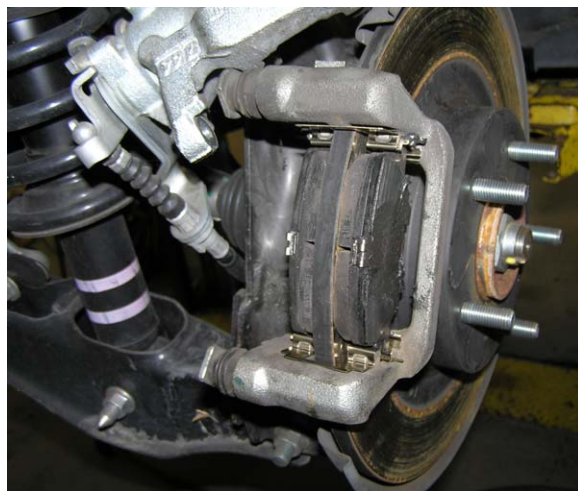
Reassembly

5. Attach the brake pad assembly to the caliper support.
- (1) Start assembly from the lower side of the brake pad assembly.
  - (2) Fit the upper side into the clip, while pressing the lower side of the brake pad assembly.
- NOTE: Right rear shown in photo below.**

- Make sure to **NOT** get any grease on the surface of the brake disc or brake pad.
- If any grease gets on the brake disc or pad, wipe it off with brake cleaner.
