# SERVICE BULLETIN

Classification: BT15-020d	Reference: NTB15-073d	Date: January 29, 2019
------------------------------	--------------------------	---------------------------

## 2015-2018 MURANO; AUTOMATIC BACK DOOR DOES NOT OPERATE AND RELATED DTCS

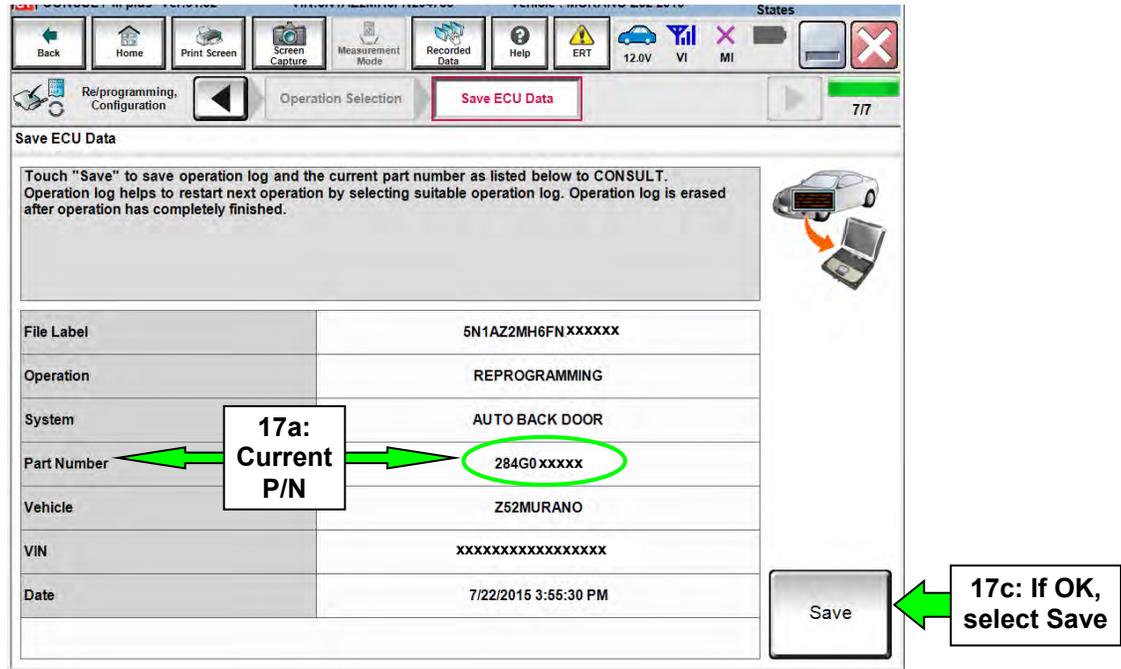
Figure 8

17. When you get to the screen shown in Figure 8, confirm reprogramming applies as follows:

- a. Find the ABD CU P/N and write it on the repair order.

**NOTE:** This is the current ABD CU P/N.

- b. Compare the P/N you wrote down to the number in **Table A** below.
  - If there is a match, the reprogramming applies. Go to step 17c.
  - If there is not a match, this reprogramming is not needed. Go to **Automatic Back Door Calibration** on page 25.

<b>CURRENT P/N: 284G0-</b>
5AA0A, 5AA2A

- c. If there is a P/N match as specified above, select **Save**, and then continue with the reprogramming procedure on the next page.

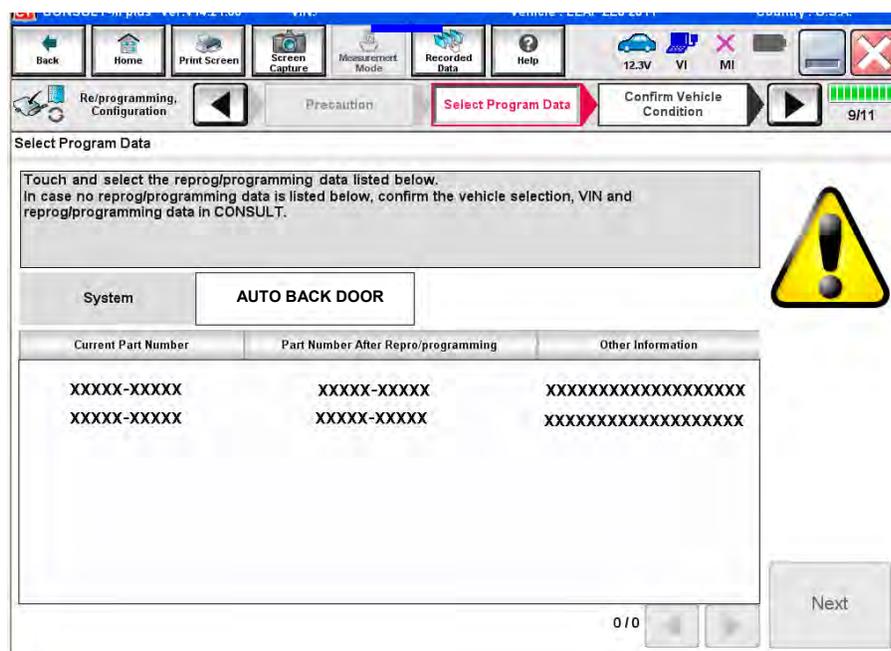
**NOTE:** In some cases, more than one new P/N for reprogramming is available.

- In this case, the screen in Figure 10 will display.
- Select and use the reprogramming option that does not have the message "Caution! Use ONLY with NTBXX-XXX".
- If you get this screen and it is blank (no reprogramming listed), it means that there is no reprogramming available for this vehicle. This bulletin does not apply or it has already been done.

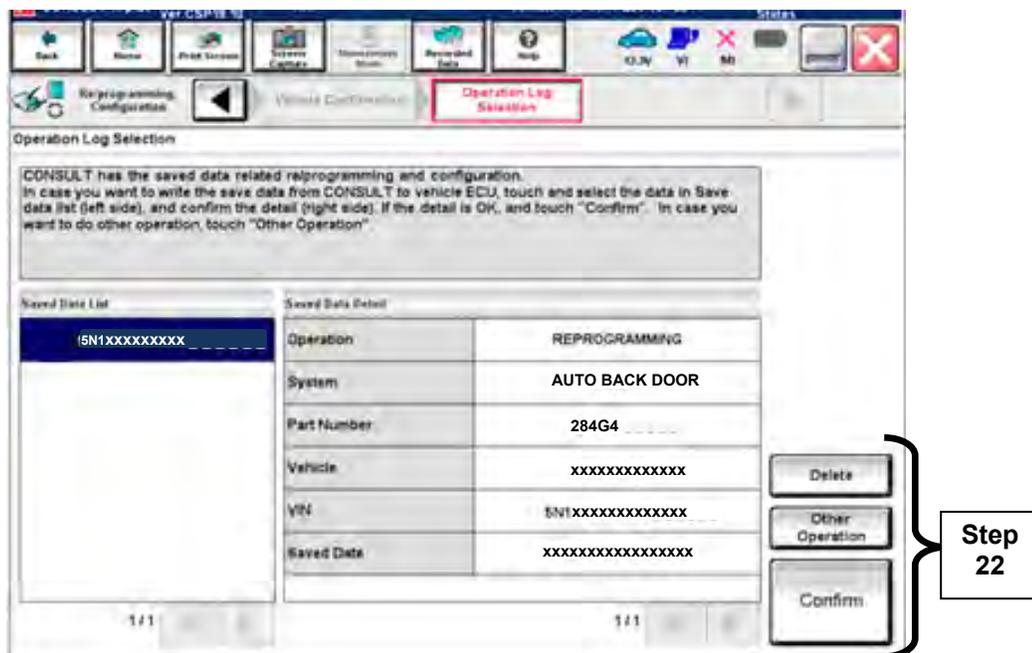
22. If the screen in Figure 12 appears, first select **Delete**, then **Confirm**, and then **Other Operation**.

- This will erase the Saved Data List and restart the reprogram from page 9, step 16. You must go back to step 12.
- If no **Saved Data List** is stored, Figure 13 on the next page will be displayed. Proceed to step 23.

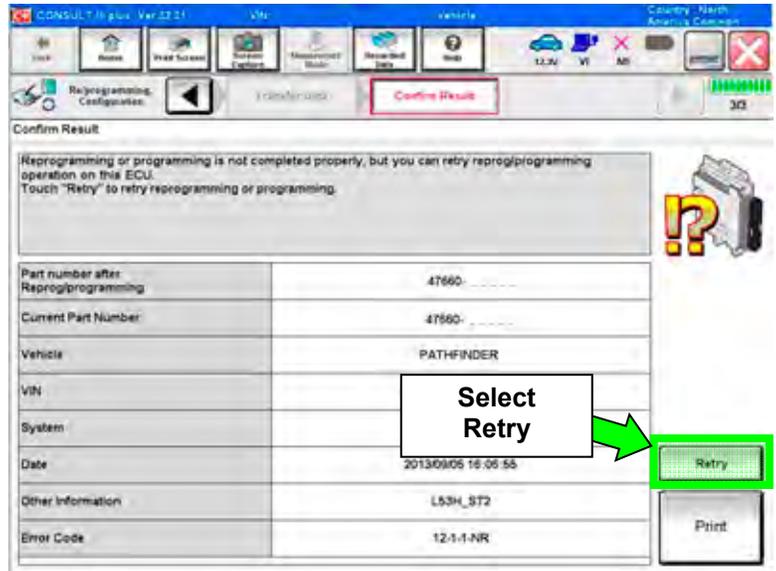
Figure 20

If reprogramming does not complete and the “!?” icon displays as shown in Figure 20:

- Check battery voltage (12.0–15.5 V).
- Ignition is ON, engine OFF. Ready Mode is OFF.
- External Bluetooth® devices are OFF.
- All electrical loads are OFF.
- **Select retry and follow the on screen instructions.**
- “Retry” may not go through on the first attempt and can be selected more than once.

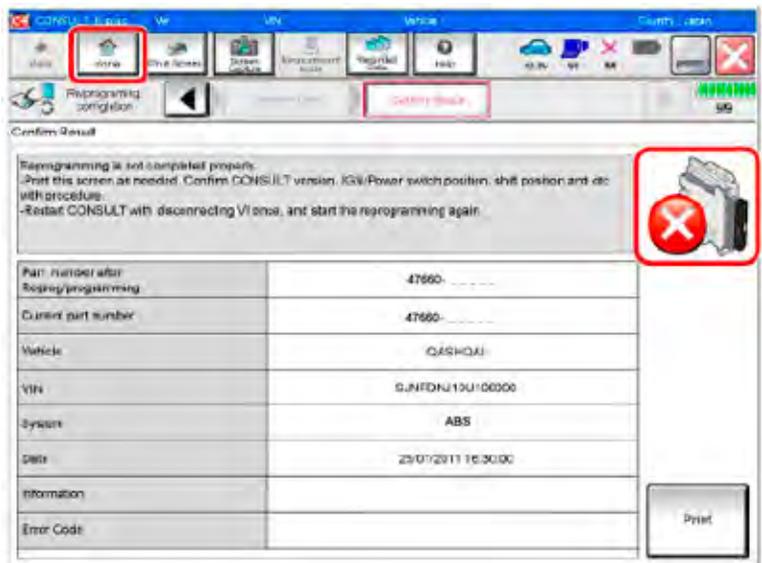
Figure 21

If reprogramming does not complete and the “X” icon displays as shown in Figure 21:

- Check battery voltage (12.0 – 15.5 V).
- CONSULT A/C adapter is plugged in.
- Ignition is ON, engine OFF. Ready Mode is OFF.
- Transmission is in Park.
- All C-III plus / VI cables are securely connected.
- All C-III plus updates are installed.
- **Select Home, and restart the reprogram procedure from the beginning.**

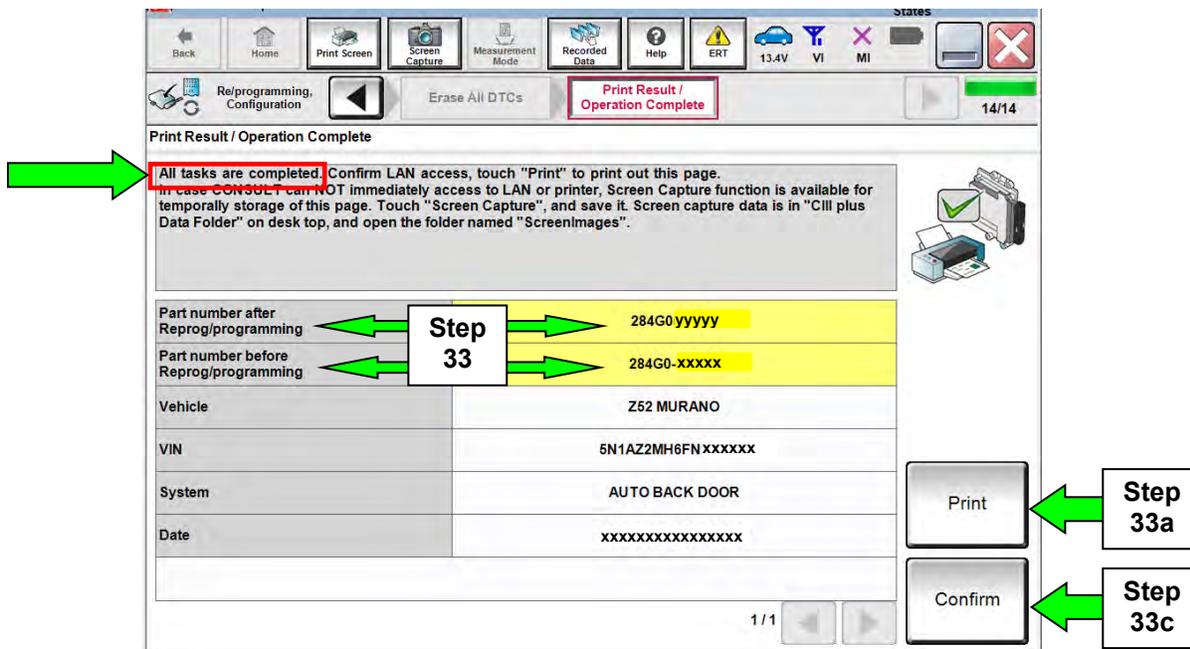
33. Verify the part number has changed (before and after reprogramming part numbers should be different).

- a. Print a copy of the screen in Figure 23 by selecting **Print**.
- b. Attach the copy to the repair order.
- c. Once a copy has been printed, select **Confirm**.

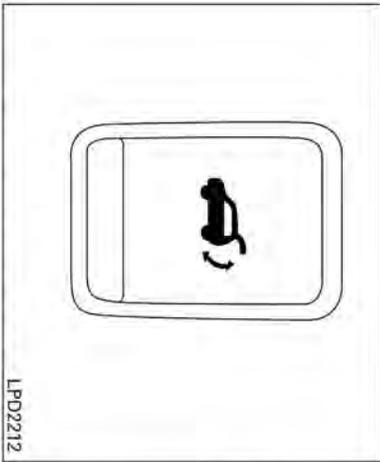
**Instrument panel switch**  
**OPERATING THE POWER LIFTGATE**  
 (if so equipped)

The power liftgate automatically moves from the fully closed position to the fully open position in approximately 5 – 8 seconds. The power open feature can be activated by the switch on the Intelligent Key, the instrument panel switch, the glove box switch and the liftgate request switch. A chime sounds to indicate the power open sequence has been started.

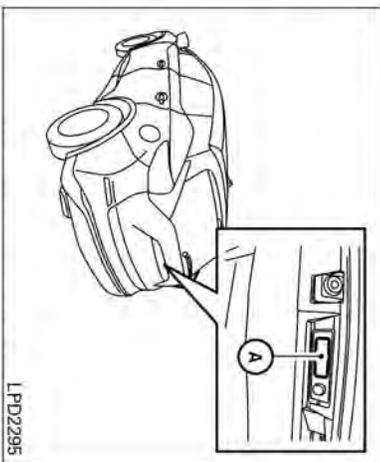
**Liftgate opener switch**

- The liftgate can be opened by the instrument panel switch, liftgate request switch and the Intelligent Key even if the vehicle is locked. The liftgate will individually unlock and open. Once the liftgate is closed, the vehicle will remain in the unlock status.
  - The Intelligent Key button must be held for 1 second before the liftgate opens.
  - The liftgate must be unlocked to open it with the liftgate opener switch (A).
- A warning chime will sound if the shift lever is moved out of P (Park) during a power open operation.

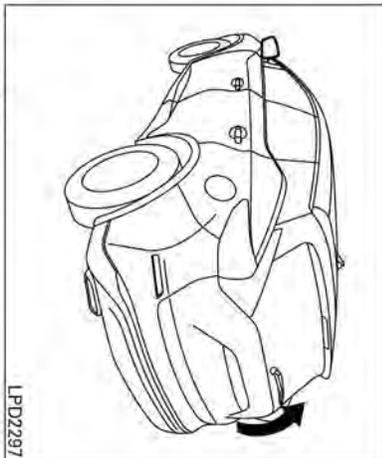
**If the pinch strip is damaged or removed, the power close function will not operate.**

**There are some small distances immediately before the closed position which cannot be detected. Make sure that all passengers have their hands, etc., inside the vehicle before closing the liftgate.**
