SERVICE BULLETIN

Classification: EL19-003	Reference: NTB19-009	Date: January 29, 2019
-----------------------------	-------------------------	---------------------------

2017-2019 ROGUE, ROGUE HYBRID AND ROGUE SPORT; CHASSIS CONTROL UNIT AND ADAS CONTROL UNIT 2 IDENTIFICATION

APPLIED VEHICLES: 2017-2019 Rogue (T32)
2017-2019 Rogue Hybrid (T32H)
2017-2019 Rogue Sport (J11)

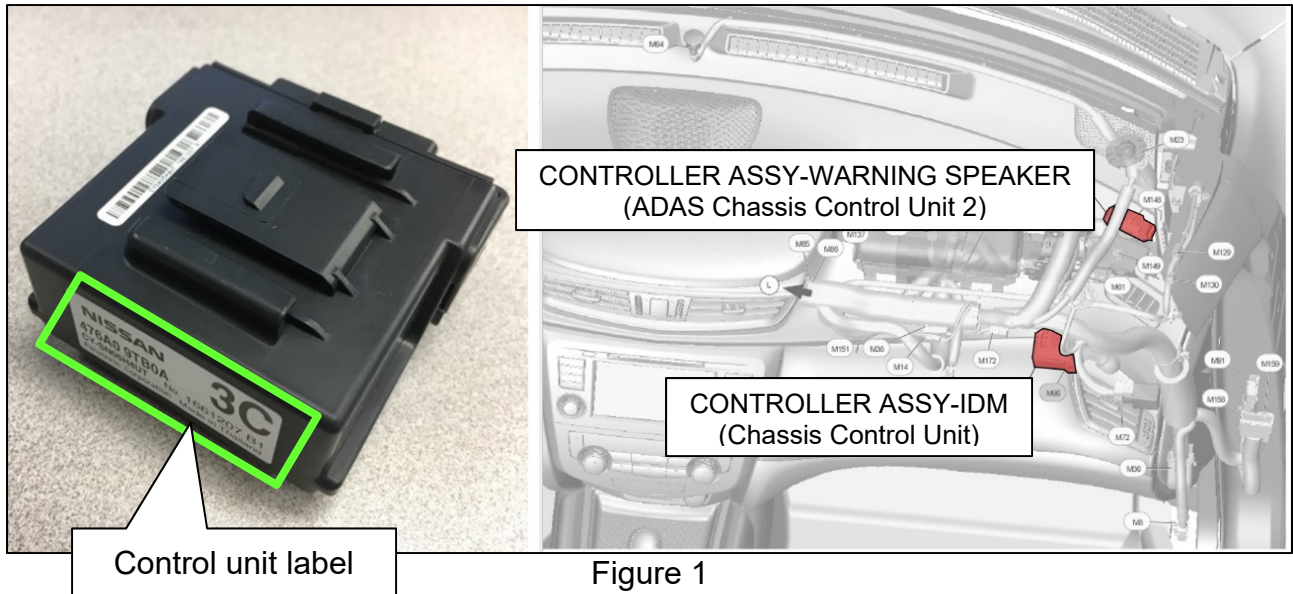
NOTE: See Figure 1 for the correct locations of the Chassis Control Unit and the ADAS Control Unit 2.

- Can be identified by their location (shown in Figure 1) and confirmed by the part number on the control unit's label.

Control Unit Locations

- Cases, externally, appear identical.
- Are located behind the glove box, in the same area.
- Harness connectors are the same, and can be connected to the wrong component.

CONTROLLER ASSY-IDM (Chassis Control Unit)	476A0-XXXXX
CONTROLLER ASSY-WARNING SPEAKER (ADAS Chassis Control Unit 2)	284P1-XXXXX
