## 9700 PTO REPLACEMENT

Volvo Vehicles

### DESCRIPTION

On the vehicles affected by this bulletin, a preventive replacement of the engine power take off (PTO) must be performed.

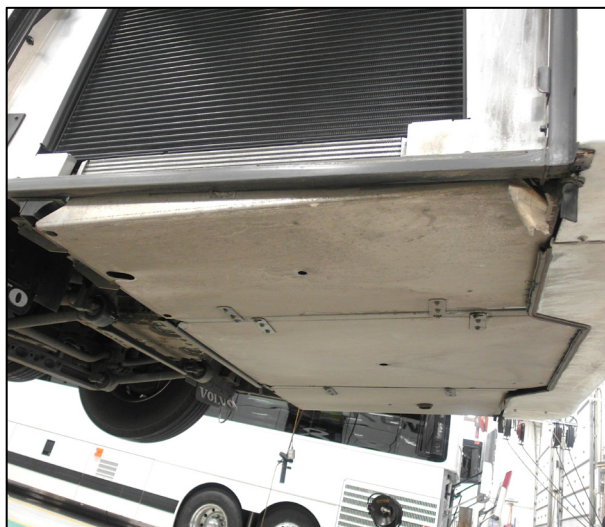
1. Lift the vehicle & remove the underside engine protective plates.

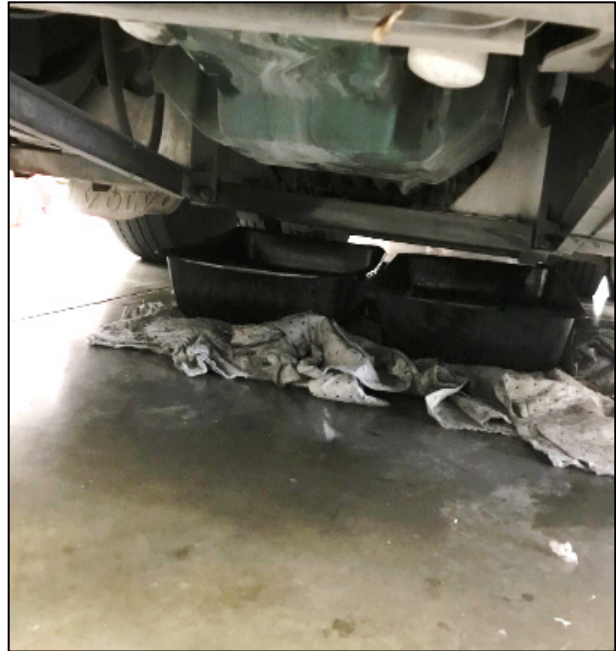
2. Put a large drain pan under the vehicle at the engine/transmission junction.

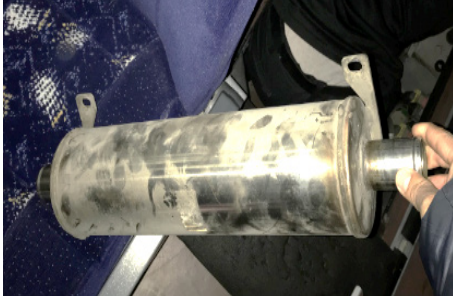
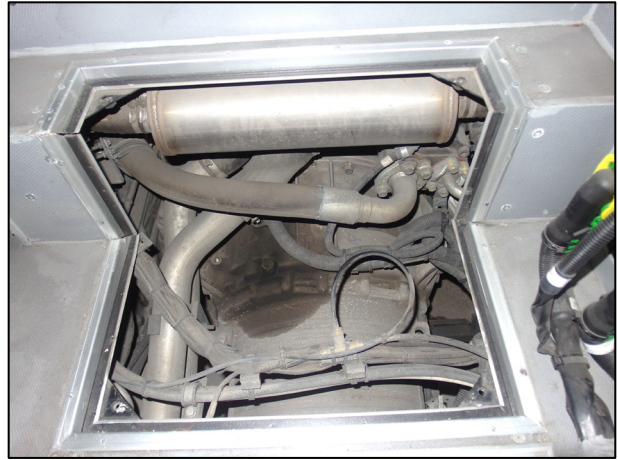
4. Remove the compressor air silencer.

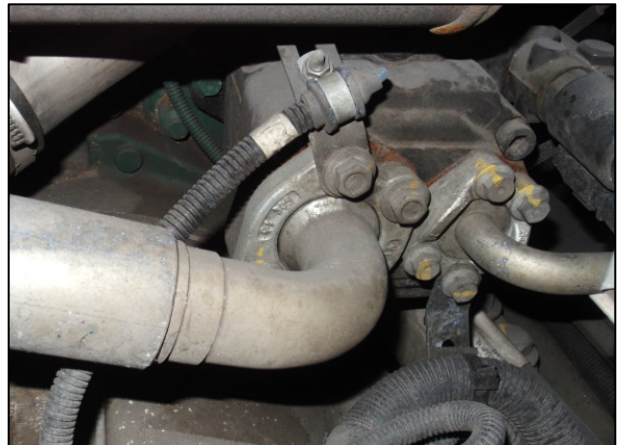
5. Disconnect both hydraulic hoses at the back of the hydraulic pump.

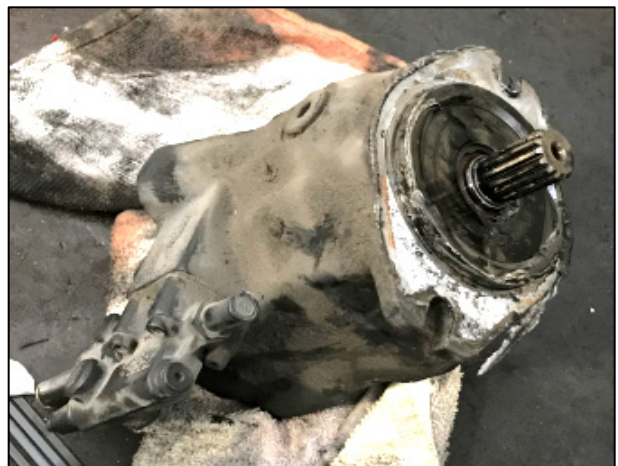
6. Remove the pump from the vehicle (discard pump O-ring).

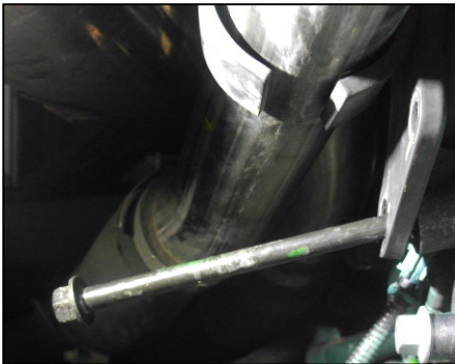
7. Remove the PTO from the vehicle.

- Remove the pipes bracket (one of the bracket screws is also the PTO cover upper left screw).
- Gently pry up the steel coolant hose on the upper right corner to allow PTO removal.
- Unscrew the remaining PTO cover screws.

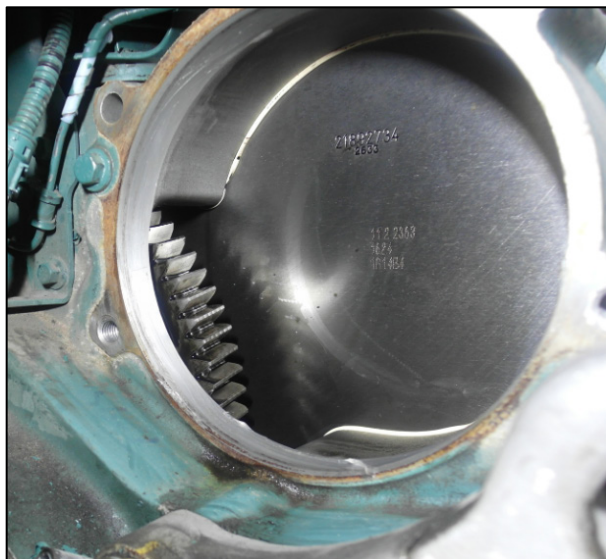
8. Clean the PTO mounting surfaces (make sure debris are not falling inside the engine).

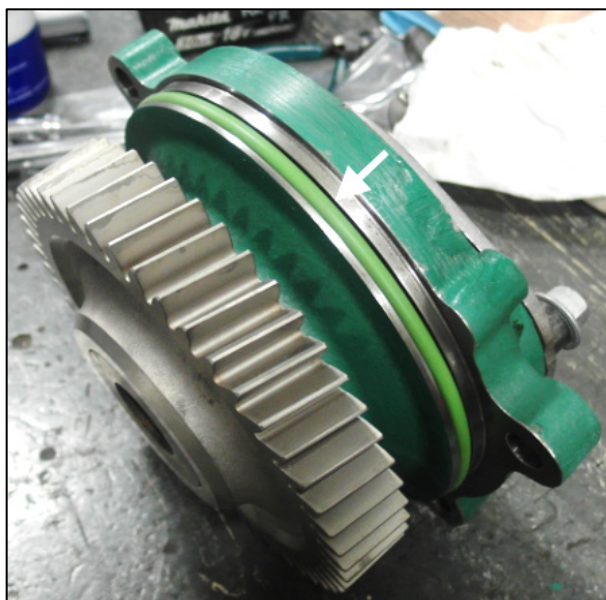
9. Install the supplied # **976068** O-ring on the new PTO # **21913080** (slightly lube the O-ring with engine oil).

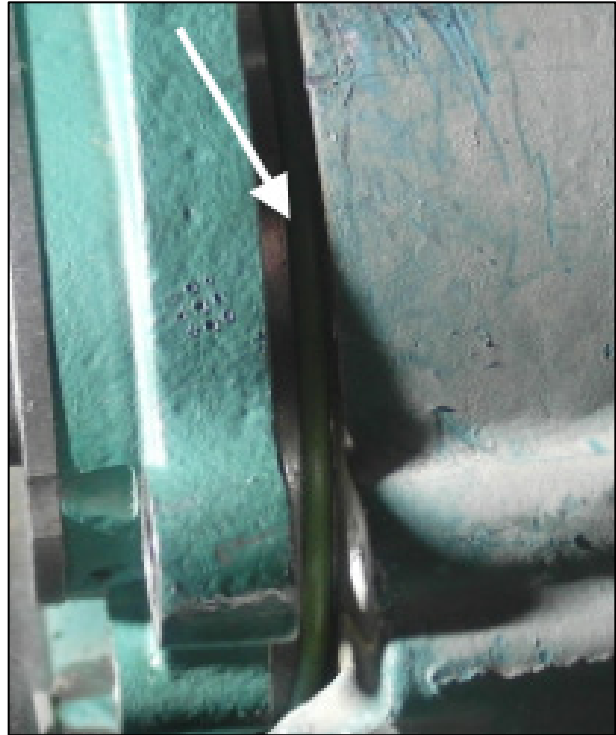
10. Slide the new PTO in place (pry coolant hose as required). Make sure the O-ring is engaging smoothly.

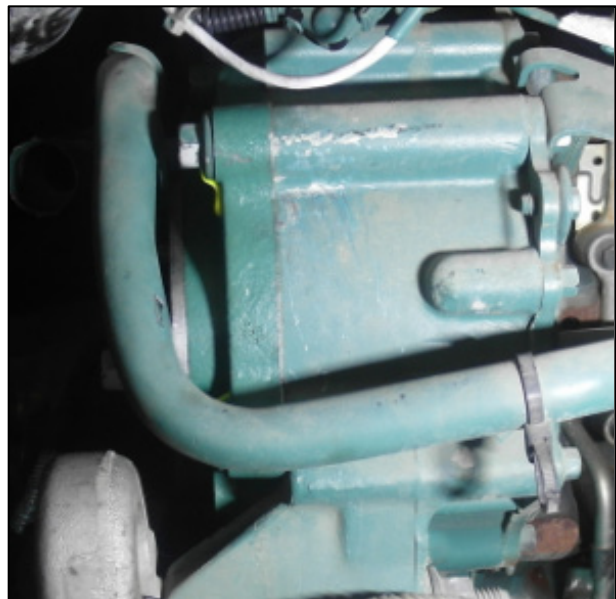
11. Secure the PTO to the engine (reinstall the pipes bracket)

**TORQUE: 52 +/-5 Nm (38 +/- 4 lb-ft)**

- *Apply torque seal to the bolt heads.*

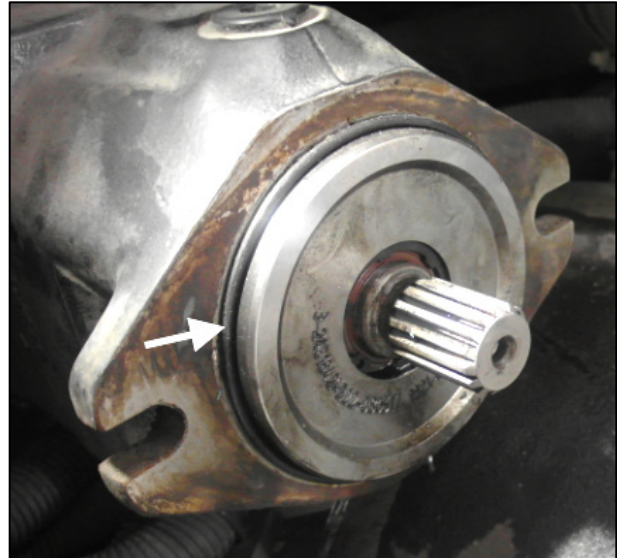
12. Clean the hydraulic pump mounting surface & install the new supplied # **925259** hydraulic pump O-Ring (slightly oil the O-ring).

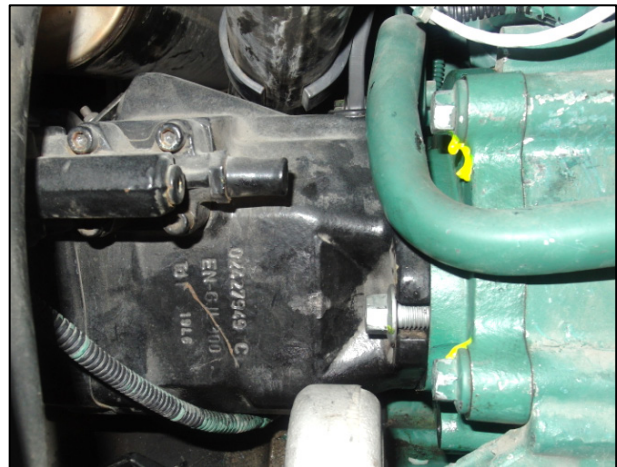
13. Remove PTO protective cover & reinstall the hydraulic pump.

**TORQUE: 52 +/-5 Nm (38 +/- 4 lb-ft)**

- Apply torque seal to the bolt heads.

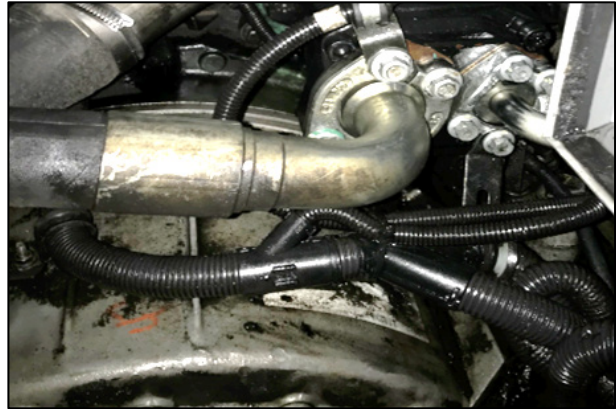
15. Clean the area (oil spillage).

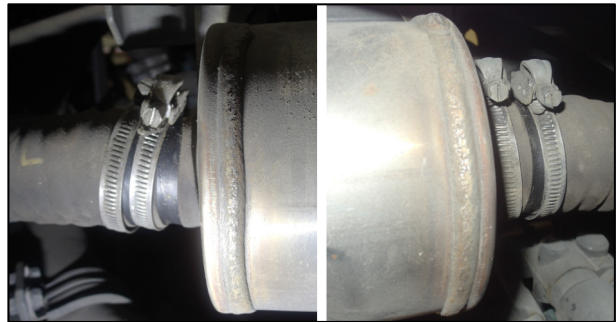
16. Reinstall air compressor silencer (bracket & clamps).

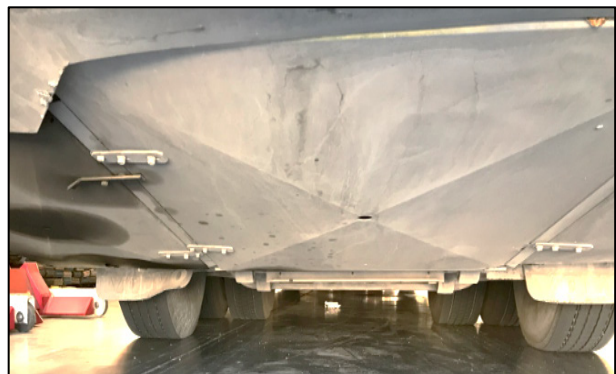
18. Lower and start the vehicle to check for leaks (correct as necessary). If no leaks are found, reinstall protective plates under the vehicles and close the floor hatches.
