| <b>Topic</b> | Air spring fault finding |
| <b>Brand</b> | Bentley |
| <b>Transaction No.</b> | 2030217/5 |

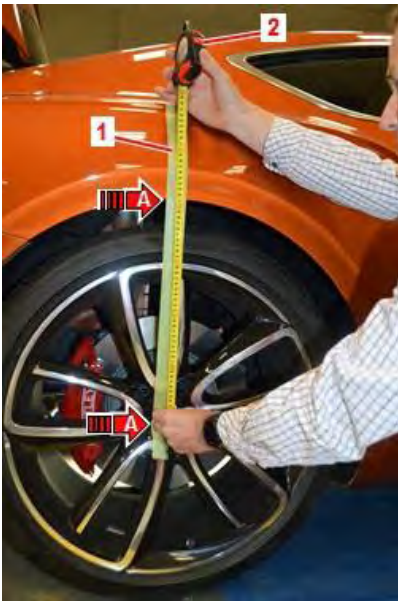
**Figure 1**

Adhere strips of masking tape (**1**) from the centre of each wheel to the highest part of the wheelarch as shown, making sure they are applied taut. Using a tape measure (**2**), also measure and take note of the ride heights (**A-A**) at all four corners of the vehicle. See Figure 1.

Leave the vehicle overnight and again measure the ride heights (**A-A**) at all four corners of the vehicle. Compare these values with those taken previously.

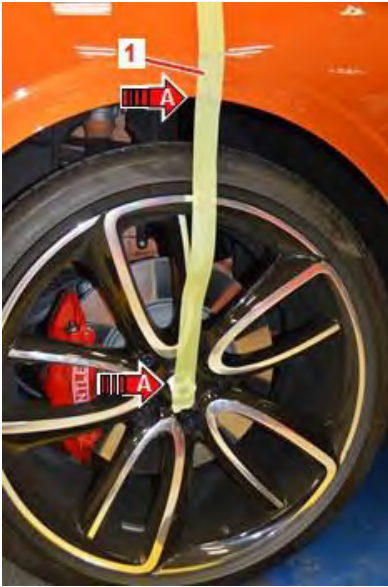
Figure 2

If there **IS** a difference in ride heights, and the strips of masking tape (**1**) have 'sagged' (shown in Figure 2), then refer to the following leak finding procedures below.
