Field campaign

Topic	12MY,13MY and 14MY Power Boot Campaign RoW (SC16/24)
Market area	Hongkong-Macau (5HK),Russische Föderation (5RU),Australia E04 Bentley rest Asia and Australia (6E04),China 796 VW Import Comp. Ltd (Vico), Beijing (6796),Germany E02 Bentley rest Europe (6E02),Japan E03 Bentley Japan (6E03),Russian Federation 935 Volkswagen Group RUS (6935),United Arab Emirates E06 Bentley Middle East and Africa (6E06),United States E05 Bentley USA and rest America (6E05)
Brand	Bentley
Transaction No.	2045092/3
Campaign number	EA62
Note	
Type	Service Campaign
US code

New Continental

Bentley has developed a boot system update pack to resolve customer issues.

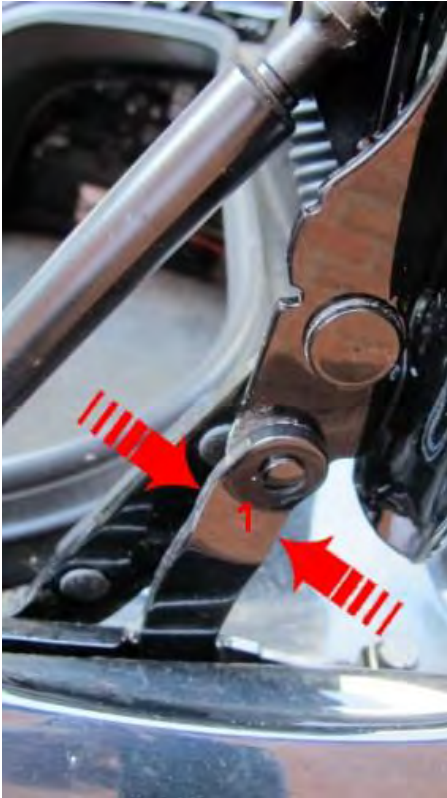
Figure 1a

Prior to performing software update on Continental models ensure the motor driven, right hand, hinge (1) is serviceable, check for excessive play in hinge pivots, manipulate the open hinge manually whilst checking for excessive play. Ensure the hinge function is uncompromised and no misalignment exists in the hinge elements, replace individual driven hinge where necessary (see Figure 1a)

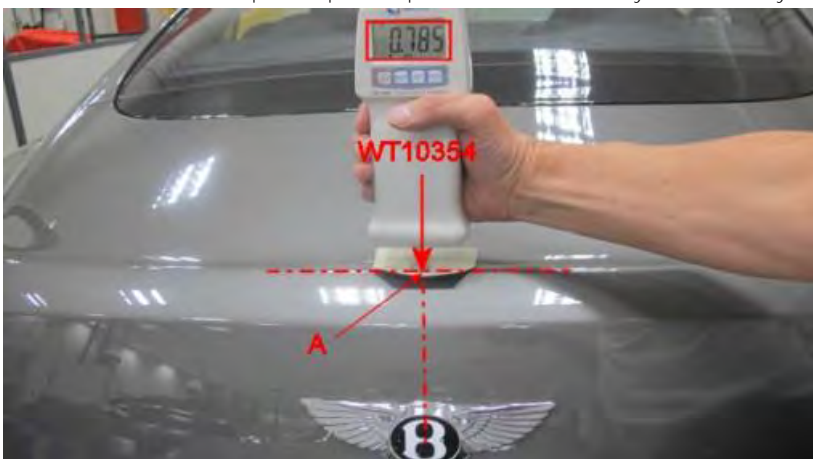
Figure 4

2. Carry out closing force gauge test – to perform this test the boot lid is operated to close and stopped short of closing on the power close cycle by pressing the close button again and manually catching the boot lid in the final centimetres of the close cycle, just before it engages with the striker pin. At this point the boot lid is resting on the boot lid seal, once in this state the force gauge (WT 10354) set to display Kg should be set in position *A on the boot lid. Apply load to the boot lid via the force gauge recording the load in Kg at which the boot lid power latched (see Figure 4).
3. Record results

***Note: Position A for the force gauge is the intersection on the centre line of the boot lid and the rear lip of the boot lid. Place protection between the boot lid painted surface and the gauge foot at position A to avoid paint damage. An offcut of leather will suffice (see Figure 4)**

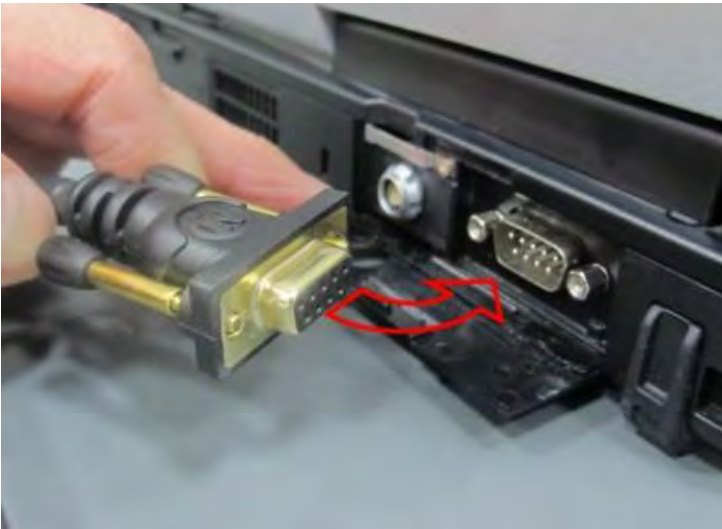
Figure 1

4. Connect boot control module update cable (part number WT10370) to the Bentley diagnostic tool VAS5052A or later approved equipment (see Figure 1)

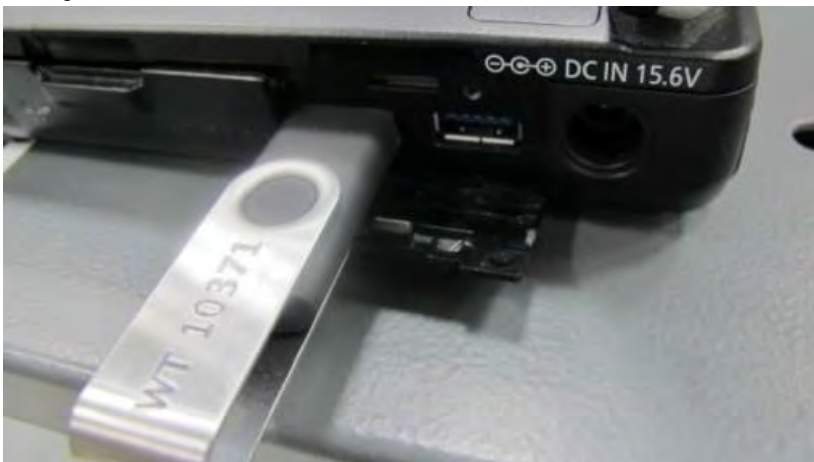
Figure 2

5. Insert USB memory stick boot CMSW (part number WT10371) into USB port of Bentley diagnostic tool (see Figure 2)

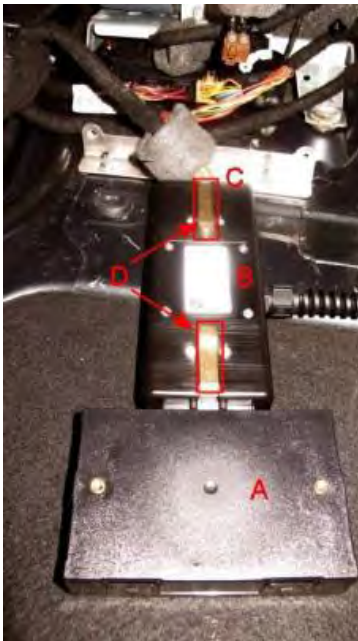
Figure 3

6. Insert boot control module 'A' and its associated plug 'C' into each end of connector 'B' of the boot control module update cable, ensure the connector release mechanism of the boot control module update cable (D) is facing up to avoid unexpected release of the module during software update (see Figure 3)
7. Switch on the ignition using the ignition key

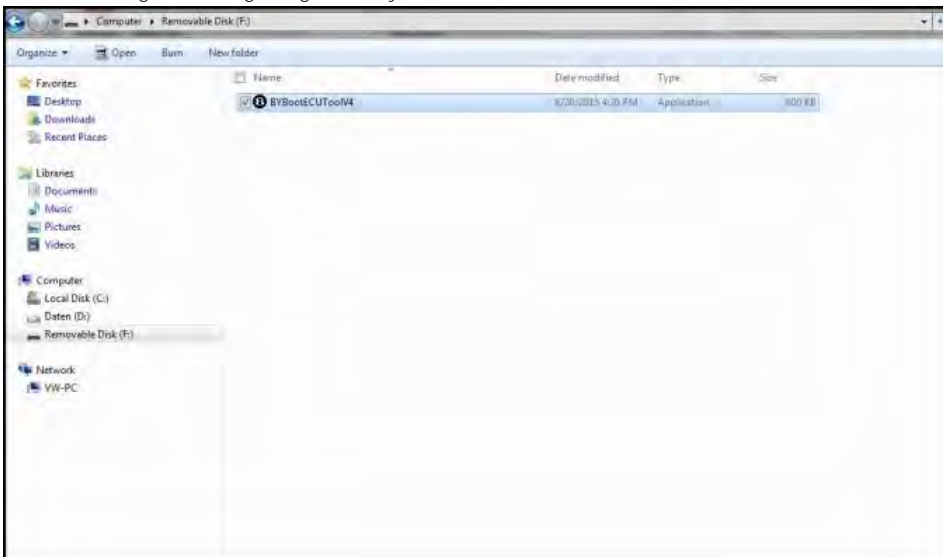
Figure 4a

8. From the diagnostic tool main desktop open USB memory stick (removable disc BYBootCUTTool) (see Figure 4a)
9. Select open application BYBootCUTTool

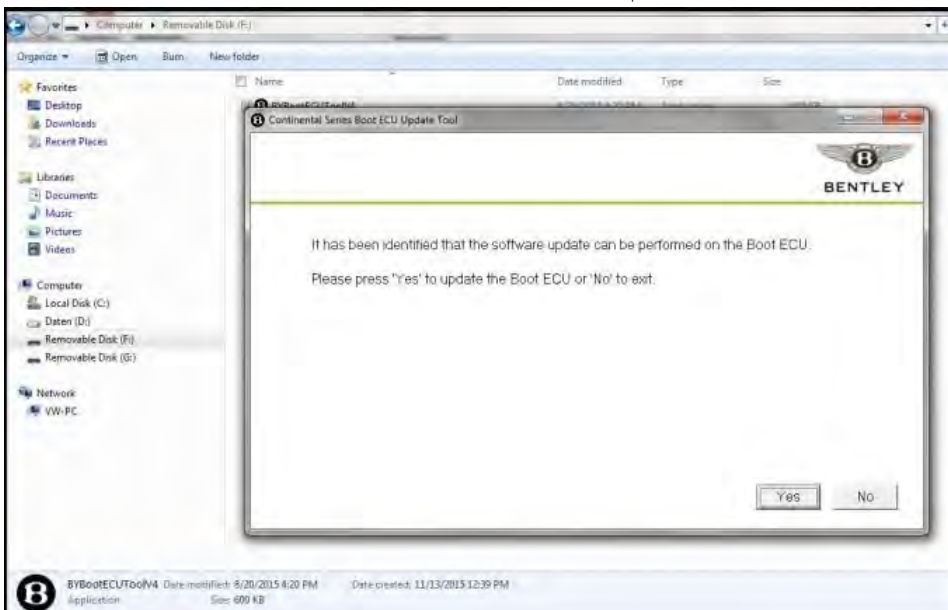
Figure 6

12. Select **Yes** to update (see Figure 6)

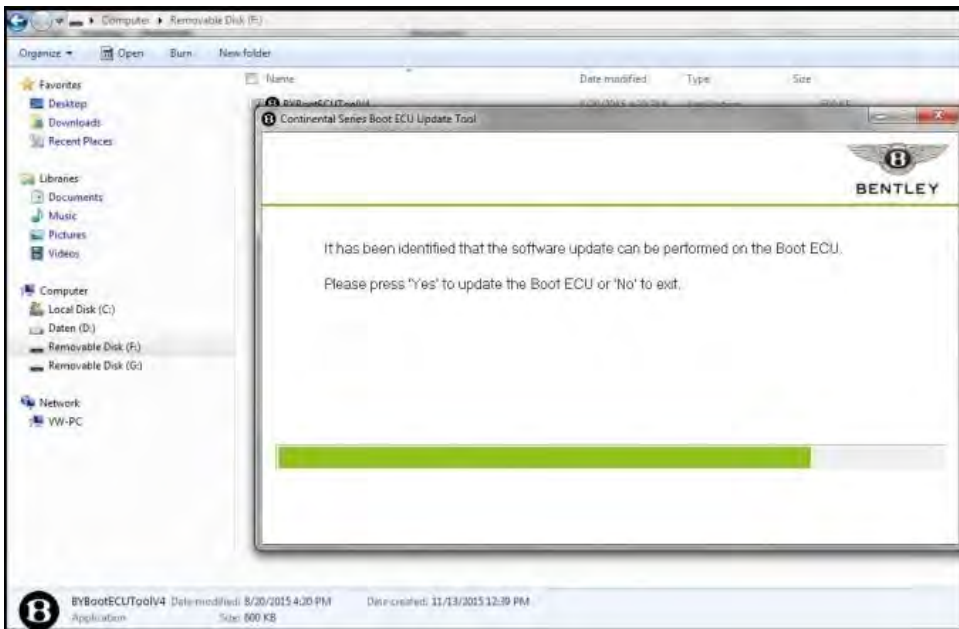
Figure 7

13. A progress bar will be displayed during update (see Figure 7)

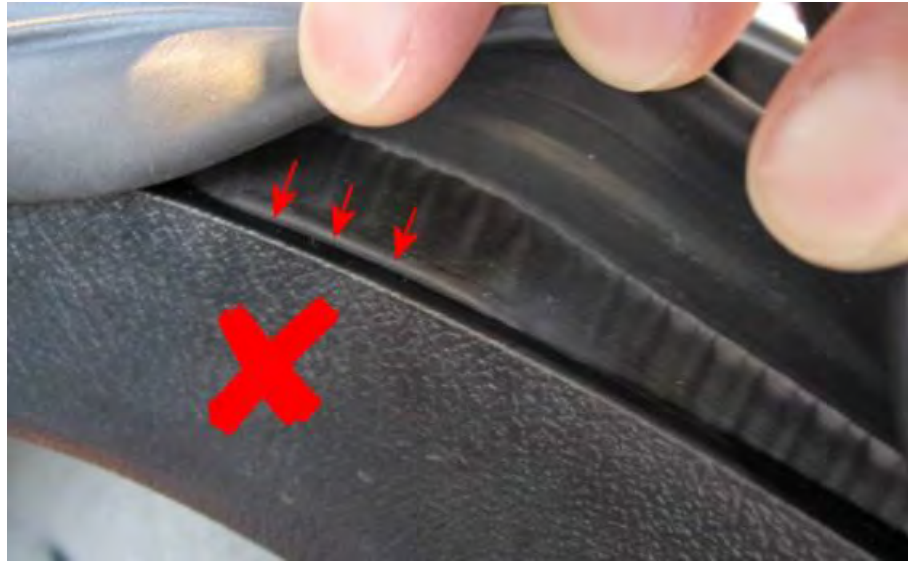
Figure 1

Ensure the boot lid seal is correctly fitted

1. Ensure the boot lid seal is correctly fitted (see Figure 1a) specifically the knock-on strip element of the seal must be fully engaged on the lip of the boot aperture and not as shown in figure 1 where it is displaced by the boot trim. Ensure the obscuration tape fitted to the boot aperture flange is not restricting seal fitment (see Figure 1b). Check seal is correctly orientated, the vulcanised joint -1- should be to the centre line (+/- 10mm) of the ball joint -2- on the boot lid gas strut (see Figure 2 and 2a)

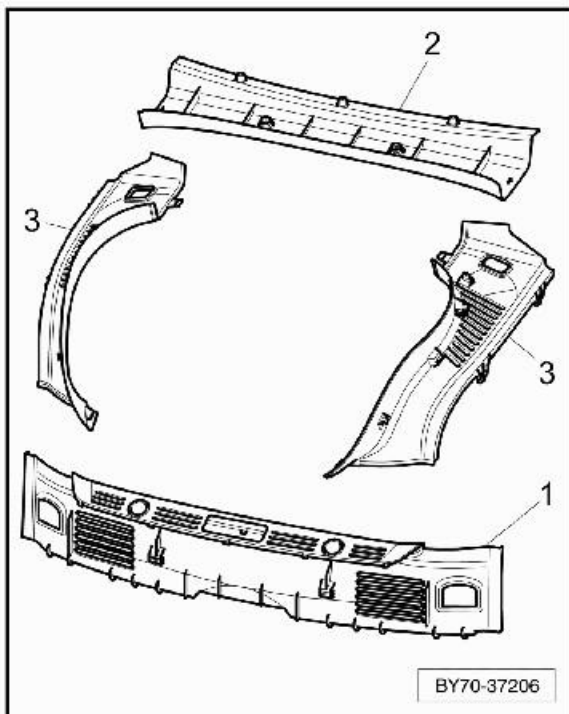
Figure 3

4. Ensure the boot aperture finishers (see Figure 3) are secure, correctly fitted and not compromising the boot lid seal fitment, rectify and replace damaged clips where necessary

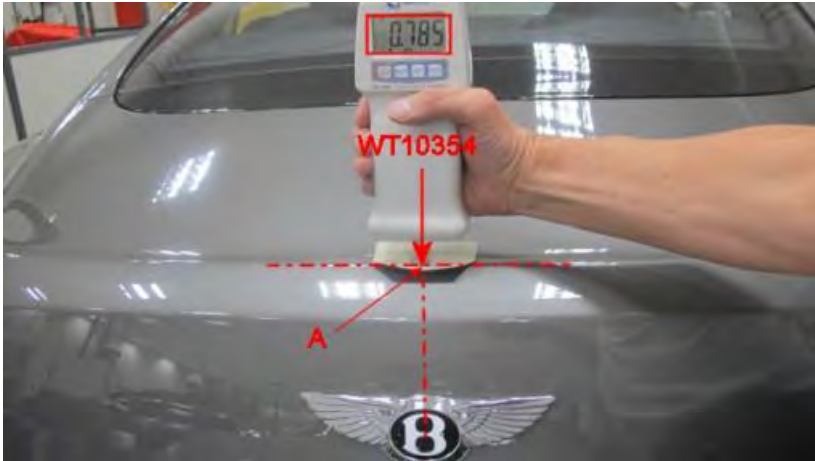
Figure 4

2. Carry out closing force gauge test – to perform this test the boot lid is operated to close and stopped short of closing on the power close cycle by pressing the close button again and manually catching the boot lid in the final centimetres of the close cycle, just before it engages with the striker pin. At this point the boot lid is resting on the boot lid seal, once in this state the force gauge (WT10354) should be set in position *A on the boot lid. Apply load to the boot lid via the force gauge recording the load at which the boot lid power latched (see Figure 4)
3. Record results

***Note: Position A for the force gauge is the intersection on the centre line of the boot lid and the rear lip of the boot lid. Place protection between the boot lid painted surface and the gauge foot at position A to avoid paint damage. An offcut of leather will suffice (see Figure 4)**

The load measured should be less than 1 Kg. If the load measured to initiate the close cycle is less than 1 Kg or the boot latches under its own weight and the boot completed three consecutive power open and close cycles then the campaign is complete, apply a white campaign identification mark to the boot striker plate (see Figure 25).

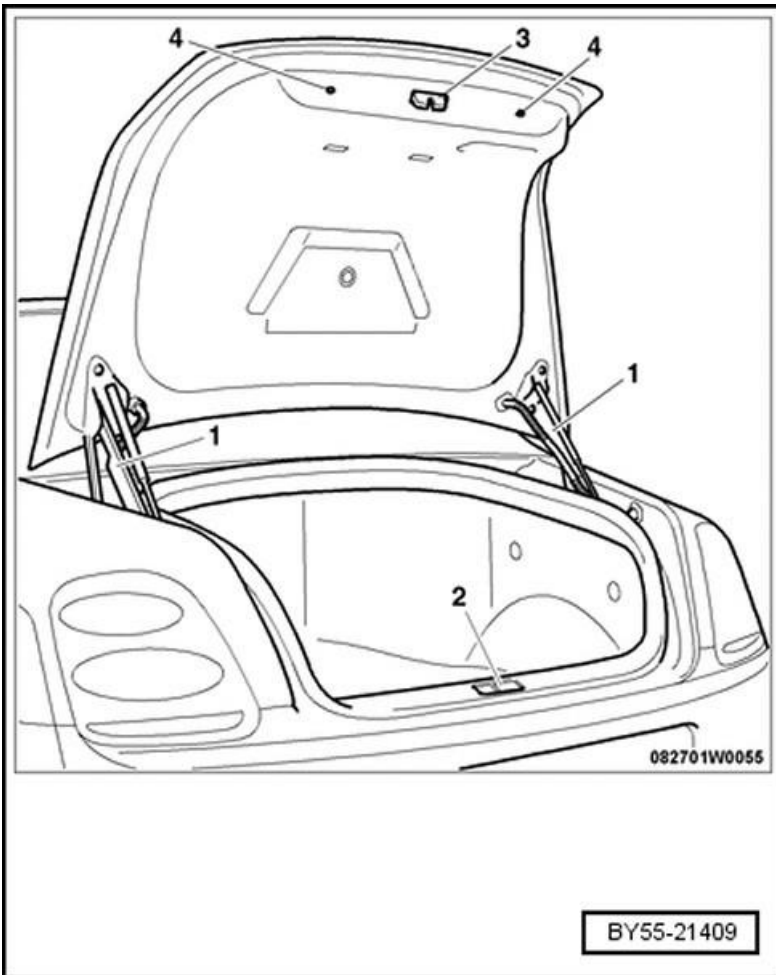
Figure 5

The position of the boot lid can be set by adjusting the hinges (1) or the striker (2). The locking latch (3) is attached directly to the boot lid. It does not have slotted holes and therefore has no means of adjustment. Before any adjustments are made the car must be resting on its wheels and on level ground. Ensure the socket used to release the fasteners is 'as new' and that it is fully engaged with the fastener. Tapping the socket with small dead blow hammer to assist the tool in cutting into the paint to aid engagement is recommended. Releasing the harness conduit clips from the each hinge will assist in access. When applying specific torque to fasteners ensure any adaptors or extensions used on the torque wrench are accounted for in your calculation for applied torque

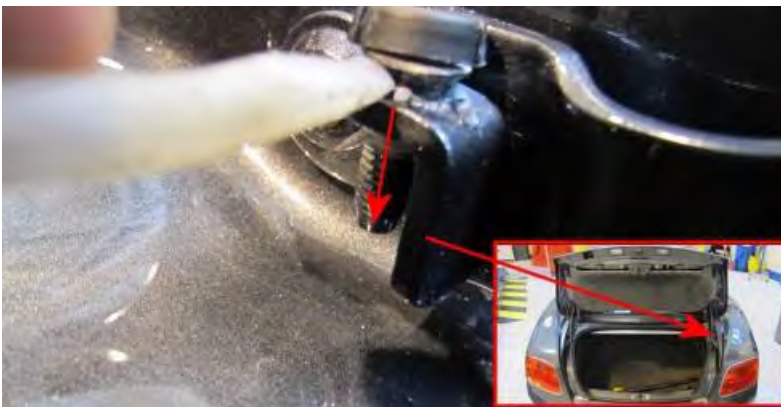
Figure 6

Remove the plastic cap and wind down the boot lid hinge bump stops located on each hinge assembly, these are adjusted back after the setting procedure (see Figure 6)

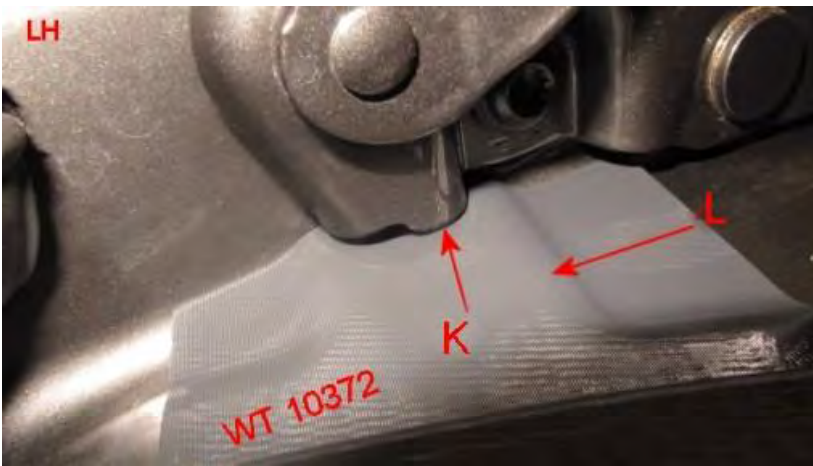
Figure 7

For New GT – use gauge part number WT10372 left hand or WT10373 right hand

The gauge is loaded into the drain channel from the front of the hinge in direction L. With the gauge correctly positioned the full length of the gauge will be in contact with both vertical sides of the drain channel whilst sitting on the channel bottom

In this position the rearward section of hinge should be touching the gauge at point K (see Figure 7). If the gauge is tight or loose, not touching, at K then slacken both fasteners and adjust hinges to achieve the base setting at K. The gauge adjustment at K is achieved at the hinge rear mounting bolt therefore although the front mounting bolt has to be slackened the hinge should only rotate at the front bolt with the vertical adjustment performed at the rear bolt. Re-tighten the fasteners **Note New GT** the torque figure of 28Nm \pm 2 is critical

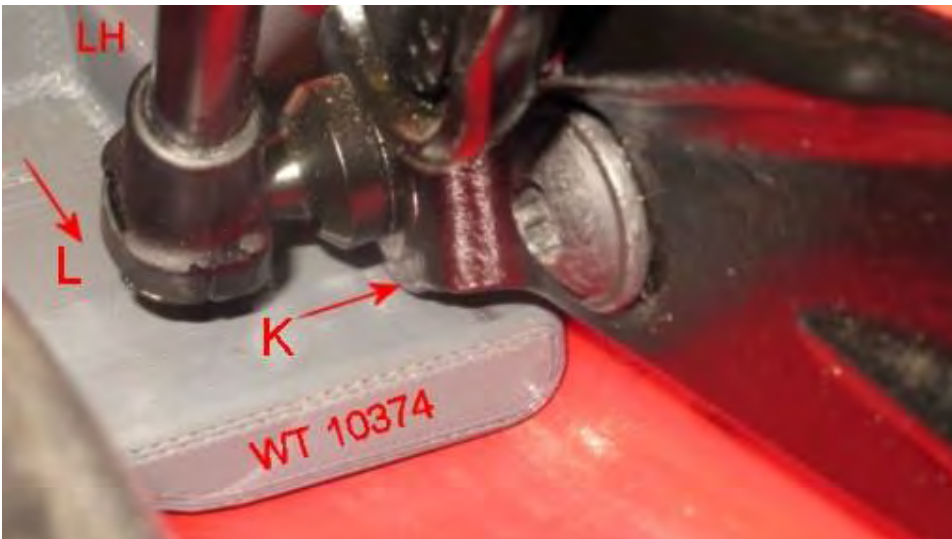
Figure 8

For New Continental GT Convertible – use gauge part number WT10374 left hand or WT10375 right hand

In this position the rearward section of hinge should be touching the gauge at point K (see Figure 8). If the gauge is tight or loose, not touching, at K then slacken both fasteners and adjust hinges to achieve the base setting at K. The gauge adjustment at K is achieved at the hinge rear mounting bolt.

– **Note New Continental GT Convertible** new bolts (increased length) must be fitted and the torque for these bolts are critical at 20Nm + angle 45°
new bolt is part number is N.910.097.01 x 4 off

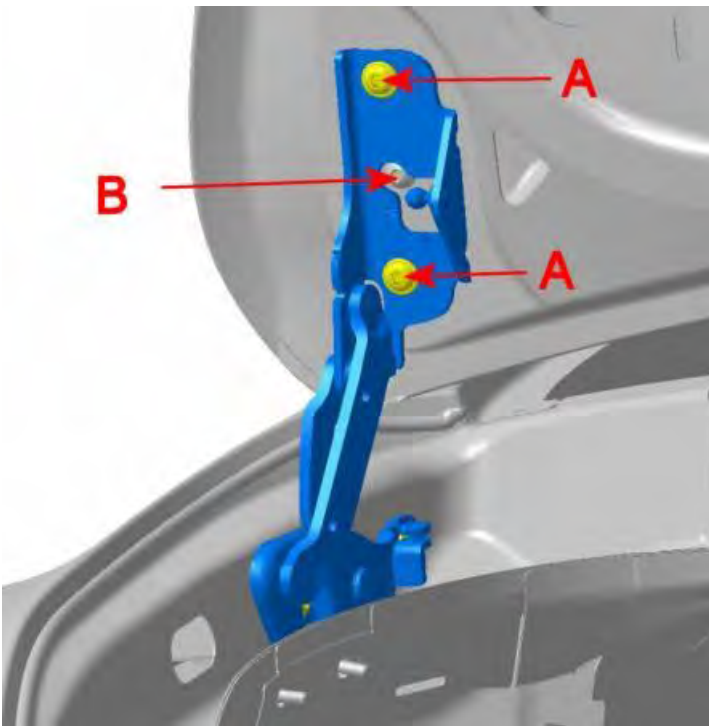
Figure 9

AllCars - Slacken the fasteners (A) securing the boot lid. (see Figure 9) **Note:** do not slacken fastener B at this time. Allow the hinges to "float" ensuring that left and right hinge are not working against each other and operate in same plane without undue resistance. Re-tighten the four fasteners (A) 20Nm \pm 2

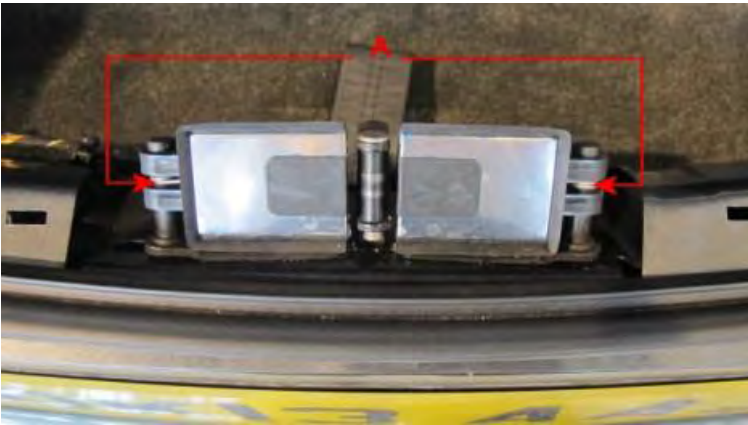
Figure 11

Replace both boot lid striker door springs (A) (see Figure 11). First replace the left hand spring using the right hand as a reference

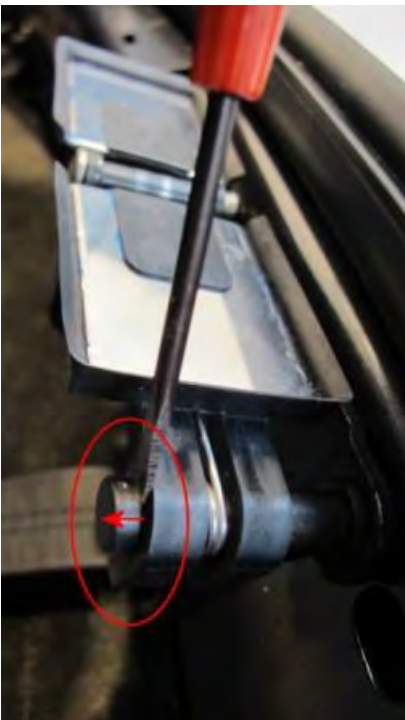
Figure 12

Detached plastic retaining cap and discard (see Figure 12)

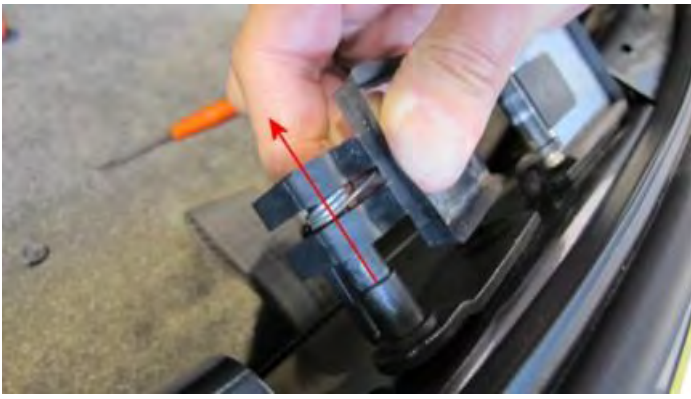
Figure 13

Slide door and spring off the bearing pin discard the original spring (see Figure 13)

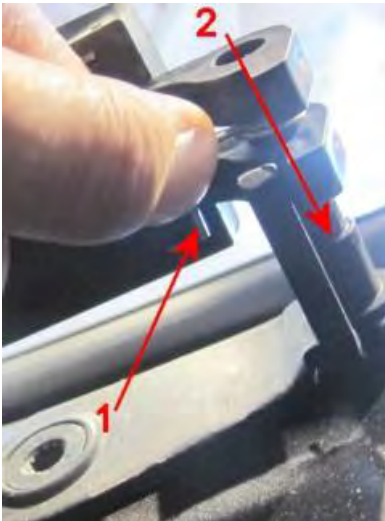
Figure 14

Position the new spring (part number 3W0827441 or 3W0827665) in the removed door. Whilst holding the spring tang back (1) partially fit door and new spring onto bearing pin (see Figure 14)

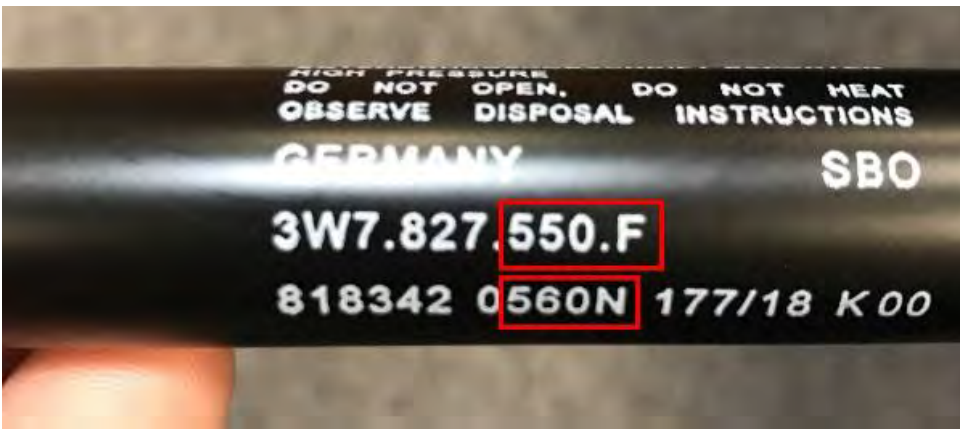
Correct left hand side strut **3W7827550F(560N)** - marked in White writing.

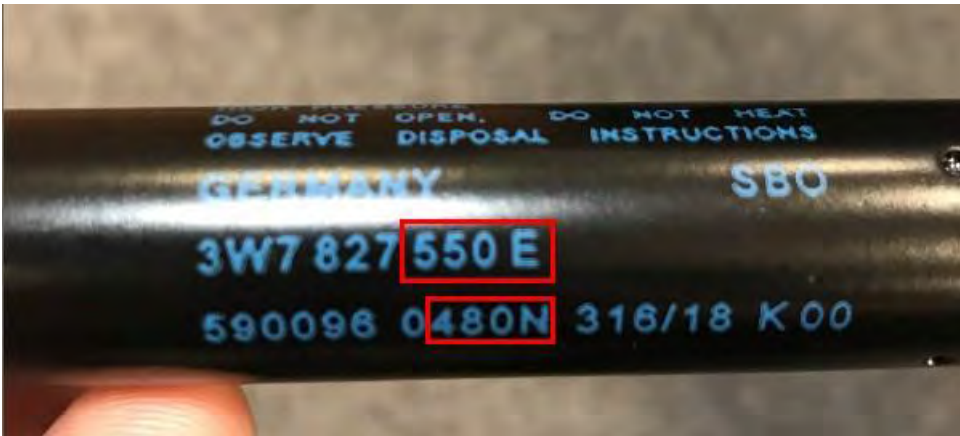
Correct right hand side strut **3W7827550E (480N)** - marked in Blue writing.

Should any of the boot lid struts not be correct as detailed above, replace the incorrect strut/s according to ETKA.

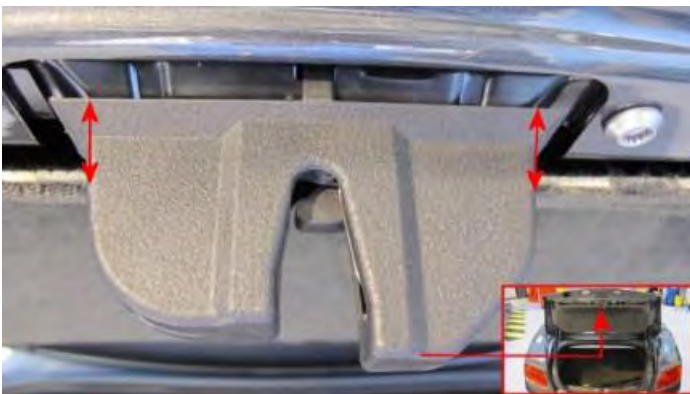
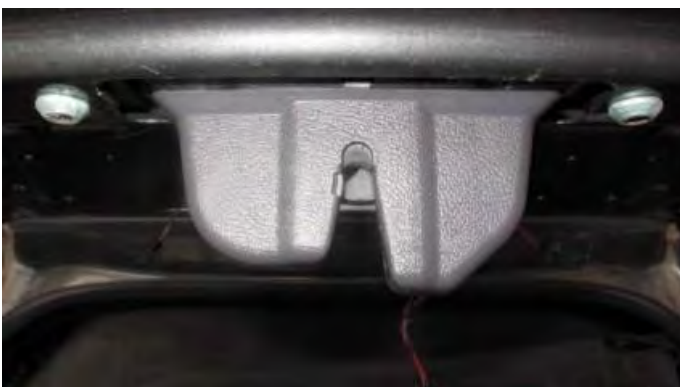
Figure 15

To replace remove and discard latch plastic cover (see Figure 15). Note: figure 15a shows the original cover, figure 15 shows the new cover

Inspect the area of the latch cover that receives the striker pin if damage is evident indicating a clash with the striker pin then replace the cover with the latest part which has a wider opening "Refer to Boot lid trim panels - To remove and fit" Rep.Gr.70

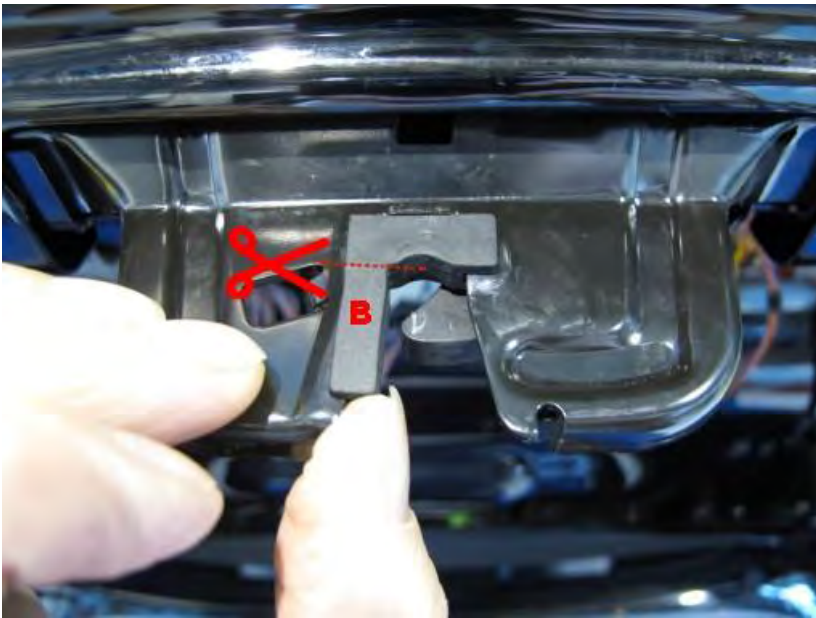
Figure 16a

With the original plastic cover removed modify the latch buffer by removing section B shown in figure 16a

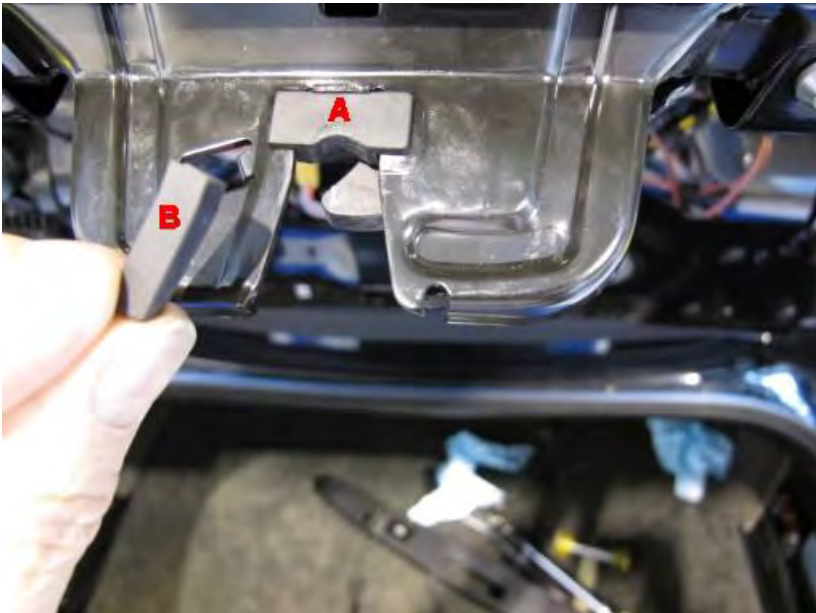
Figure 16b

With section B cut and discarded from the main buffer to form part A (see Figure 16b) then the new latch plastic cover (part number 3W0827520A) can be fitted

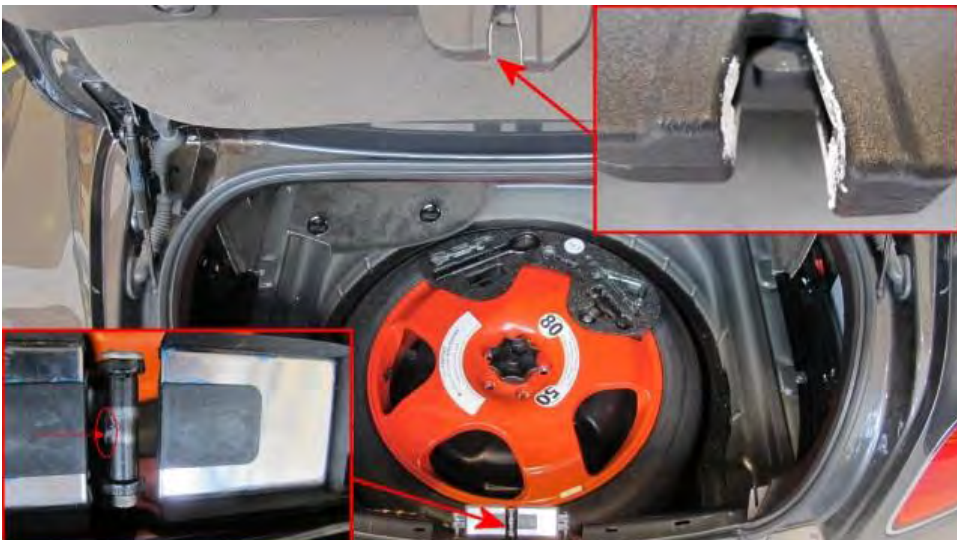
Figure 17

With the fit and profile of the boot lid set check and if necessary adjust the striker plate to ensure it is central in the boot latch striker plastic cover. To do this apply chalk to the boot latch striker plastic cover and operate the boot close function. If chalk is deposited on the striker pin then adjust the striker assembly to the left or right to reduce this occurrence. In the example the chalk is deposited on the left hand side of the pin this would necessitate the striker assembly being adjusted 1 or 2 mm to the right (see Figure 17). Once set remove chalk traces

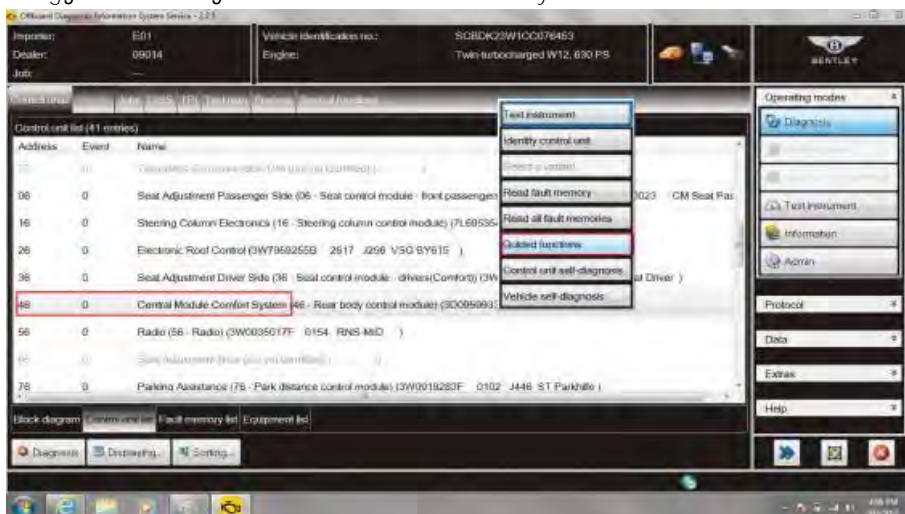
Figure 18

- Within Control units – Select (single touch) **46 Central Module Comfort System** – Reveal drop down menu (extended touch and release), Select *Guided functions* (see Figure 18)

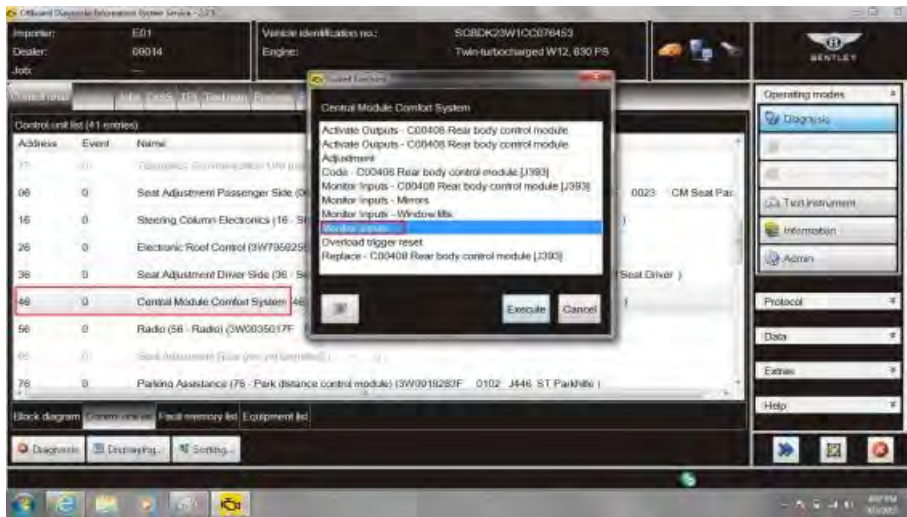
Figure 19

- Within Control units, *Central Module Comfort System*, Select *Monitor Inputs* and then Execute (see Figure 19)

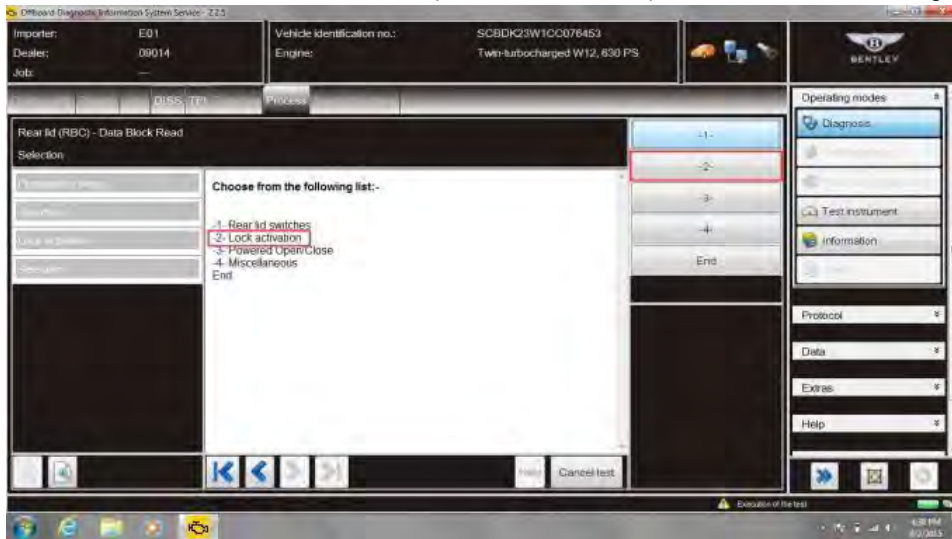
Figure 20

- Within Rear lid (RBC)-Data Block Read select *-2- Lock activation* (see Figure 20)

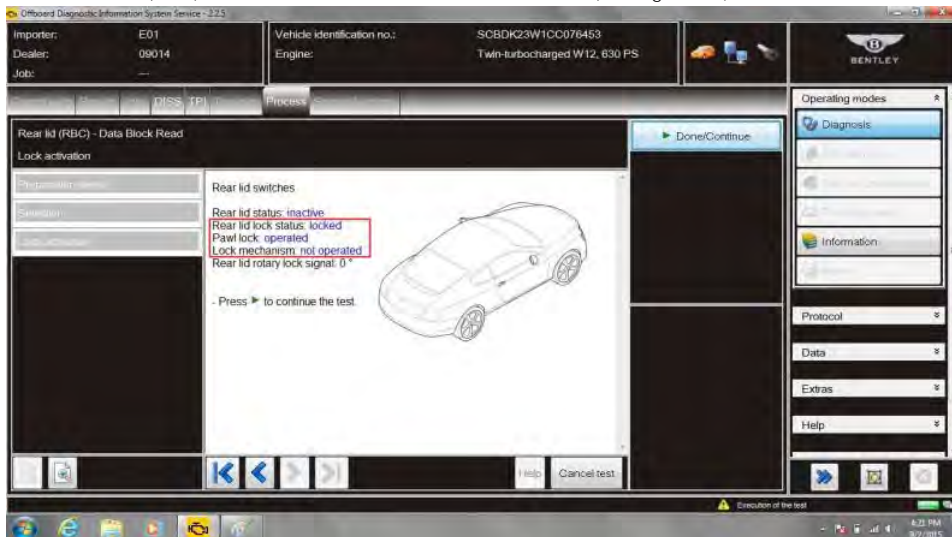
- The correct status for the boot lid micro switch assembly in the closed position is highlighted in Figure 21

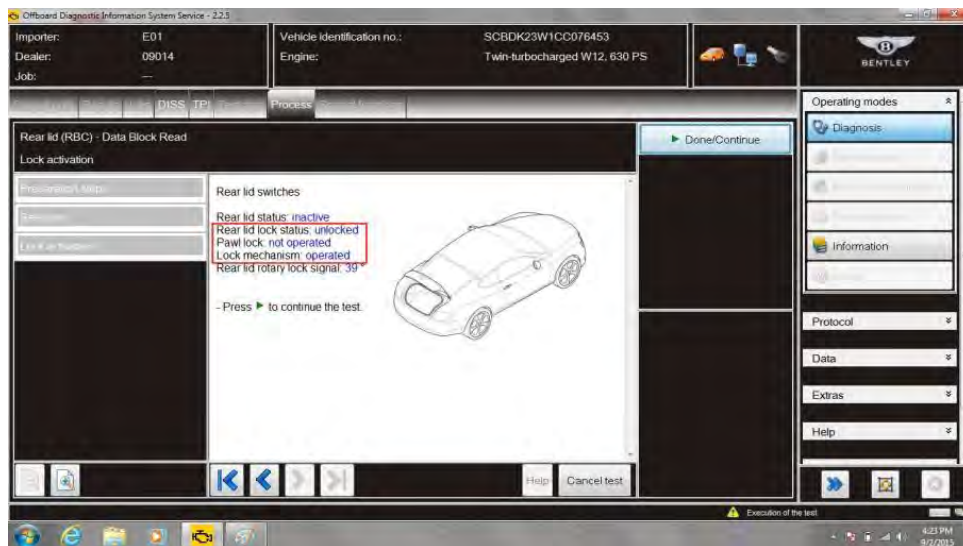
- The correct status for the boot lid micro switch assembly in the open position is highlighted in Figure 22
 - if either open or close status in relation to the micro switch is functioning incorrectly then replace boot latch assembly "Refer to Boot lid and fittings - Boot lid latch – To Remove and Fit – Rep.Gr.55.

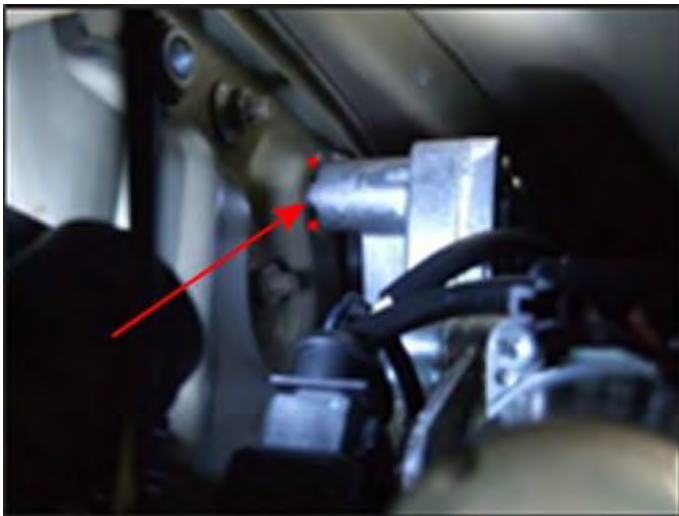
Figure 23

- a. Not applicable to GT Convertible derivatives - Remove tail lamp (right hand) on boot motor side to enable check. Check that the power boot motor is correctly aligned on to the hinge splines and that the locating peg (see figure 23) is fully engaged in the body location and tapping plate - where necessary loosen motor and correct alignment
- Carry out closing force gauge test – if the load measured to initiate the close cycle is less than 1 Kg and the boot completed three consecutive power open and close cycles then the campaign is complete, apply a white campaign identification mark to the boot striker plate (see Figure 23) otherwise continue with stage 3 checks

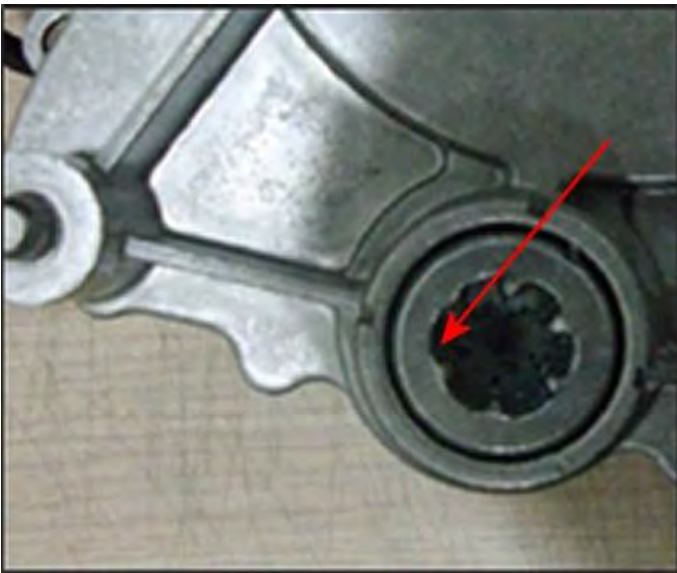
Figure 24

- a. Remove motor and inspect motor spline drive and hinge spline for damage replace damaged components where necessary (see Figure 24)
- Carry out boot lid function and force gauge test – if the load measured to initiate the close cycle is less than 1 Kg and the boot completed three consecutive power open and close cycles then the campaign is complete, apply a white campaign identification mark to the boot striker plate (see Figure 25)

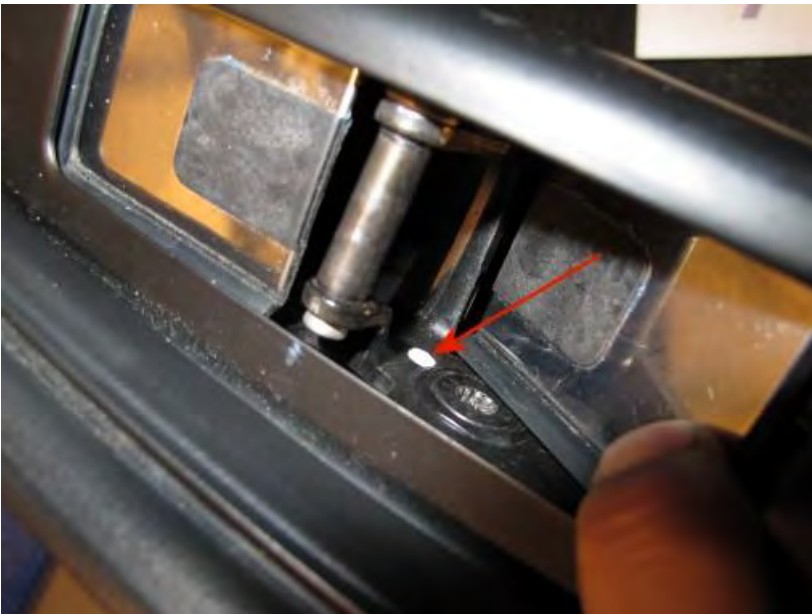
Figure 25

On completion apply a white identification mark to the boot striker plate (see Figure 25)

If the vehicle is not already listed as repaired in the "Repair history" (in Elsa pro), check for the presence of a white campaign identification mark (see Figure 25), should neither be evident carry out the required work in accordance with these instructions
