Version 1

Rear Climate Control Panel Buttons Do Not Work

Year	Model	Trim	VIN Range
2018-19	Odyssey	ALL	ALL

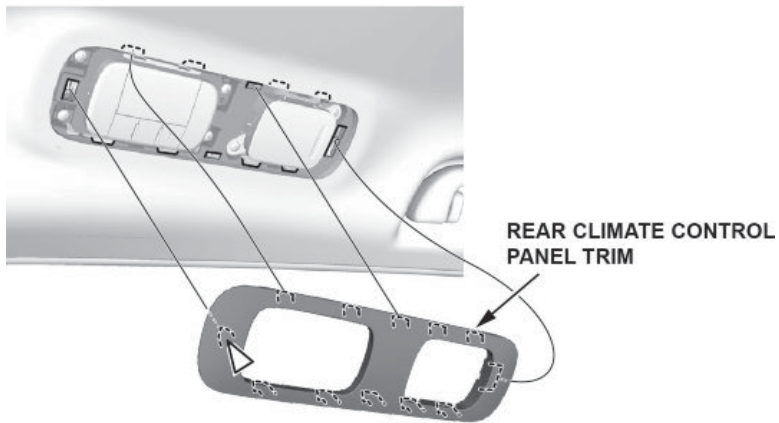
1. Using the plastic trim tool, remove the rear climate control panel trim piece.

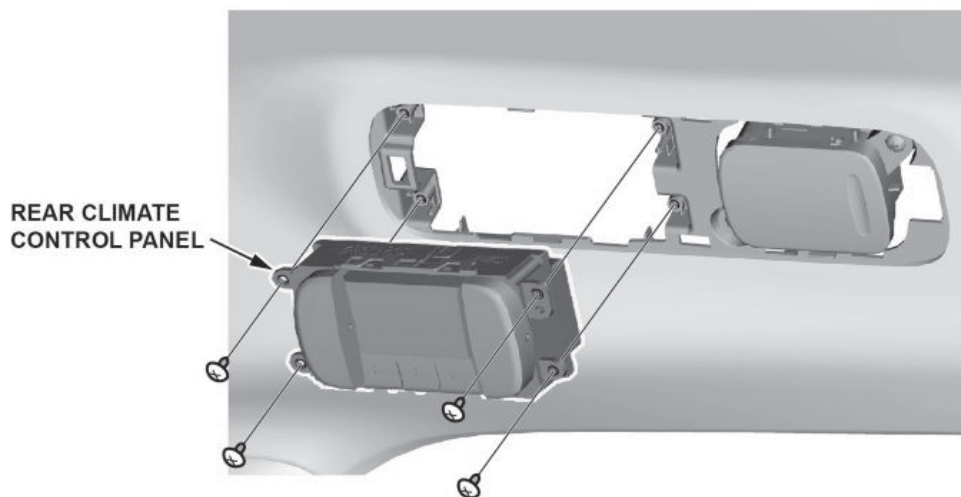
2. Remove the four screws, disconnect the connector and remove the rear climate control panel.

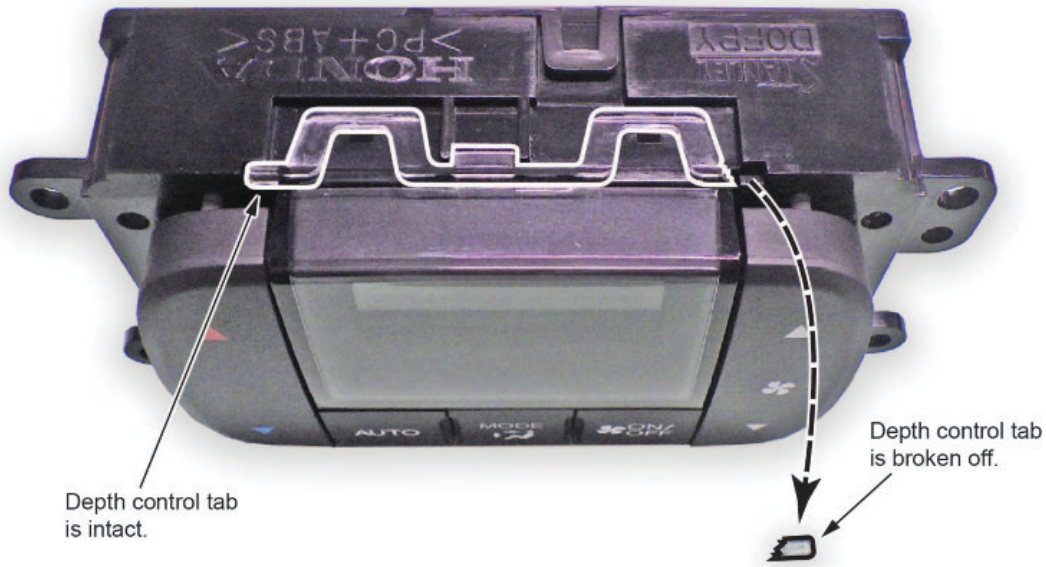
3. Shake the rear climate control panel, and listen for rattling inside. If one or both of the depth control tabs have broken off, they will rattle and may even fall out while shaking.
 - If you do not hear any rattling or see anything fall out, go to step 4.
 - If one or both tabs fall out and you no longer hear any rattling, go to step 5.

One or both of the depth control tabs used for locating the screen cover during assembly may have broken off and lodged behind the rear fan control and/ or rear temperature control buttons and the control panel housing, preventing the button(s) from raising fan speed or temperature.

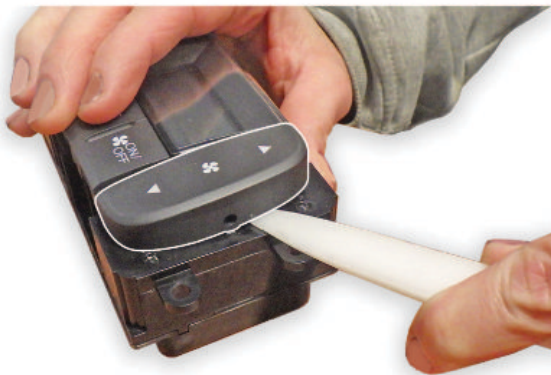
4. Use a plastic trim tool to gently pry the affected button(s) from the control panel. Clear out any lodged tab(s).

Fan control button is shown; the temperature control button is similar.

Remove the rear climate control panel, and clear out the lodged tab(s) between the rear fan control and/or rear temperature control buttons and the control panel housing. You may need to remove the button(s) to do this.
