## Display message "Coolant temperature too high" appears in multifunction display

| Topic number | LI54.15-P-067157 |
| Function group | 54.15 Fuse and relay box |
| Validity | Model 205, 213 and 253 with engine 274 with electric coolant pump M75/11 |

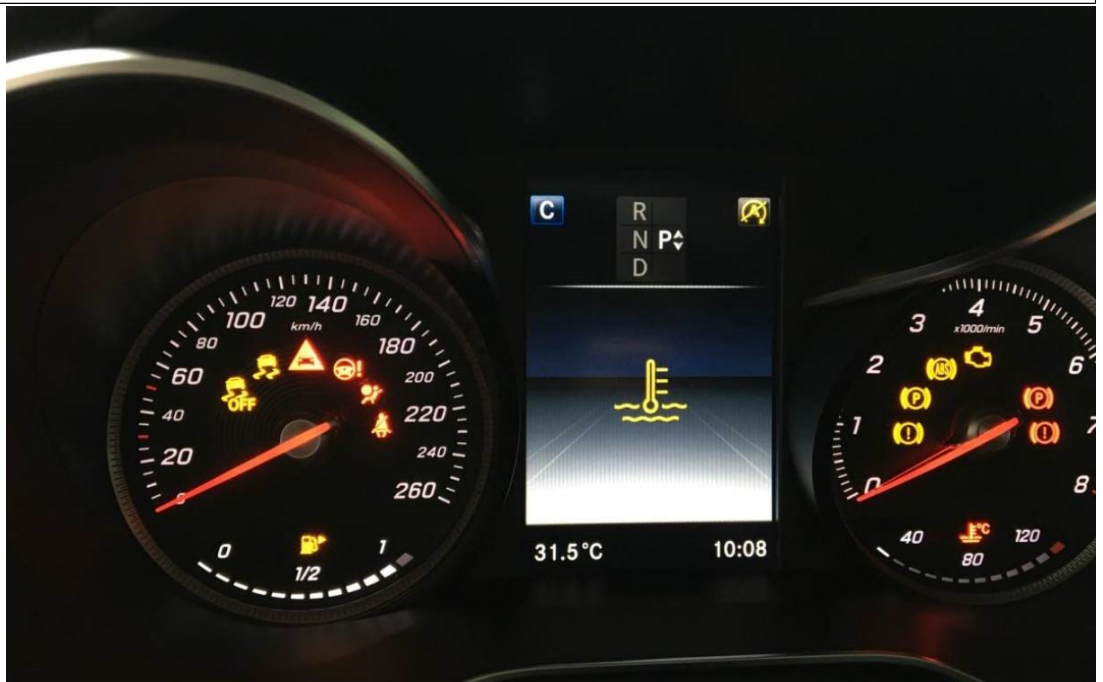
Display message.jpg:

Display message "Coolant temperature too high" appears in multifunction display.

| Attachments | |
|---|---|
| Display message.jpg | Coolant temperature display message |

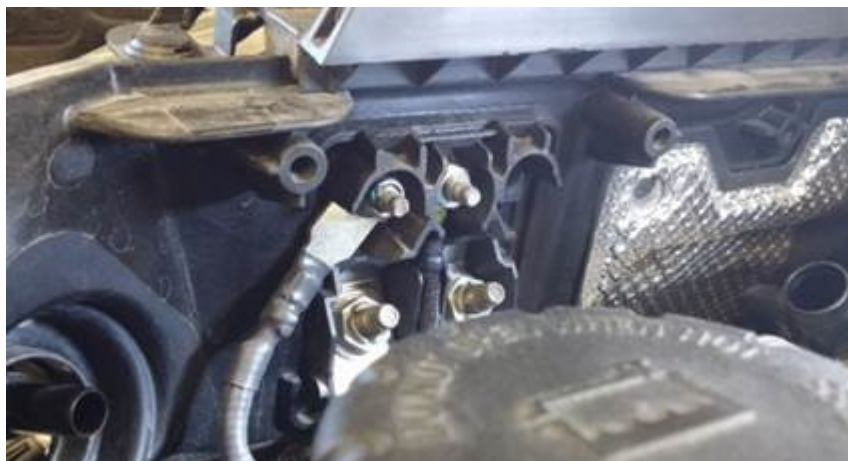
X244\_Photo2.jpg:

1. Feed line from K40/8 connector S3 to X244/14.
2. Feed line from X244/16 to M75/11.
  - Check the circuit 30 line at the busbar X244 (see photos "X244\_Photo1.jpg" and "X244\_Photo2.jpg") for damage after carefully removing the heat-shrinkable tube (for example, the copper strands could be broken). This point must then be closed again with fabric tape.
3. Feed line to ground point W46/1.
4. Check threaded connection of ground point W46/1 (see photo "W46.1.jpg").

| File | Description |
|---|---|
| X244_Photo2.jpg | Busbar, photo 2 |
