## Model 222, model 463 with M176 engine low oil level, rough running and or misfire may be observed

| Topic number | LI01.00-P-068795 |
| Validity | 222 and 463 vehicles with M176 engine up to engine number 176.980 30 049165 |

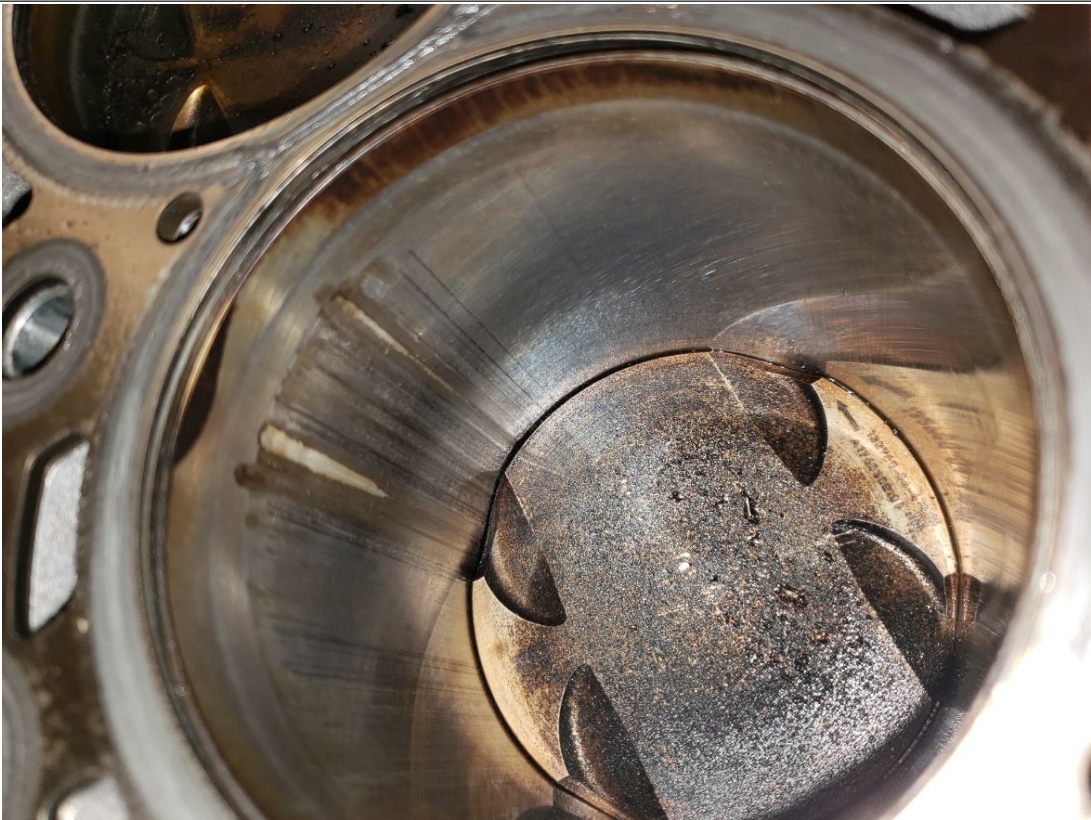
Cylinder #2 picture 1.  
JPG:

| Attachments | |
|---|---|
| Cylinder #2 picture 1.JPG | cylinder wall head removed |

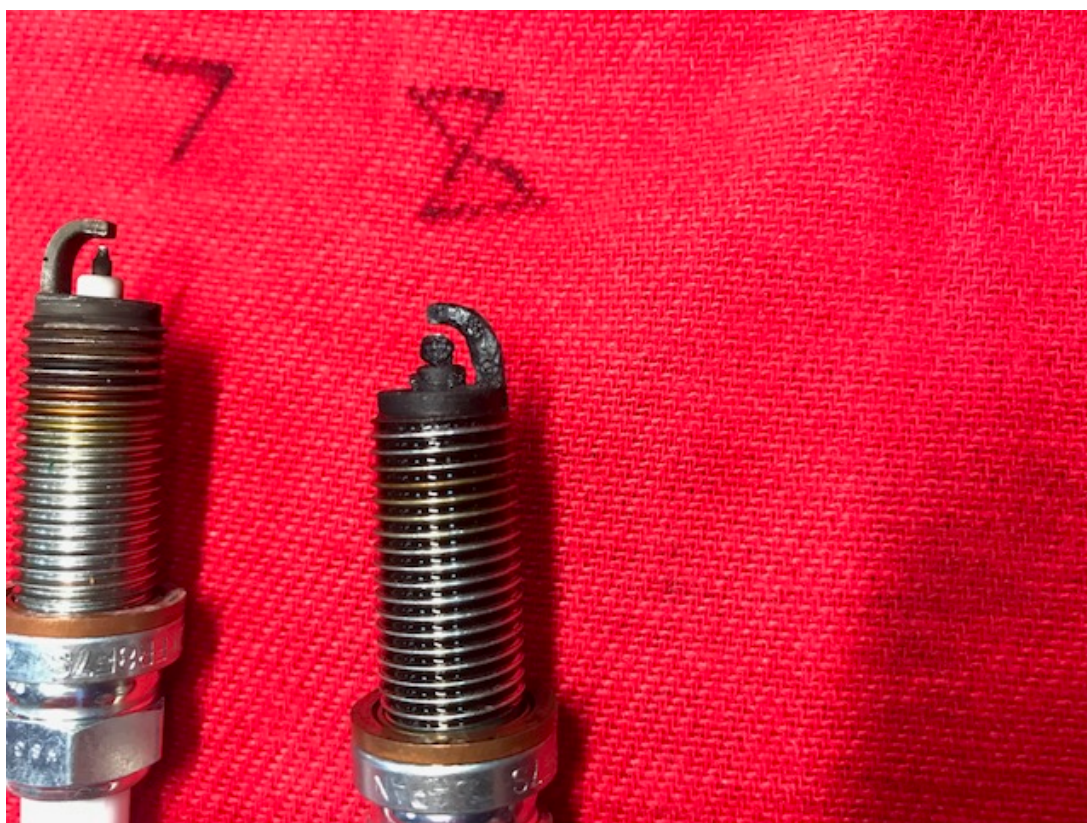
560 6.jpg:

| Attachments | |
|---|---|
| 560 6.jpg | spark plug # 8 |

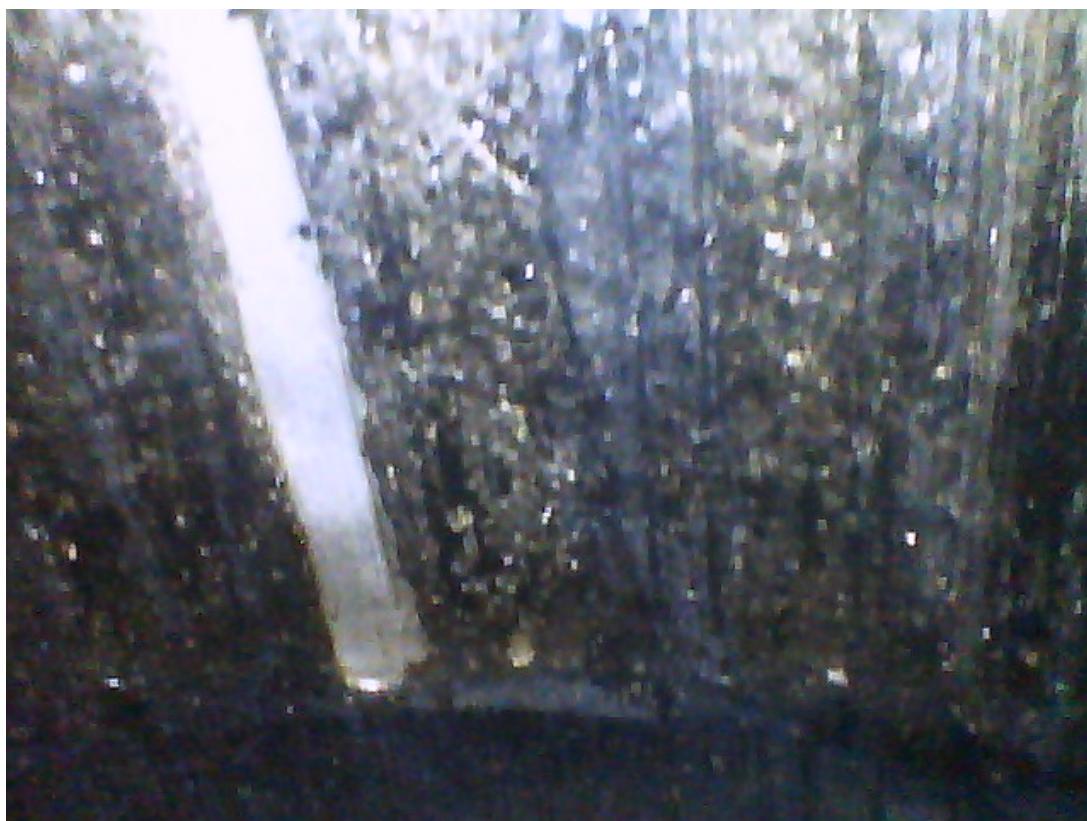
BK560351.JPG:

| Attachments | |
|---|---|
| BK560351.JPG | cylinder wall borescope picture |

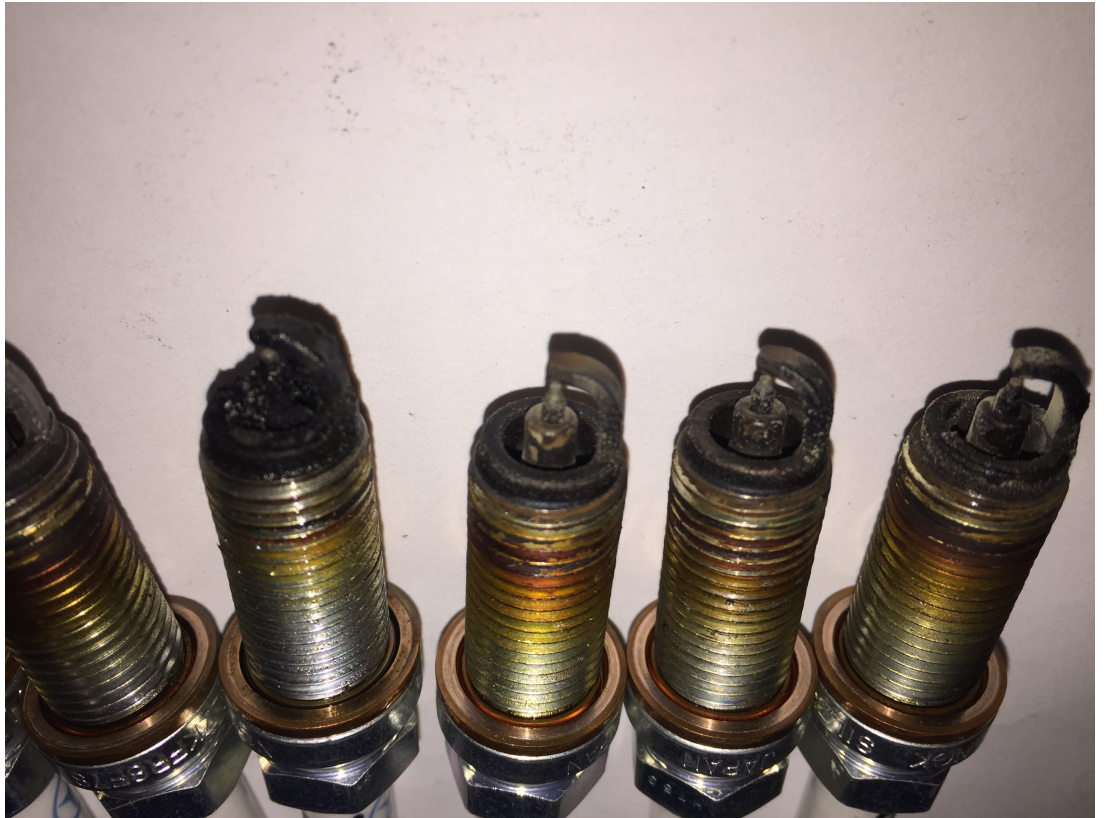
spark plug close.JPG:

| Attachments | |
|---|---|
| spark plug close.JPG | spark plugs |

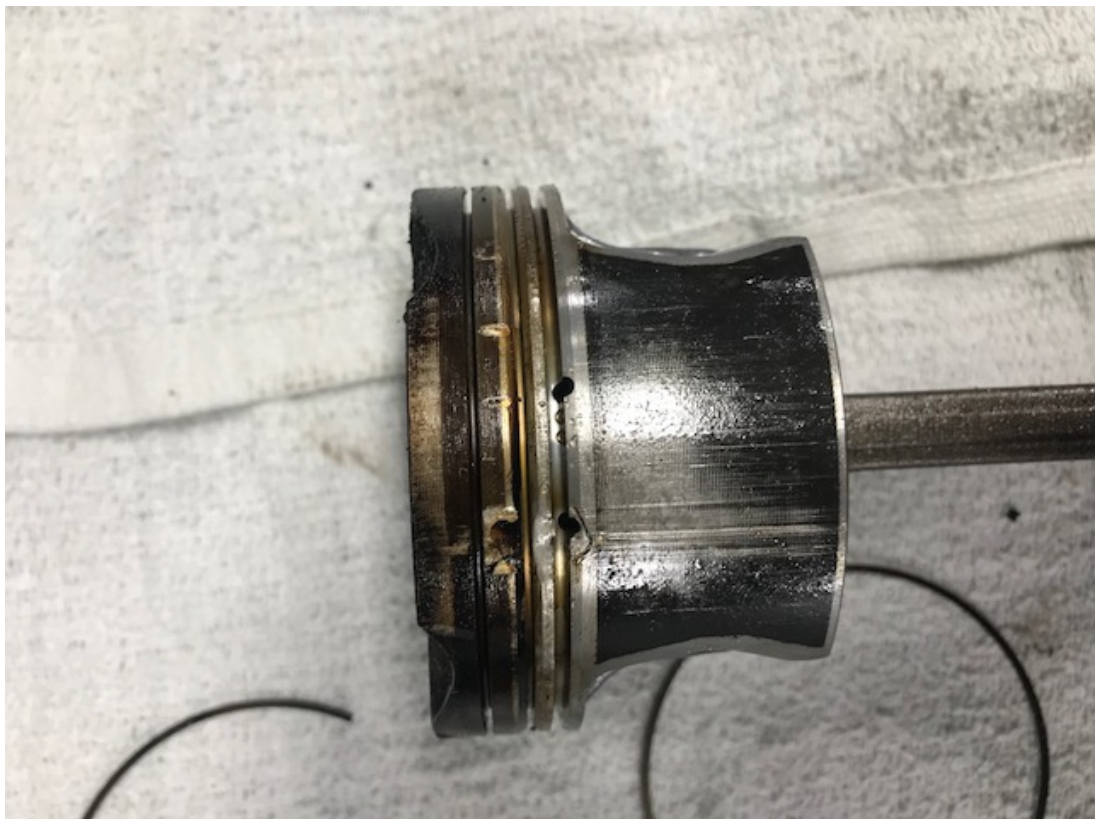
IMG\_0798.jpg:

Piston assembly installation during production process may not meet specifications.

| Attachments | |
|---|---|
| IMG_0798.jpg | piston damage |

If you receive related complaint on vehicles with engine number up to 176.980 30 049165, produced before January 08 2019, follow the steps below and refer to the WIS document AH01.00-P- 0300-01AMG.
