LTB01208NAS3

TECHNICAL BULLETIN

Hood Release Inoperative

MODEL:	MODEL YEAR:	VIN:
Discovery (LR)	2017-2018	000004-077150

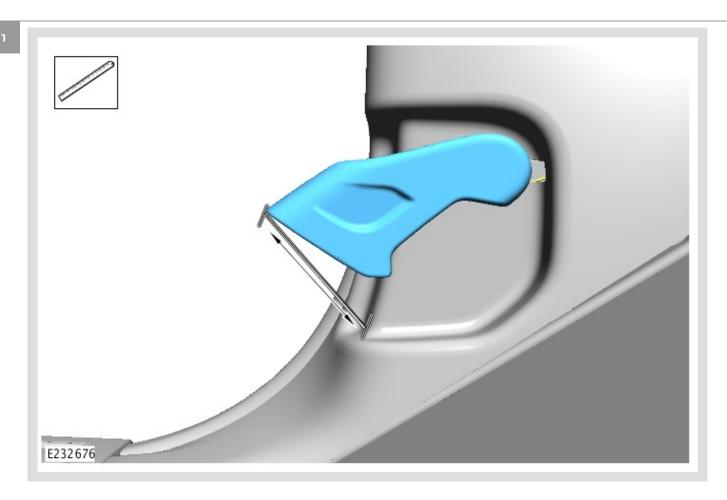
Open the hood and use a steel rule or similar engineer's scale to record the distance the interior release lever travels to operate the hood latches.

- If the hood interior release lever does operate the hood latches, the hood can be opened, and the distance is less than 120mm, release the vehicle.
 - No further action required.

- If the hood interior release lever does operate the hood latches, the hood can be opened, and the distance is more than 120mm, go to Step 5.
- If the hood interior release lever does not operate the hood latches and the hood cannot be opened, go to Step 2.

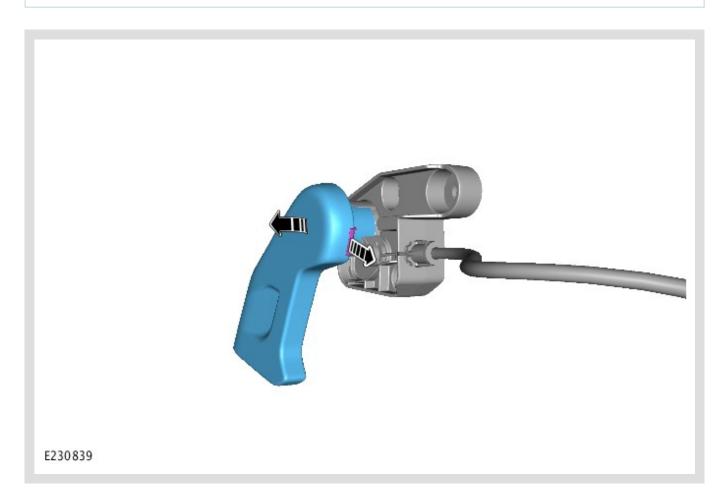
2

Components shown removed from the vehicle for clarity.

Remove hood interior release lever from the hood release mechanism.

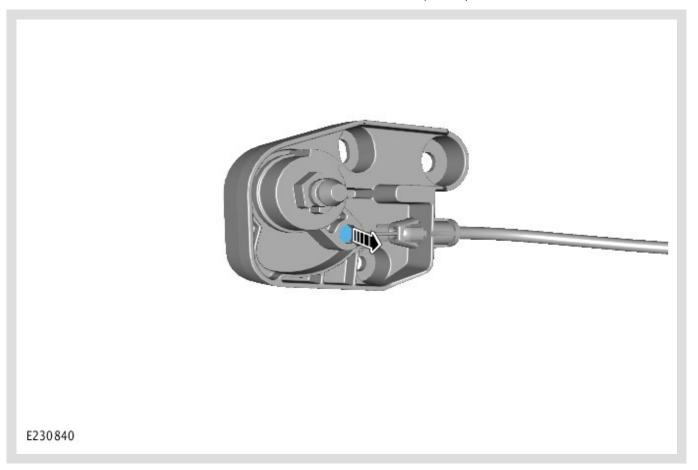
3

Components shown removed from the vehicle for clarity.

Release the hood release cable from the hood release mechanism.

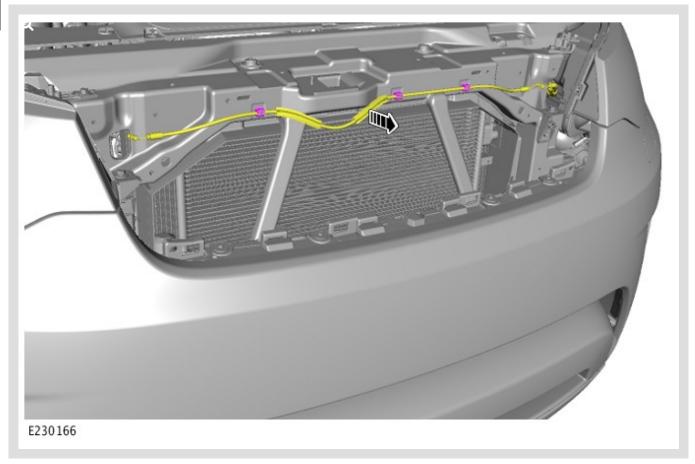
Release the hood release cable.

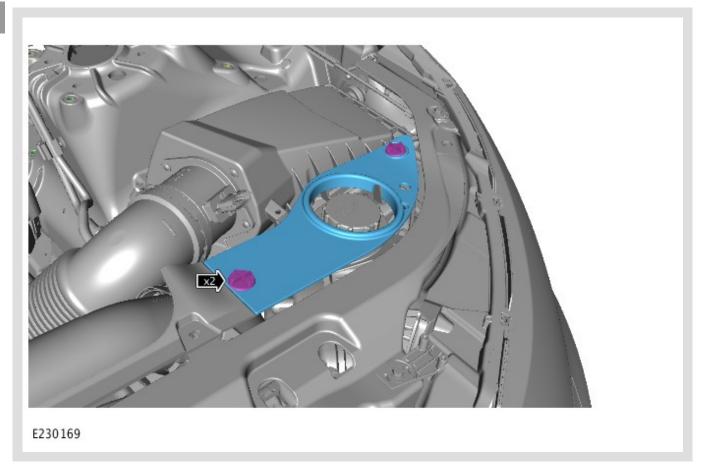
Remove the trim.

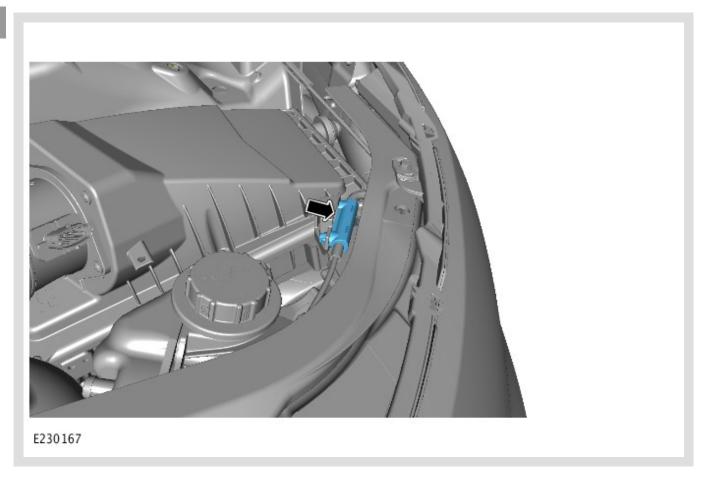
Release the hood release cable from the retainer.

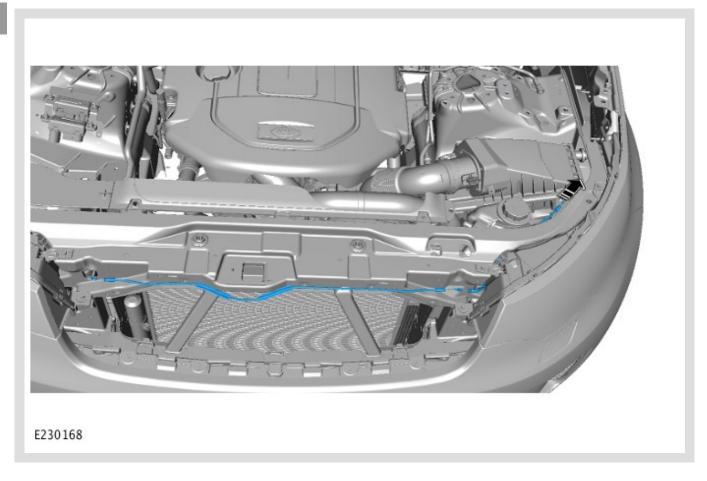
Remove the hood release cable from the vehicle.

Reverse Steps 5-9 to install the new hood release cable.
