SERVICE BULLETIN

Reference number:	SB-09-1218	Issued: 28 January, 2019
Subject:	Loose Exhaust Finishers	
Model(s):	Vantage 19MY	
VIN Range:	All	
Applicable to:	All Dealers	
Distribute to:	After Sales Manager Executive Manager Service Manager Sales Manager	Warranty Staff Technician(s) Parts Staff

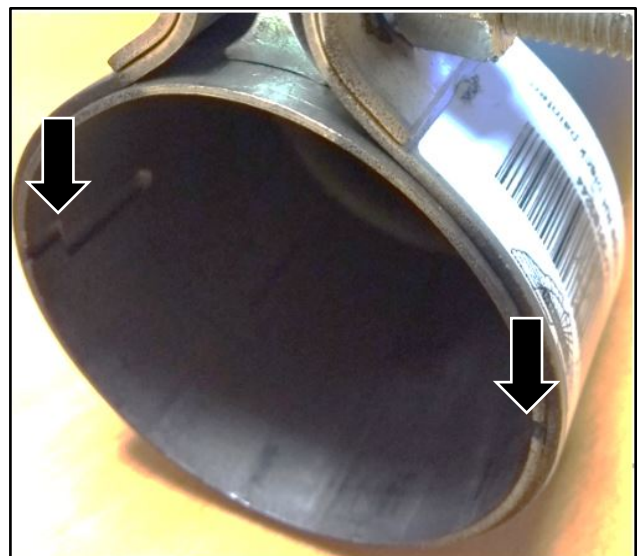
Figure 1

1. Do a push pull test of each exhaust finisher to check if it is loose.
2. If an exhaust finisher is loose, remove the exhaust finisher from the vehicle (refer to Workshop Manual Procedure 01.19.BX).
3. Each exhaust finisher has two slots (refer to Figure 1).

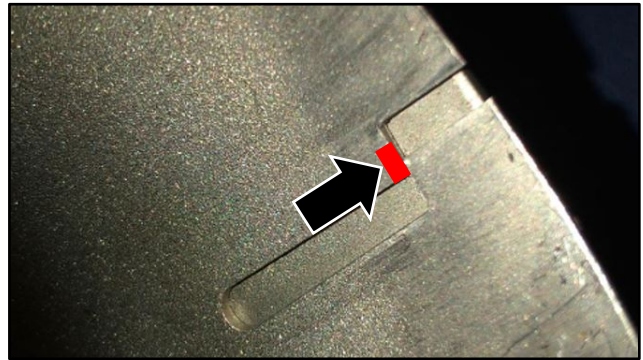
Figure 2

Some Vantage 19MY vehicles with twin and quad exhaust finishers can become loose. Do the procedure that follows to check and, if necessary, remove unwanted material from the exhaust finisher so it can be installed correctly:

4. Use an applicable tool to cut 1mm of exhaust finisher material from the area shown (refer to Figure 2).
