Special Parts Collection – FLORIDA ONLY

Code:69V8

Subject	Special Parts Collection – Driver & Passenger Seat Mounted Takata Side Airbags
Repair Restriction	Florida Dealers ONLY
Revision Summary	Updated wire part number claiming quantity
Release Date	January 24, 2018
Affected Vehicles	<p><u>U.S.A.: Certain 2009 MY Volkswagen Tiguan Registered in Florida Only</u></p> <p><i>Check Campaigns/Actions screen in Elsa on the day of repair to verify that a VIN qualifies for repair under this action. Elsa is the <u>only</u> valid campaign inquiry & verification source.</i></p> <ul style="list-style-type: none"> ✓ Campaign status must show “open.” ✓ If Elsa shows other open action(s), inform your customer so that the work can also be completed at the same time the vehicle is in the workshop for this campaign.
Special Parts Collection Program Description	<p>In coordination with the National Highway Traffic Safety Administration (NHTSA), Volkswagen will proactively conduct a special parts collection program involving Takata driver and front passenger seat-mounted side airbags in the State of Florida only, as follows:</p> <ul style="list-style-type: none"> • Driver and front passenger seat-moun

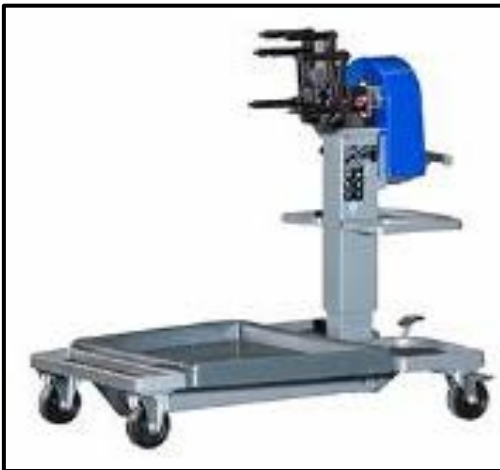
- VAS6136 – Seat Repair Fixture

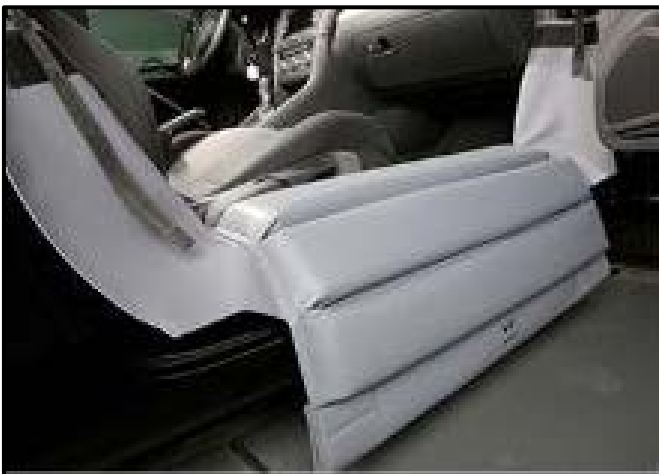
- To protect the sill panel before removing the front seat, install the Universal Vehicle Protector VAS871 001 <as shown>.
- Carefully remove the seat from the vehicle through the door opening.

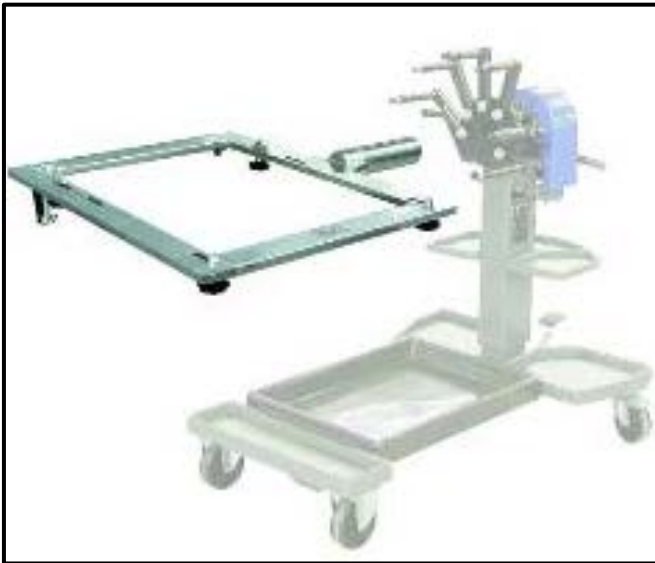
- Mount the Engine/Transmission Holder – Seat Repair Fixture VAS6136 on the Engine and Gearbox Bracket VAS6095A.
- Secure the seat to the Engine/Transmission Holder – Seat Repair Fixture VAS6136.

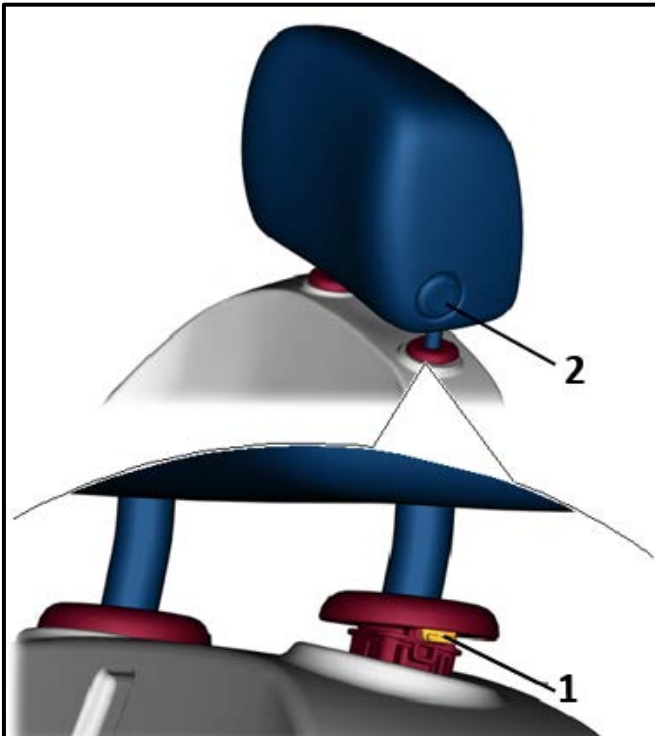
- Lift the headrest to its fully-raised position.
- Using a small screwdriver (or equivalent) press and hold the release button <1> on the RIGHT SIDE headrest post.
- Press and hold the release button <2> on the LEFT SIDE of the headrest itself.
- Remove the headrest from the seat.

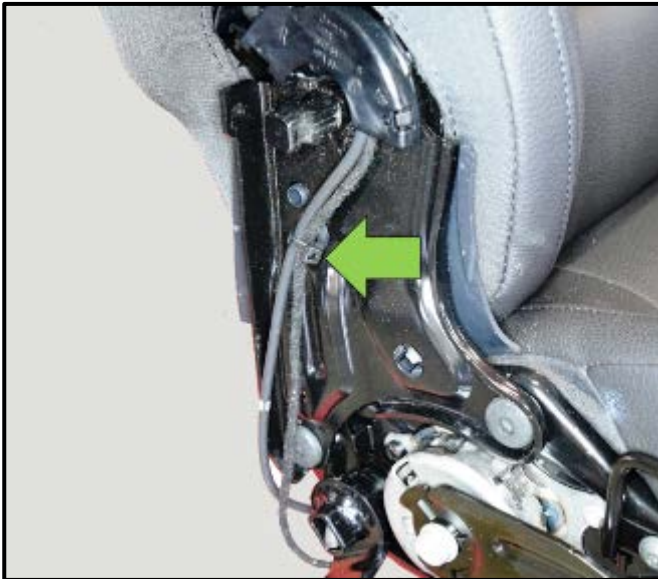
- Carefully remove the seat and airbag wiring harnesses from the seatback frame.

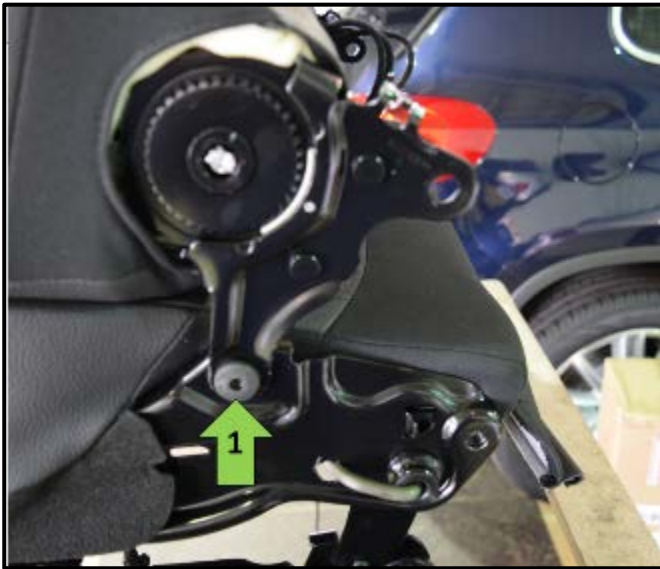
- Remove the front mounting bolt <arrow 1> from both seatback hinges.
- Remove the seatback from the seat bottom and place it on a clean, dry working surface.

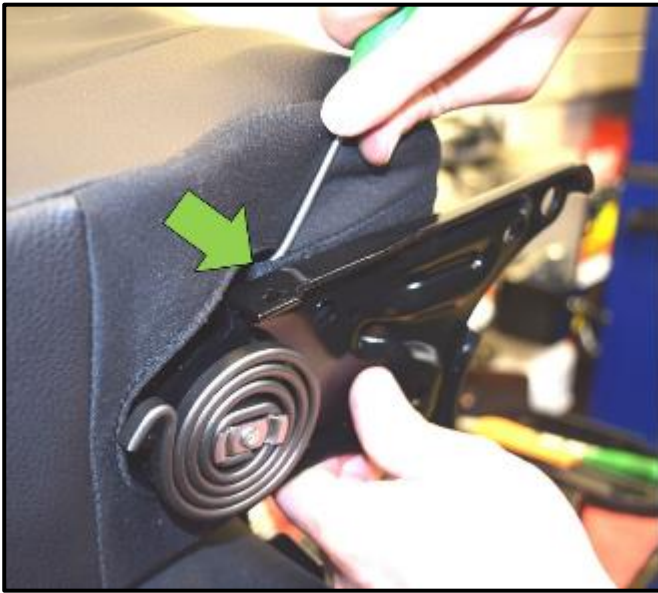
- Using a small screwdriver (or equivalent) extract the end of the seatback zipper on both sides of the seat <arrow>.

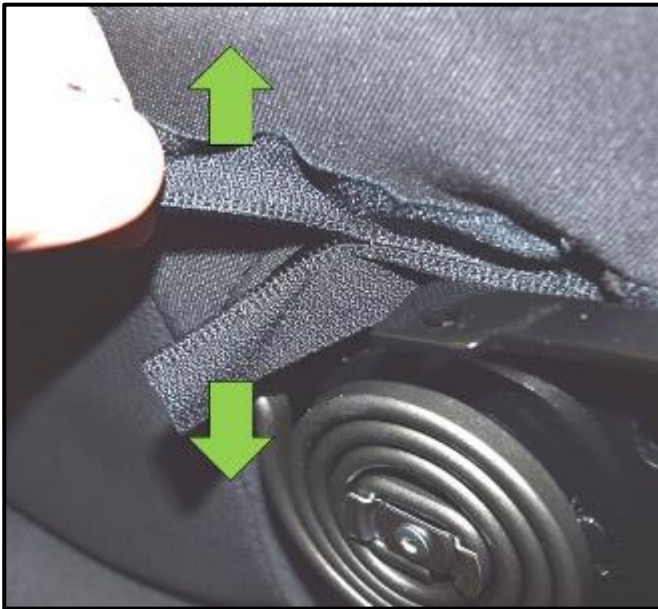
- Once the ends of the seatback zipper have been extracted, carefully separate the zipper by pulling both halves in the directions shown <arrows>.

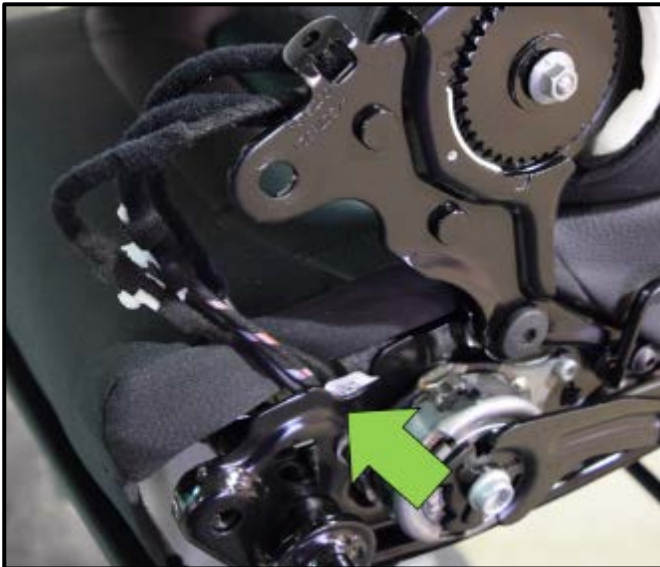
- Carefully remove the seat and airbag wiring harnesses from the seat bottom <arrow>.

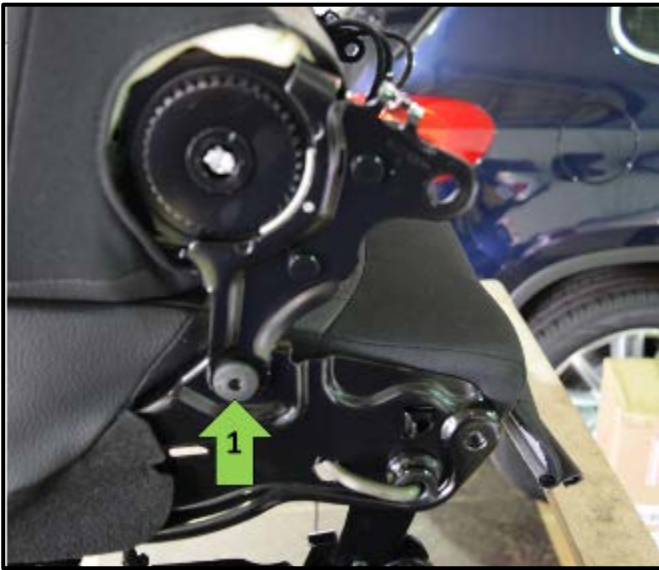
- Remove the front mounting bolt <arrow 1> from both seatback hinges.
- Remove the seatback from the seat bottom and place it on a clean, dry working surface.

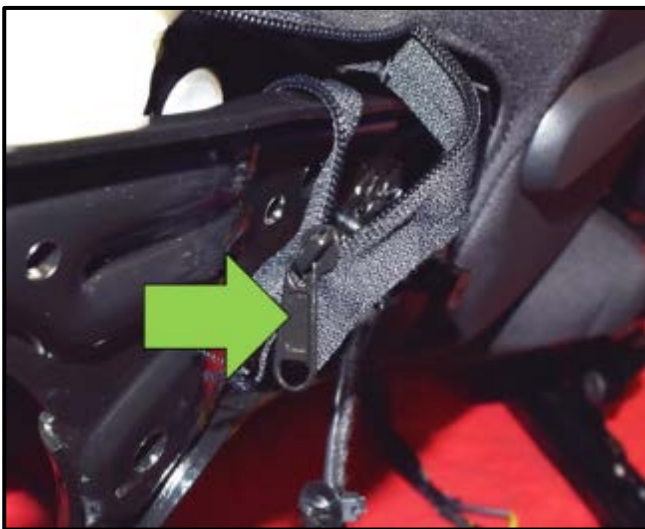
- Install the slide <arrow> - P/N 1S0881451 to the seatback cover zipper.

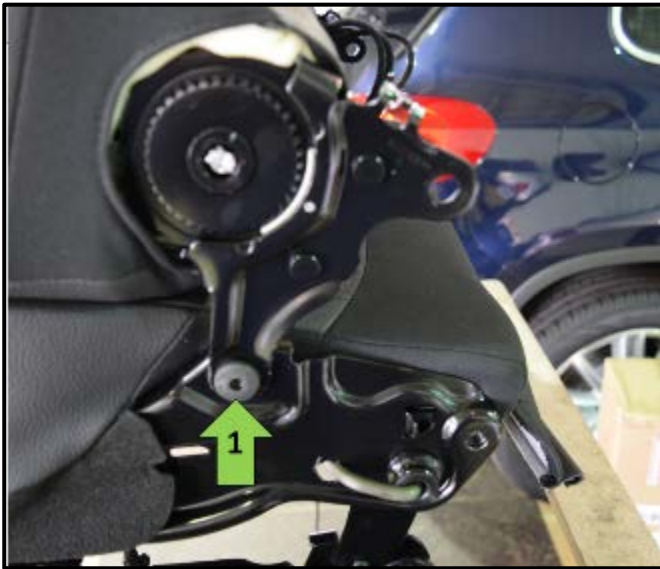
- Align the seatback to the seat bottom, tilting the seatback forward and resting it against the seat bottom as shown.
- Reinstall the front mounting bolts <arrow 1> to both seatback hinges, but do not tighten.

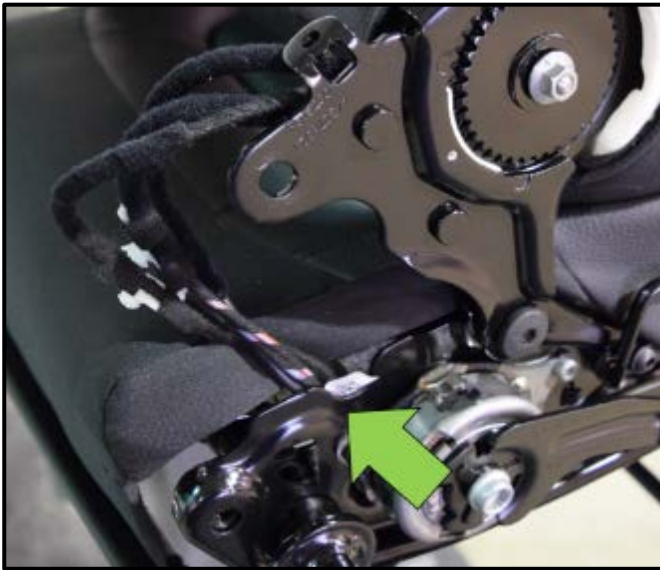
- Properly route the seat and airbag wiring harnesses through the seat bottom <arrow>.

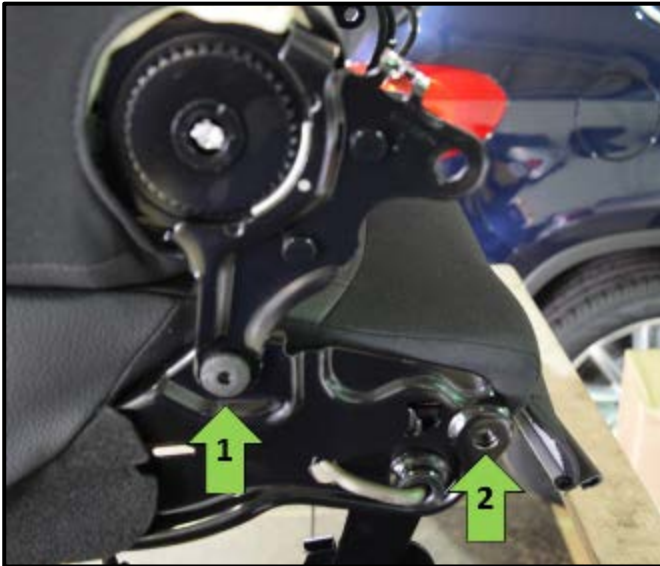
- Tilt the seatback rearward and reinstall the rear mounting bolt into position <arrow 2> on both seatback hinges.
- Torque both bolts <arrows 1 & 2> on both sides to 34.5 Nm using torque wrench - VAG1331 (or equivalent).

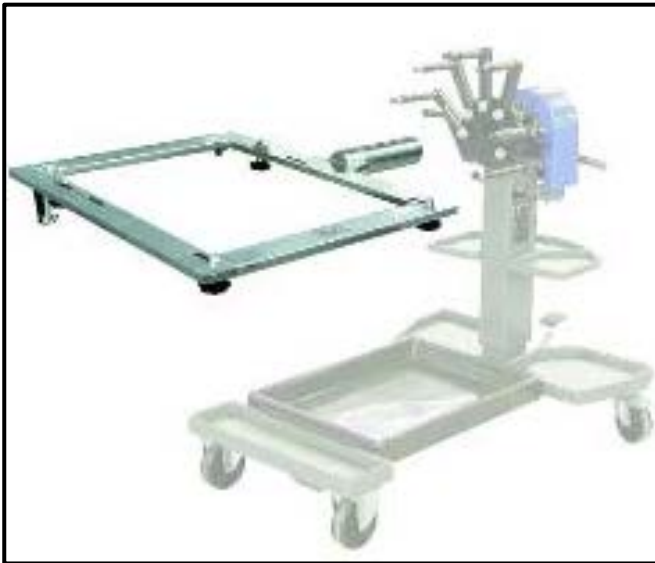
- Remove the seat from the Engine /Transmission Holder – Seat Repair Fixture VAS6136.

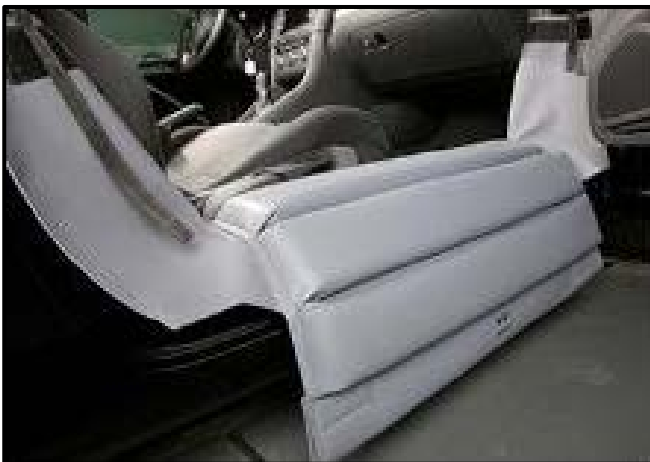
- Before reinstalling the front seat, ensure the Universal Vehicle Protector - VAS871 001 remains in place <as shown> to protect the sill panel during installation.
- Carefully lift the seat into the vehicle through the door opening.
- Insert the seat into corresponding openings in floor via the centering pins on the tunnel-side.
- Once the seat has been placed into the vehicle, remove the Universal Vehicle Protector - VAS871 001.
