Subject: CHECK ENGINE LIGHT ON WITH DTC P061B, SURGING ON ACCELERATION, TRANSMISSION WON'T SHIFT PAST 4TH GEAR, VARIOUS U CODES SET	Service Alert No.: SA-011/19
	Last Issued: 02/28/2019

2018 CX-5

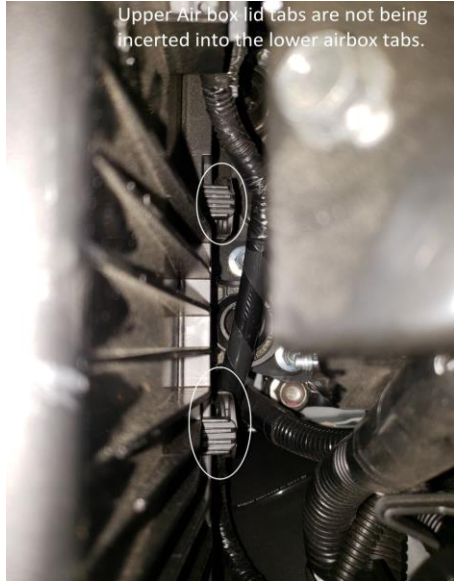
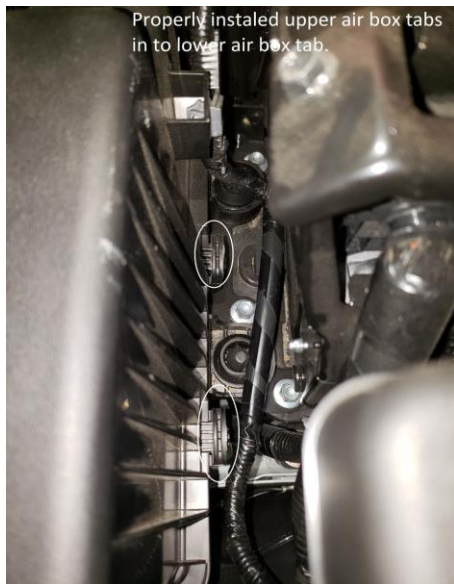
1. Verify the customer concern.
2. Before beginning normal diagnosis, inspect the air cleaner assembly. The three (3) attaching tabs at the lower rear area of the air cleaner assembly may not be properly attached. This could accidentally occur during an air filter inspection or replacement.

1. Open the hood.
2. Grasp the air cleaner assembly by hand and gently pull it toward the front of the vehicle.
 - If the air cleaner assembly moves, inspect the three (3) tabs at the lower rear area of the air cleaner assembly. Ensure that all three (3) tabs are properly attached to the lower air cleaner assembly.
 - If the air cleaner assembly is properly attached, perform normal diagnosis according to the instructions on MGSS online.

3. Verify the repair.
