# Replace Incorrect Labeling

**Classification** Campaign Bulletin **Section/Group** 19 - Labels **Country/Region** EMEA

**Year** 2019 **Model** Model 3 **Version** LHD

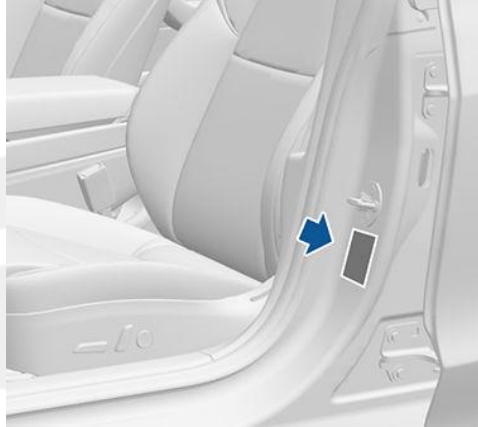
Figure 1

1. Open the driver's side door and inspect the manufacturing certification label near the base of the B-Pillar (Figure 1).

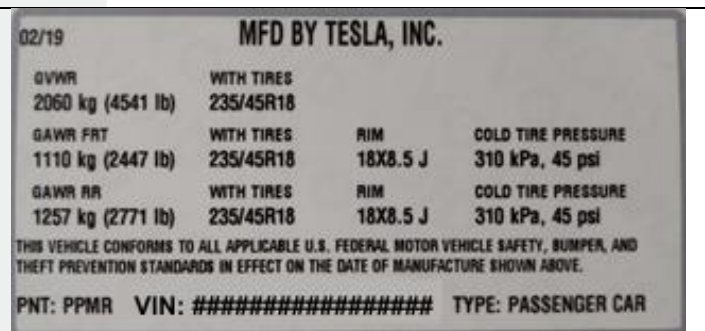
Figure 3 (US Label)

Certain Model 3 vehicles were manufactured with incorrect regulatory labeling near the base of the driver side B-pillar.

- If the label is an EU label (Figure 2), discontinue this procedure.
- If the label is a US label (Figure 3), continue to the next step.

2. Retrieve the updated label for the specific VIN.
3. Inspect the new label and check that the VIN matches the dashboard VIN plate.
4. Starting from one corner, carefully peel the label off the B-Pillar. Discard the label.

5. Use an alcohol wipe to remove any remaining adhesive or label shreds. Allow the alcohol to completely dry before continuing.

6. Install the updated label in the same location.
