GROUP
Voluntary Service Campaign

MODEL
2019MY Optima (JFa)

NUMBER
SC173

SUBJECT: FRONT SEATBACK FRAME REPLACEMENT (SC173)

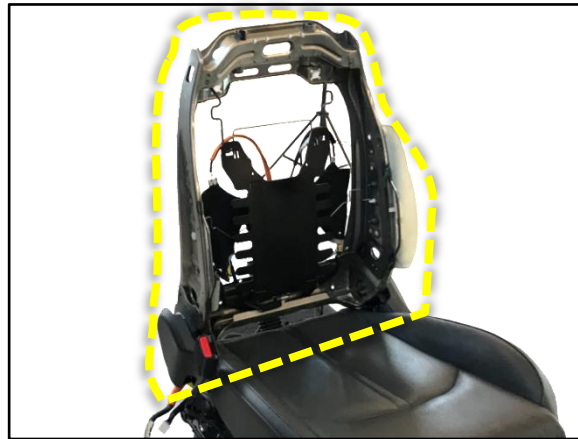
This bulletin provides the procedure to replace the front driver and/or passenger seatback frames in certain 2019MY Kia Optima vehicles, manufactured from December 13, 2018 through January 2, 2019. The upper side member connection area on one side of the front seatback frame may have been improperly welded and may detach as a result. If the weld detaches, the driver or front seat passenger may hear a noise coming from the area and/or may experience slight discomfort when seated.

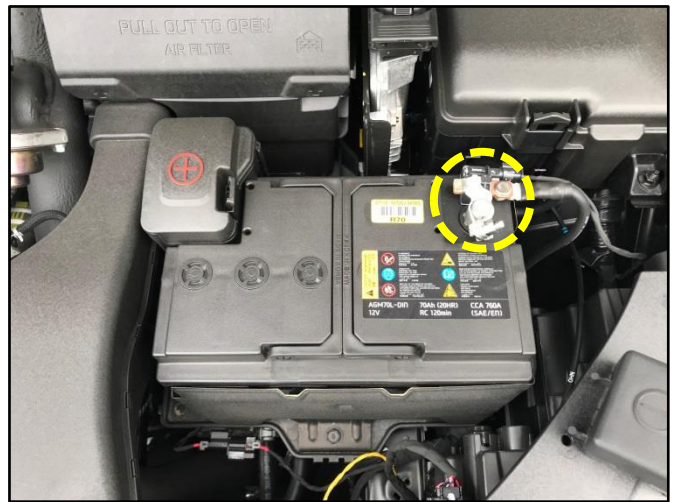
1. If necessary, use a Memory Saver to retain or record all radio presets.
2. Disconnect the negative (-) battery cable.

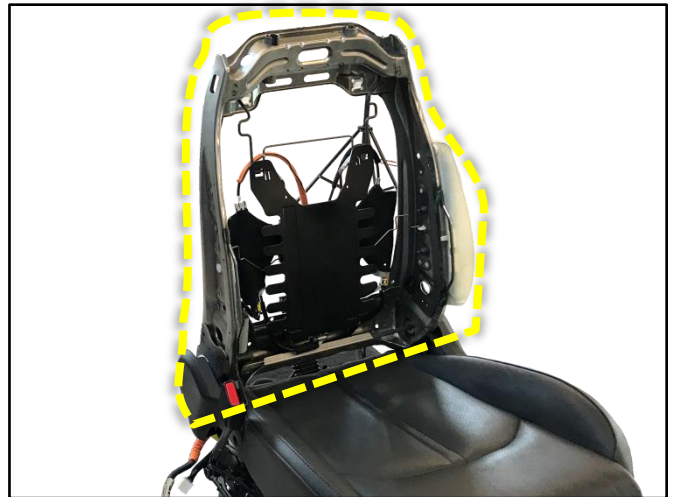
3. Determine per VIN whether the vehicle requires both (SC173B), only driver (SC173L) or front passenger (SC173R) seatback replacement, and then replace the driver and/or front passenger seatback frame(s) by referring to the "Body (Interior and Exterior) → Front Seat → Front Seat Frame Assembly → Repair procedures" chapter in the applicable Shop Manual on KGIS.

Removal of the seat cushion is not necessary.
