CAMPAIGN BULLETIN

Rear Brake Caliper

Reference: PC687

PC687 - 2019 – ROGUE BRAKE CALIPER INSPECTION

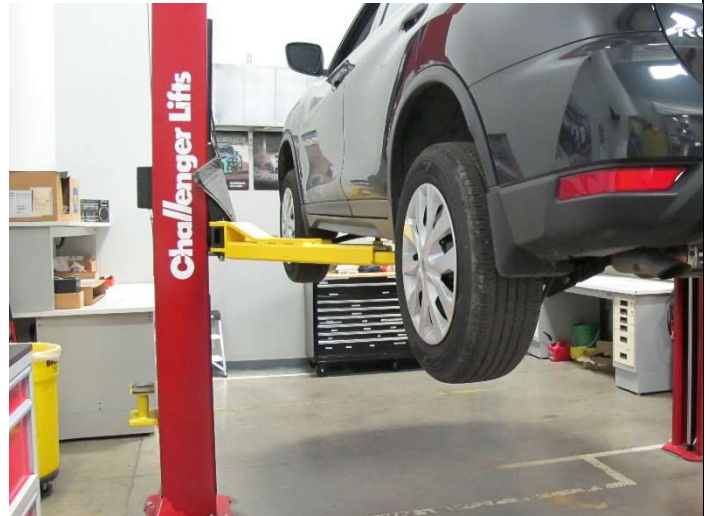
Figure 1

1. Place vehicle on lift. (Figure 1)

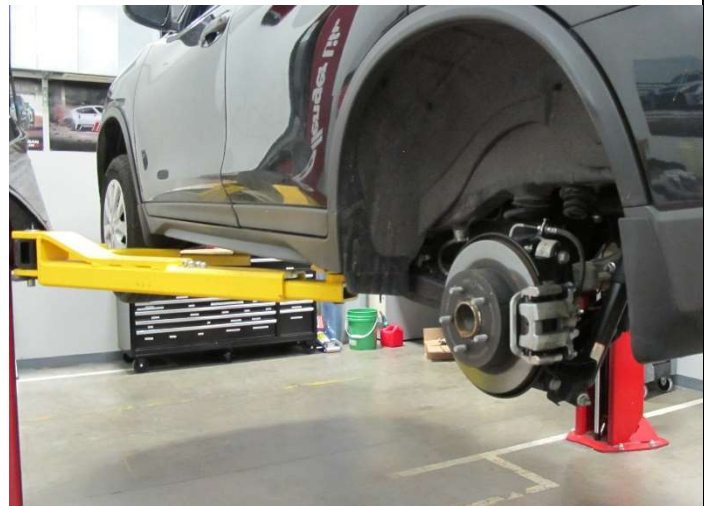
Figure 2

2. Remove the LH rear wheel and tire assembly.
- Remove the wheel cover (if applicable)
 - Remove the (5) lug nuts and the wheel and tire assembly (Figure 2)

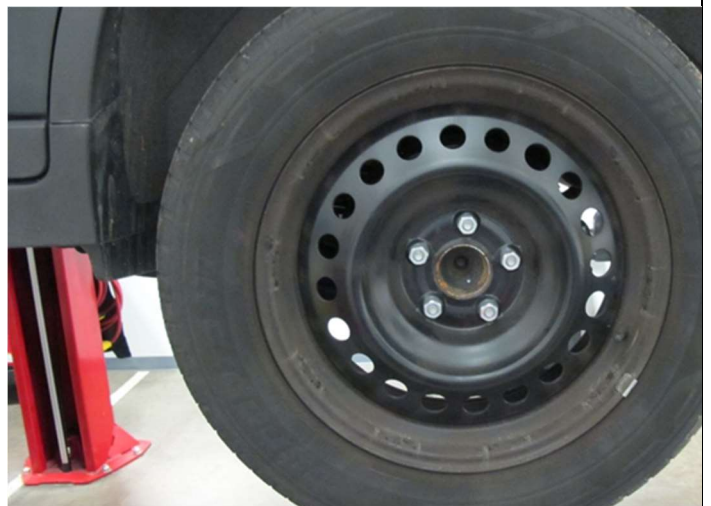
Figure 5

5. Reinstall the wheel and tire assembly. (Figure 5)

- Reinstall the LH rear wheel and tire assembly
- Torque lug nuts to 113 N•m (12 kg-m, **83 ft-lb**)
- Install wheel cover (if applicable)
- Inspection complete
- Submit warranty claim using Op code **PC6870** per "Claims Information"

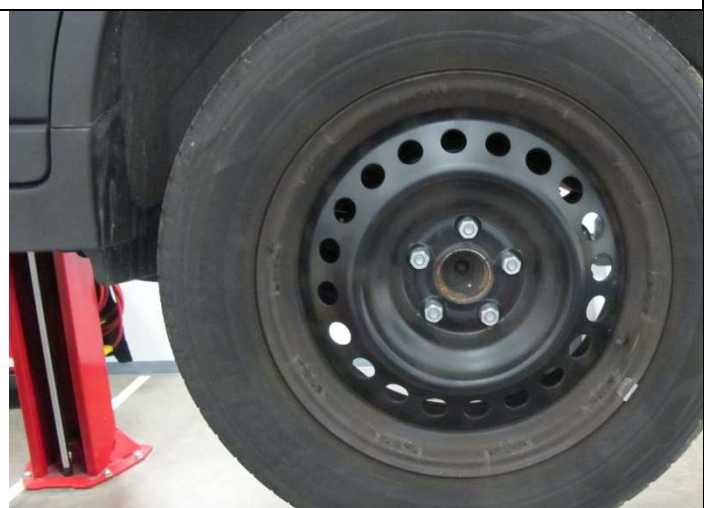
Figure 16

15. Reinstall the wheel and tire assembly. (Figure 16)

- Reinstall the LH rear wheel and tire assembly
- Torque lug nuts to 113 N•m (12 kg-m, **83 ft-lb**)
- Install wheel cover (if applicable)
