## Technical Information Bulletin

**02-147**

T680/T880/W990 Sunvisor Clips Breaking

1/11/2019

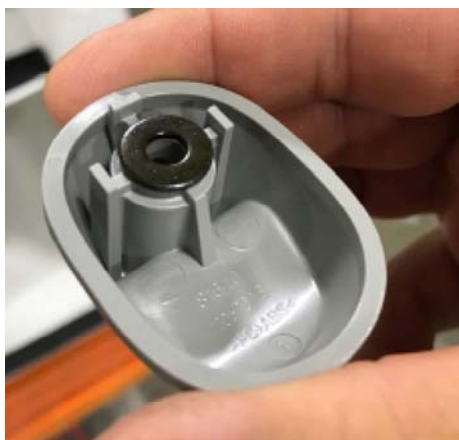
- Remove the damaged/broken sunvisor clip.
- Install a new sunvisor clip with a #10 flat washer positioned between the clip and the headliner.

- Even if the other sunvisor clip is undamaged, remove it and install a #10 flat washer between the clip and the headliner to prevent damage in the future.
