## **RECREATIONAL VEHICLE SERVICE CAMPAIGN**

### **SERVICE ADVISORY 19-344**

### Outback 341RD Air Return

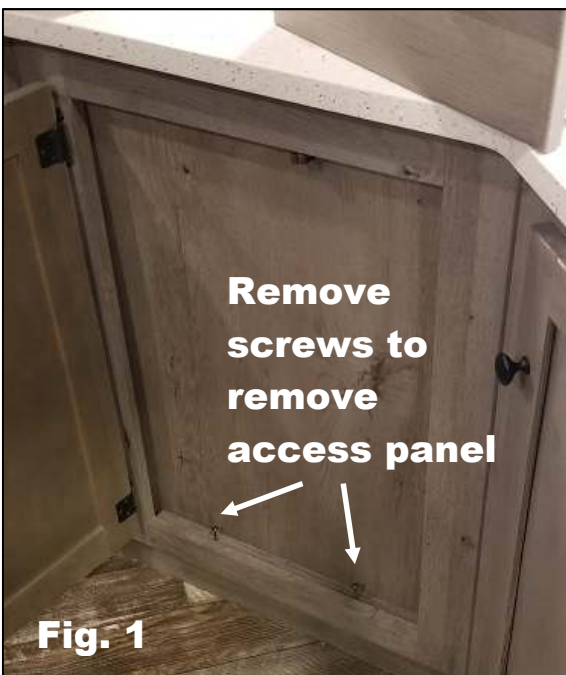
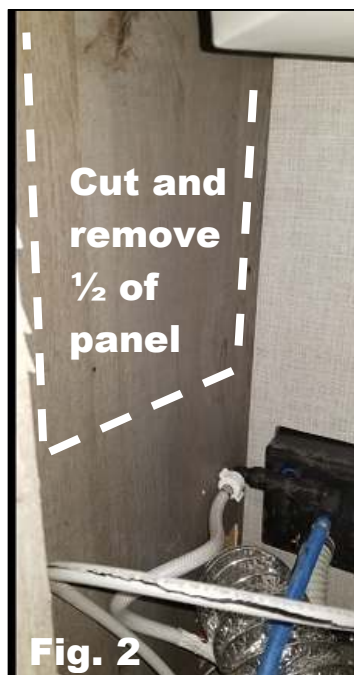
Remove the access panel under the kitchen sink. Cut and remove the top half of the plywood panel to the left of the opening as seen in Figure 1 and 2.

The remedy is to remove the access panel under the kitchen sink, cut out the lower half of the plywood panel next to the drawers for air flow, and install the return air grill in the end of the cabinet. Clean up any debris from the job and reinstall the furnace access panel under the sink.

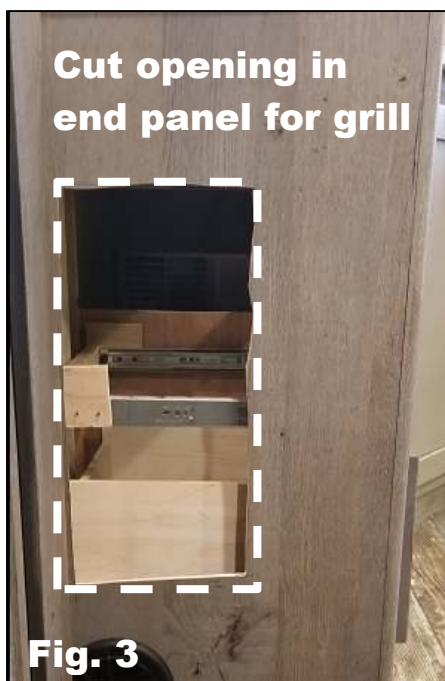
On the end panel of the cabinet base, measure from the side wall and make marks at 3 inches and 10 ½ inches. Next measure from the bottom of the counter top 8 inches and 25 inches. Carefully cut out opening using utility knife, see Figure 3.

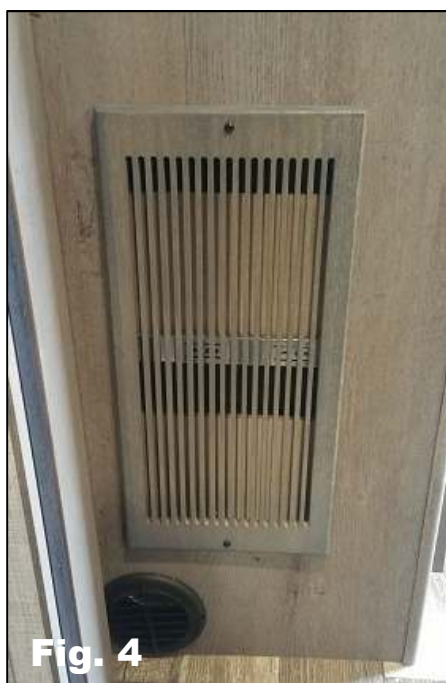
Install return air grill – 616205, see Figure 4.
