## SERVICE BULLETIN

<b>Reference number:</b>	<b>SB-01-1171</b>	<b>Issued: 4 February, 2019</b>
<b>Subject:</b>	<b>Front-Pad Wear-Warning-Lead Re-Routing</b>	
<b>Model(s):</b>	<b>DB11, Vantage 19MY and DBS Superleggera</b>	
<b>VIN Range:</b>	<b>All</b>	
<b>Applicable to:</b>	<b>All Dealers</b>	
<b>Distribute to:</b>	<b>After Sales Manager</b> <b>Executive Manager</b> <b>Service Manager</b> <b>Sales Manager</b>	<b>Warranty Staff</b> <b>Technician(s)</b> <b>Parts Staff</b>

### Reason for this Service Bulletin

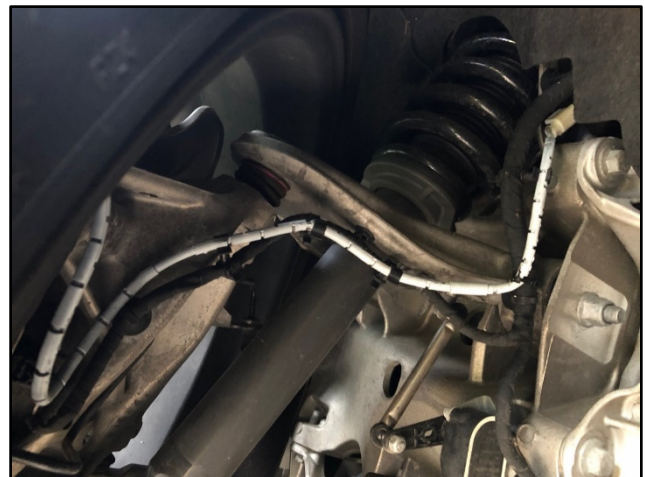
**Figure 1**

On some vehicles, a wheel can touch the Front-Brake-Pad Wear-Warning-Lead and cause damage. This can occur when the vehicle moves and the steering wheel is turned to the maximum steering angle.

1. Examine the Wear Warning Lead for damage (refer to Figure 1). Inspection can be done with the wheels removed or with the steering wheel turned to the maximum steering angle.  
If there is no indication of contact with the tyre, this Service Bulletin can be ignored.  
If there is an indication of contact with the tyre, go to Step 2.

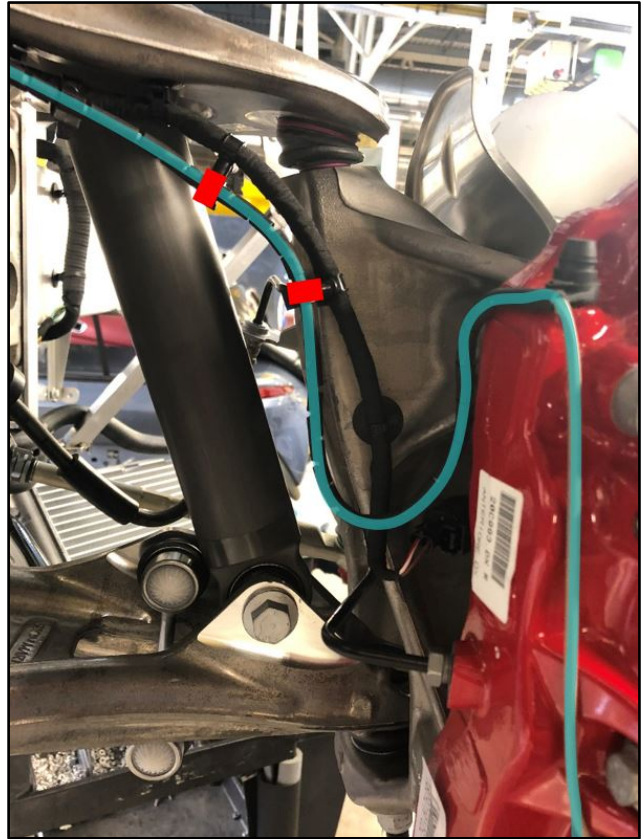
Figure 8

11. Allow the remaining lead length to collect by the caliper (refer to Figure 8).
