Service Bulletin

Bulletin No.: 18-NA-287

Subject: Blank or Distorted 7-Inch Radio Display During Radio Replacement

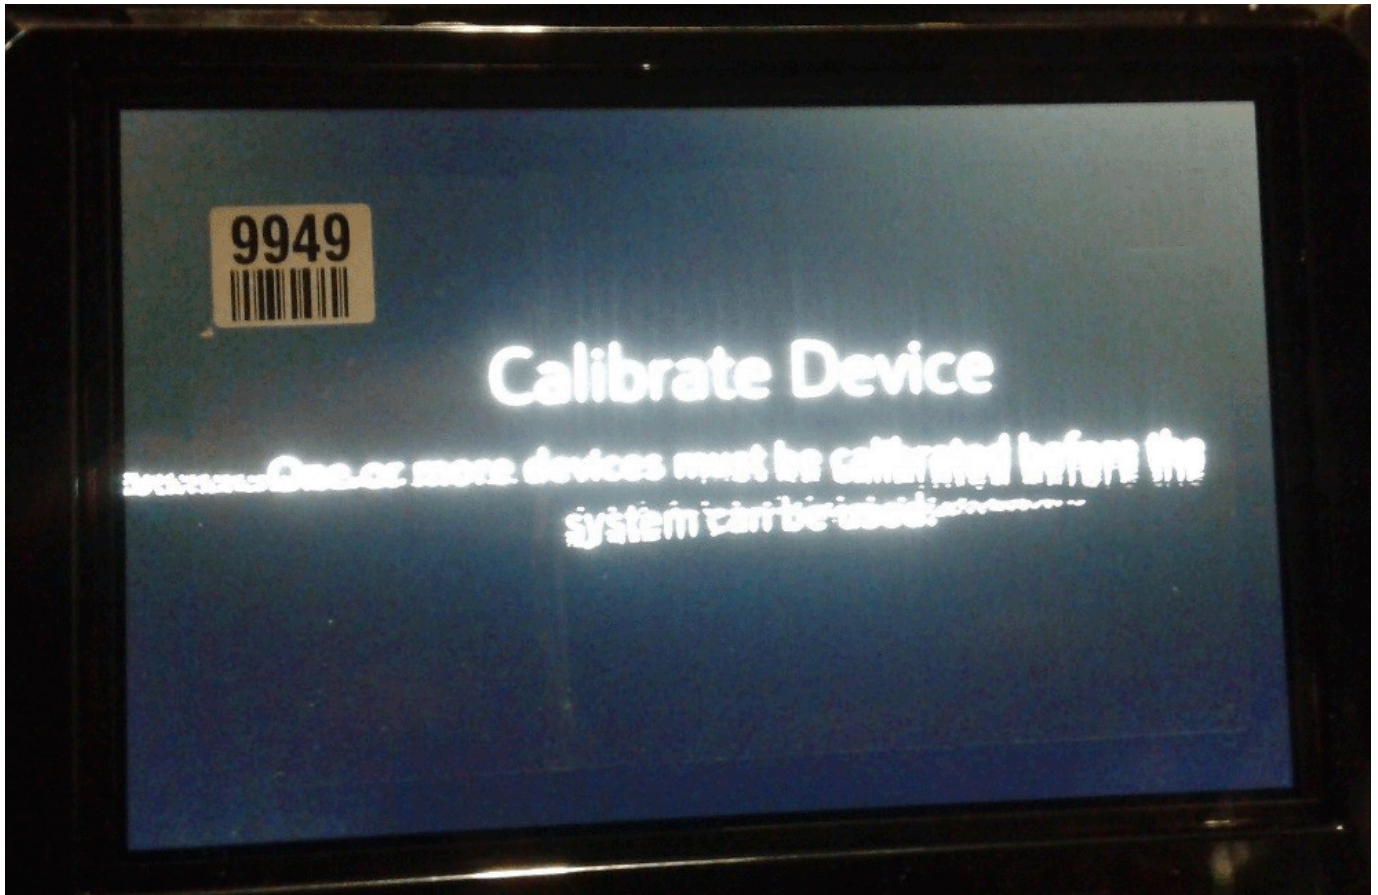
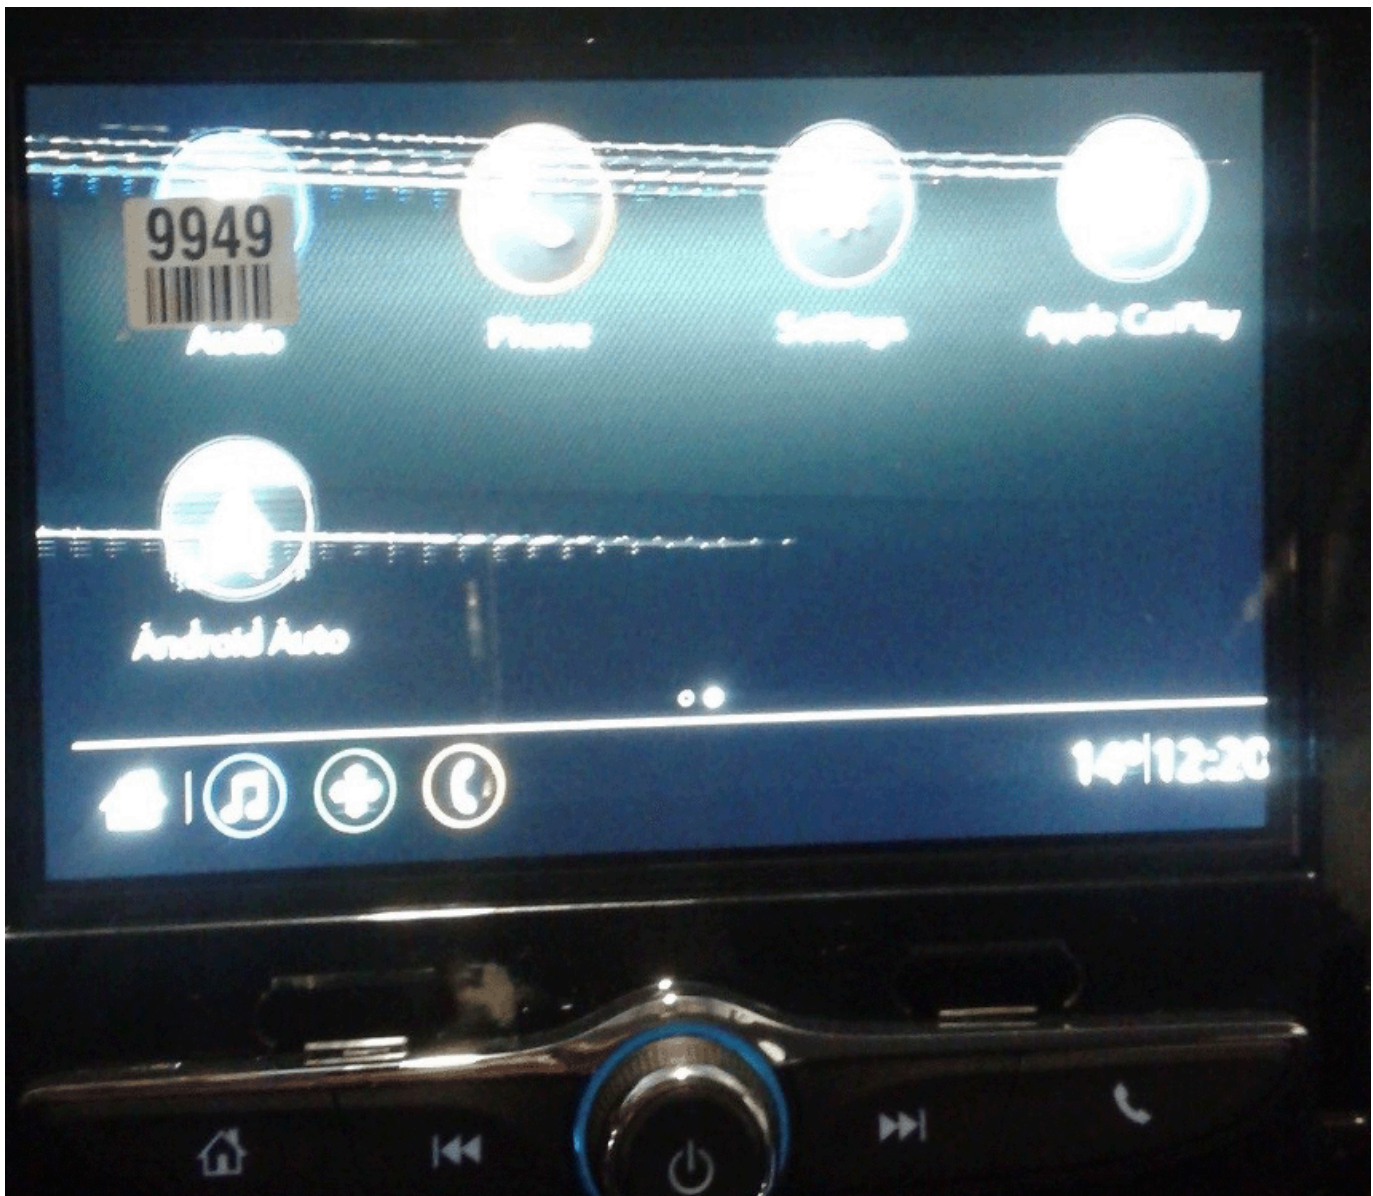
5206656

Involved Region or Country	North America, N.A. Export Regions, Australia
Additional Options (RPOs)	Equipped with Infotainment System RPO IOR or UIR
Condition	Some technicians may notice that a blank or distorted screen may appear on the radio display after radio replacement.
Cause	The cause of the condition may be that the IOR radios are manufactured with a default calibration for 8-inch displays. When a replacement radio is installed in a vehicle equipped with a 7-inch display, the radio will output a blank or distorted screen.
Correction	Complete the <i>A11 Radio: Programming and Setup procedure</i> . After successful calibration, the radio display should no longer be blank or distorted.

Note: Examples of distorted display:

Note: Do NOT replace any parts for this condition. The condition described in this bulletin only occurs during the programming and setup of a replacement radio.

1. Complete the programming procedure. Refer to *A11 Radio: Programming and Setup* in SI.
2. If calibration is correct and a blank screen is present, this bulletin does not apply and SI should be referenced for further diagnosis.
