Rear View Mirror Falls Off the Windshield

Model	Model Year	Model Type	VIN Range	Vehicle-Specific Equipment
911	2017-2019	991	N/A	N/A

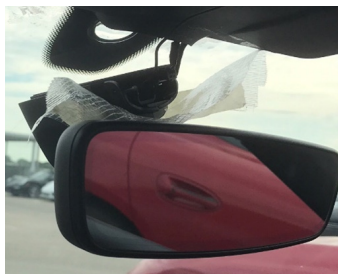
The adhesive holding the mount for the rear view mirror to the windshield fails and the mirror falls down.

The activator and primer are manually applied by the supplier. This manual process had a flaw in the application of the activator and primer. The process was revised at the supplier.

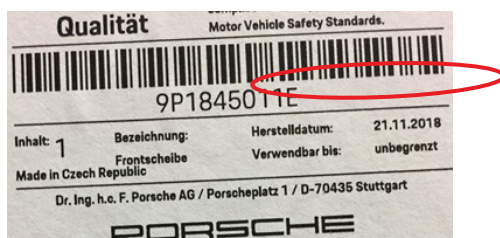
The windshield must be replaced. Windshields manufactured from June 2017 have been produced with the revised process at the supplier. The manufacturing date can be seen on the part data label.
