**SB-59**

**Securing Spoiler to Rear Cap, 2019 Allegro Buses**

## Securing Spoiler to Rear Cap on 2019 Allegro Buses, SB-59

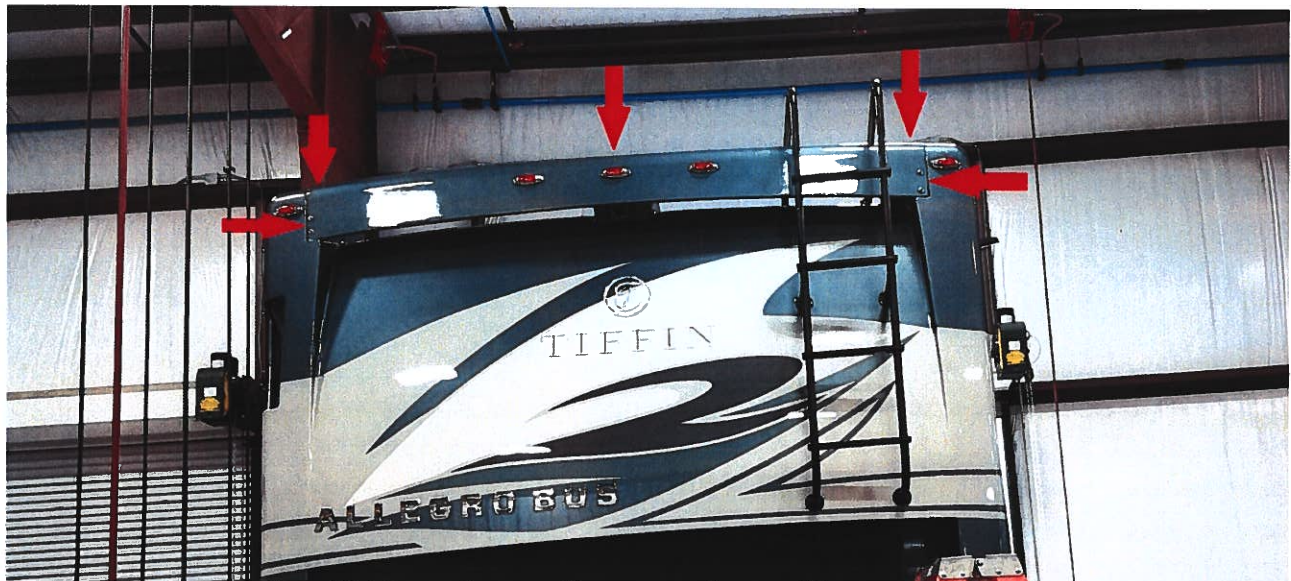
4. Starting at bolt insert on driver side, apply a bead of adhesive around each insert and surface between inserts (make sure adhesive will contact bottom of wing and top of rear cap) repeat process on passenger side. Apply adhesive to center mast (flat surface above rear camera) and around the bolt insert in this same area.

5. Apply blue "thread locker" to stainless steel bolts and reassemble wing to back cap. Bolts should only be "snug tight".
